# **2011 SCHOHARIE CREEK BASIN FLOODING**

## **Site Reconnaissance and Flood Evaluation**

*Prepared for:*  
New York Power Authority

**May 2012**

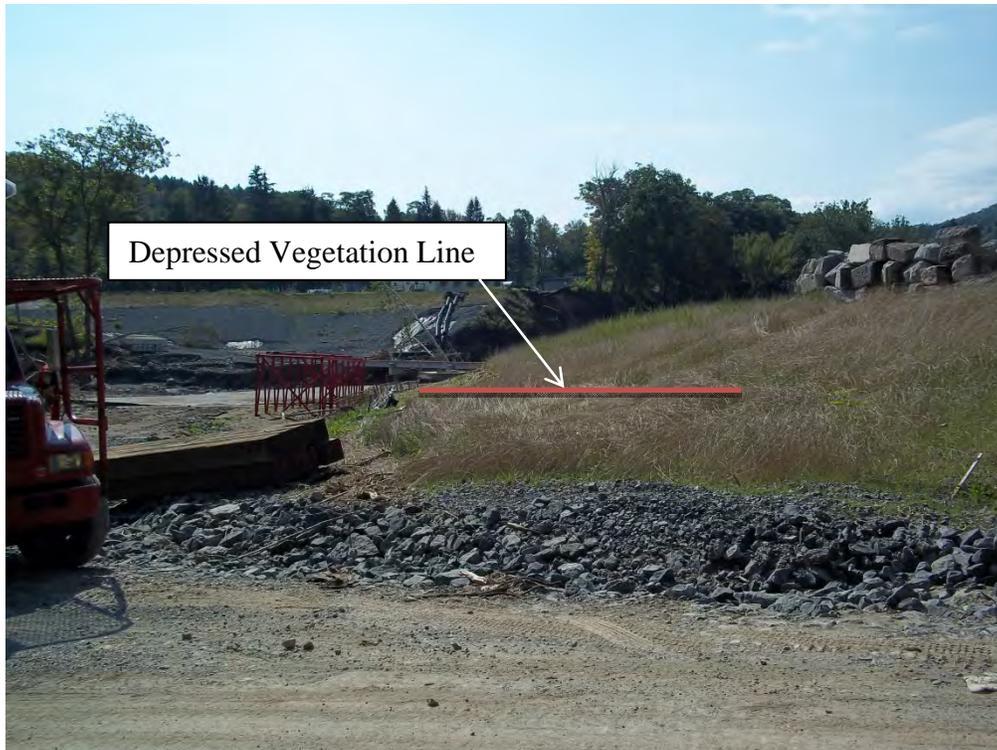
NYS Route 990V crosses the Schoharie Creek between the Gilboa Dam and the Blenheim-Gilboa Lower Reservoir, near Gilboa, NY (the bridge is approximately 0.5 miles downstream of the Gilboa Dam). A debris line was observed upstream of the bridge, on the left bank. The elevation of the debris line was surveyed at El. 977.9 (Survey Point 557).

P01 (Survey Point 557) – Left bank of Schoharie Creek, upstream of NYS Route 990V bridge. High water mark estimated by depressed vegetation in field (Photo taken 9/2/2011)

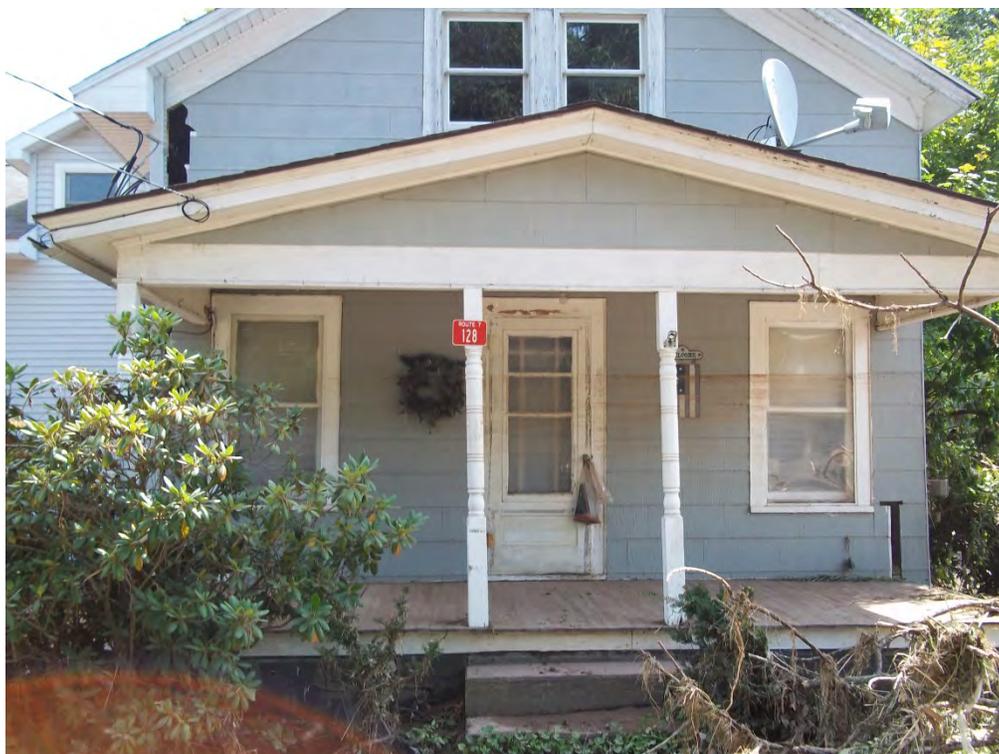
Survey Point 1002 represents a mud line that was observed around the outside of the residence at 128 County Route 7. The mud line was surveyed at El. 1151.1, approximately 5.0 feet above the first floor elevation of the home.

P03 (Survey Point 1002) – Mud line observed on outside of 128 County Route 7 in Prattsville. Mud line approximately 5.0 feet above first floor/porch. (Photo taken 8/31/2011)

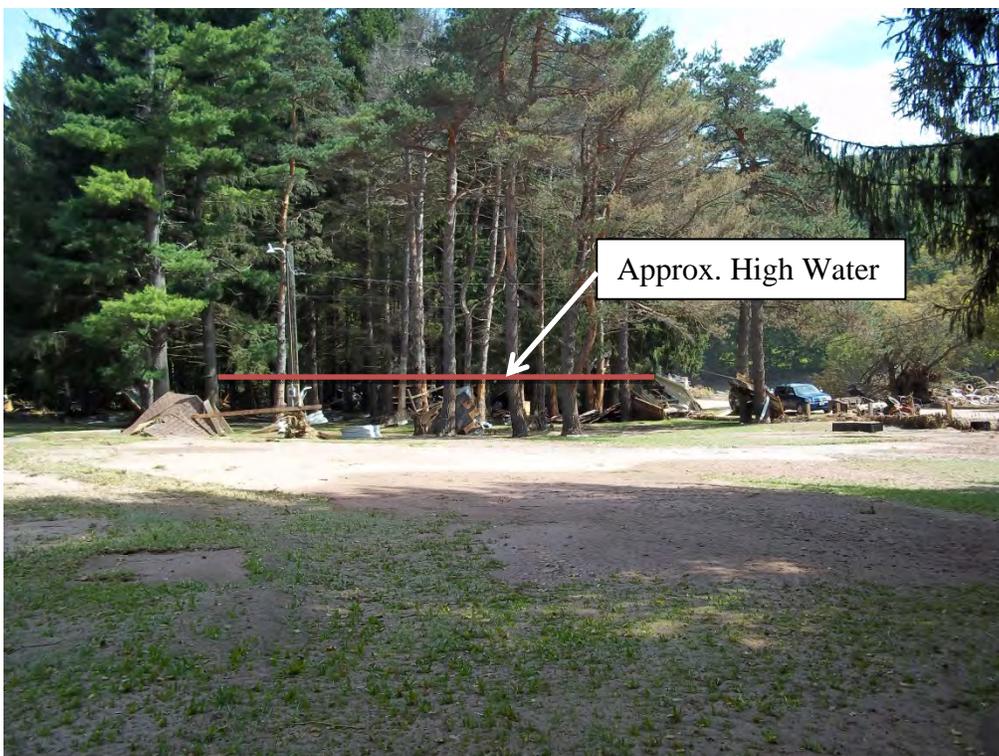
Survey Point 1005 represents a “debris” line (a line along some trees where bark had been removed/damaged, assumedly by debris from the flooding) that was observed on trees located across the road from 128 County Route 7. The debris line was surveyed at El. 1150.0.

P04 (Survey Point 1004) – Trees located across road from 128 County Route 7. Note line across trees where bark has been damaged/removed. (Photo taken 8/31/2011)

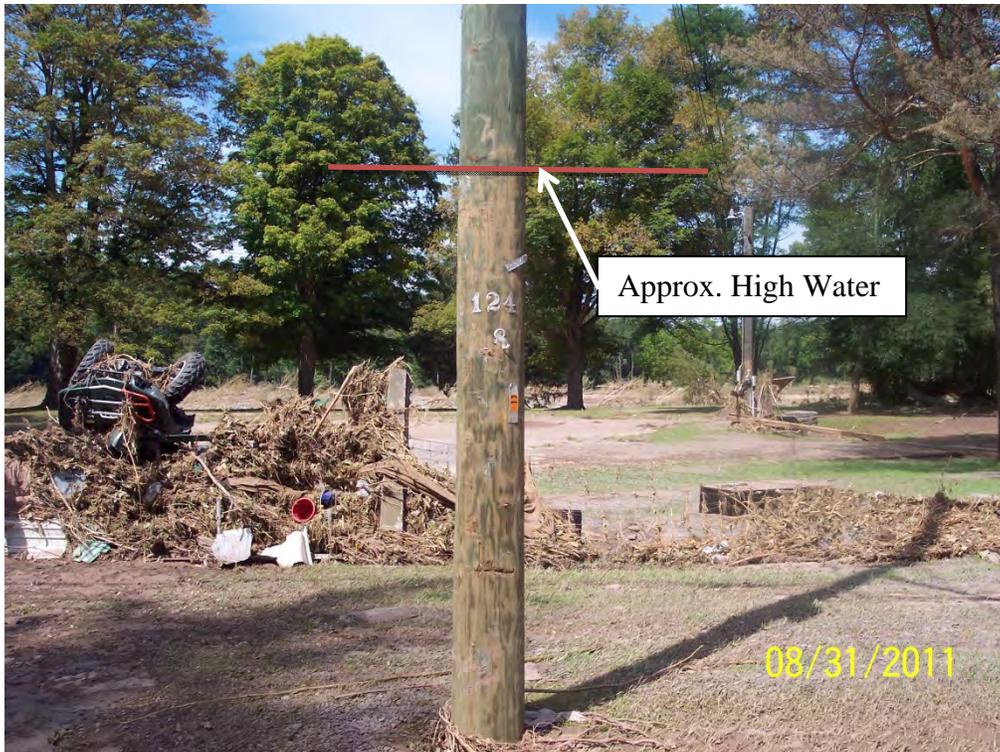
Survey Point 1004 represents a debris line that was observed on a utility pole located across the road from 128 County Route 7. The debris line was surveyed at El. 1150.7.

P05 (Survey Point 1005) – Utility pole located across road from 128 County Route 7. Note discoloration on lower portion of the pole, assumedly due to high water and debris (Photo taken 8/31/2011)

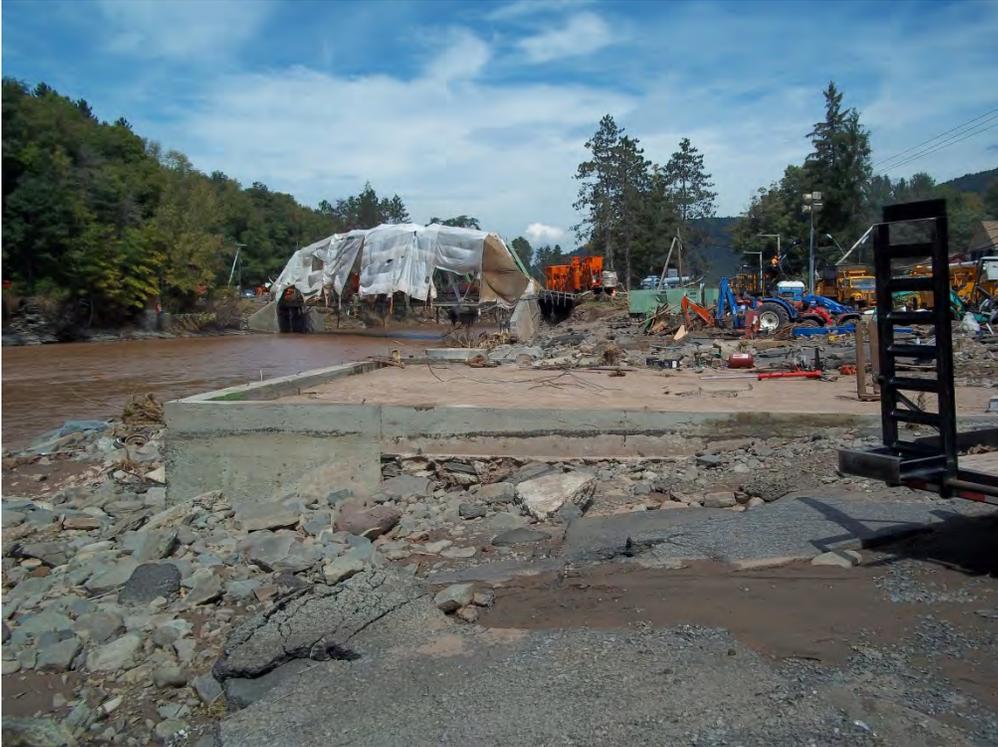
A mud line was observed on the outside of the residence at 14686 NYS Route 23. This residence was located across the road from a concrete foundation slab where a garage had been lost during the flooding. The mud line was surveyed at El. 1152.6, approximately 6.2 feet above the concrete slab (where the garage had been). The elevation of the mud line and the top of the concrete slab were recorded with Survey Points 1010 and 548, respectively.

P07 (Survey Point 548) – Concrete foundation slab of garage lost during flooding. Across the road from 14868 NYS Route 23. High water estimated to have been 6.2± feet above slab. (Photo taken 8/31/2011)

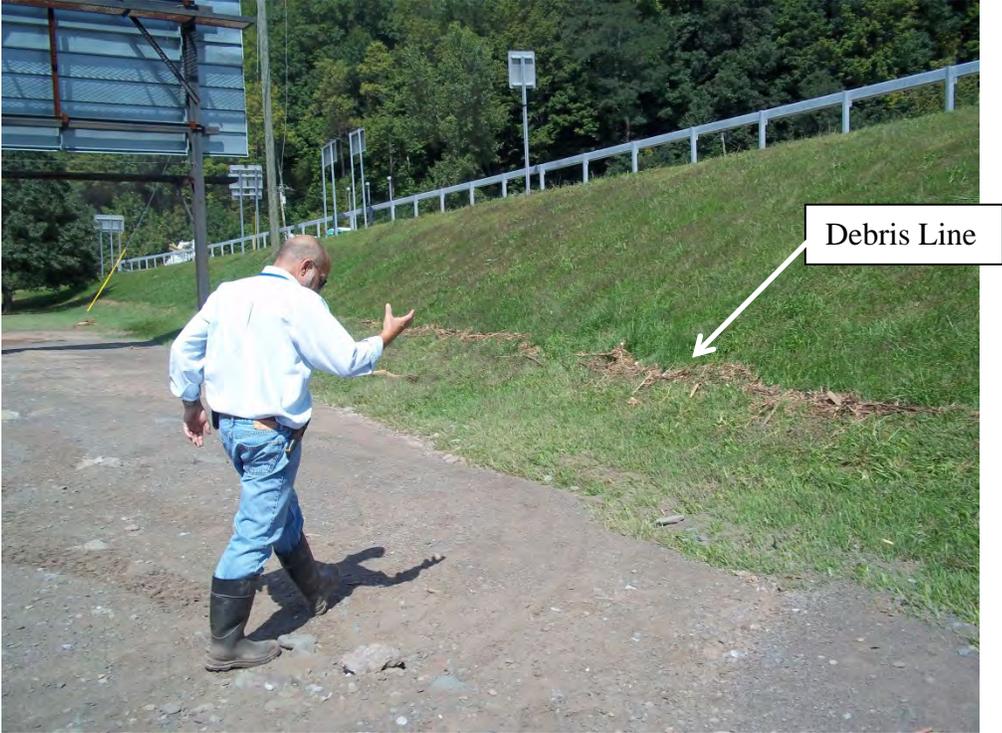
P08 (Survey Point 1011) – Debris line observed along embankment of NYS Route 23, near intersection with NYS Route 23A. (Photo taken 8/31/2011)

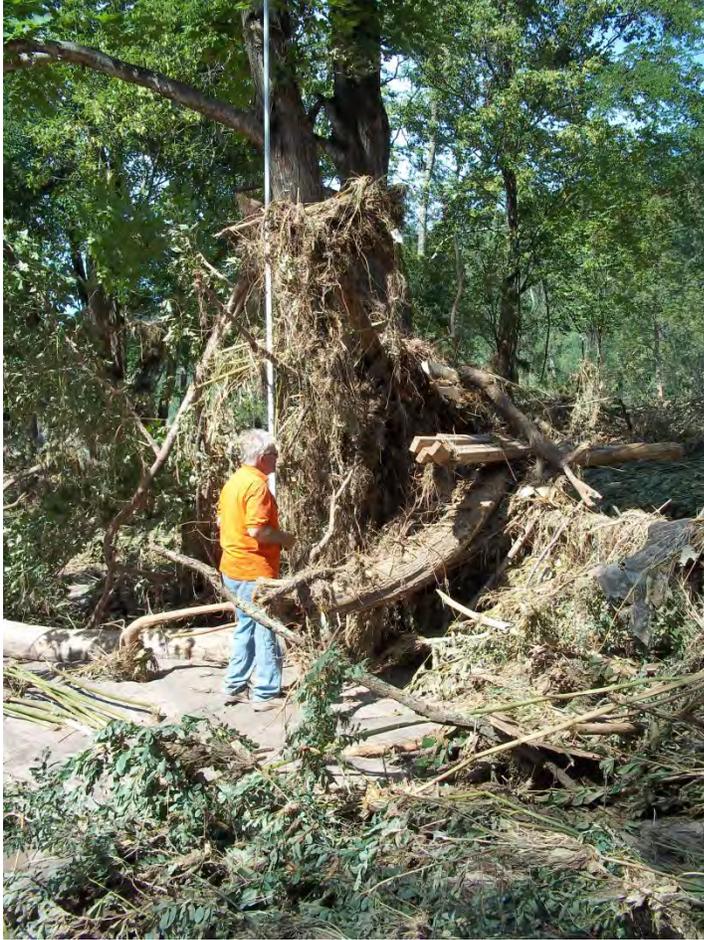
The intersection of NYS Routes 23 and 23A is located near the confluence of the Batavia Kill with the Schoharie Creek. A park with athletic fields and woods is located near the intersection. In this area, a debris line was seen along the embankment of the road and debris was observed in some trees. A benchmark disk was located on the northeast abutment of the NYS Route 23A bridge over Batavia Kill. The elevation of the debris line observed on the road embankment was surveyed at El. 1178.75 (Survey Point 1011), approximately 9.2 feet below the benchmark disk. The elevation of the debris in the tree was surveyed at El. 1177.2 (Survey Point 1012), approximately 10.7 feet below the benchmark disk.

P09 (Survey Point 1012), left – Debris observed in trees near confluence of Batavia Kill with Schoharie Creek. (Photo taken 8/31/2011)

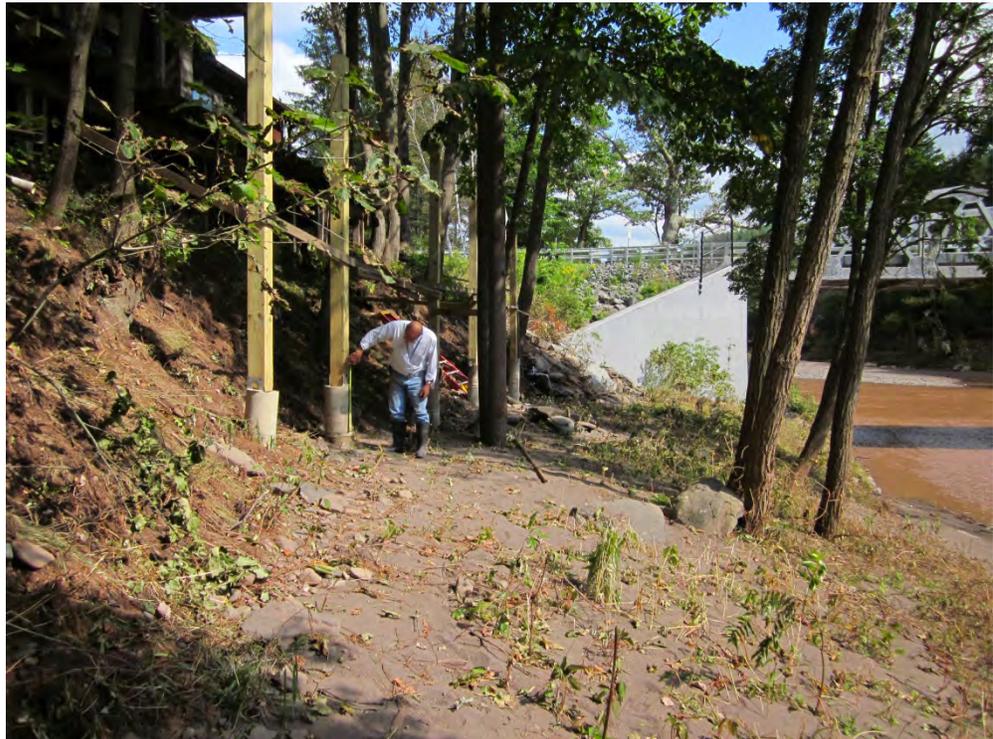
A mud line was observed on a concrete pier behind the residence at 12293 NYS Route 23A, immediately downstream of the Mosquito Point Bridge (County Route 2 over the Schoharie Creek), approximately 2.5 miles west of Lexington, NY. The elevation of the mud line was surveyed at El. 1267.0 (Survey Point 1033).

P10 (Survey Point 1033), below – Mud line observed on concrete pier behind residence at 12293 NYS Route 23A, approximately 2.5 miles west of Lexington, NY. Note Mosquito Point bridge in background. (Photo taken 9/2/2011)

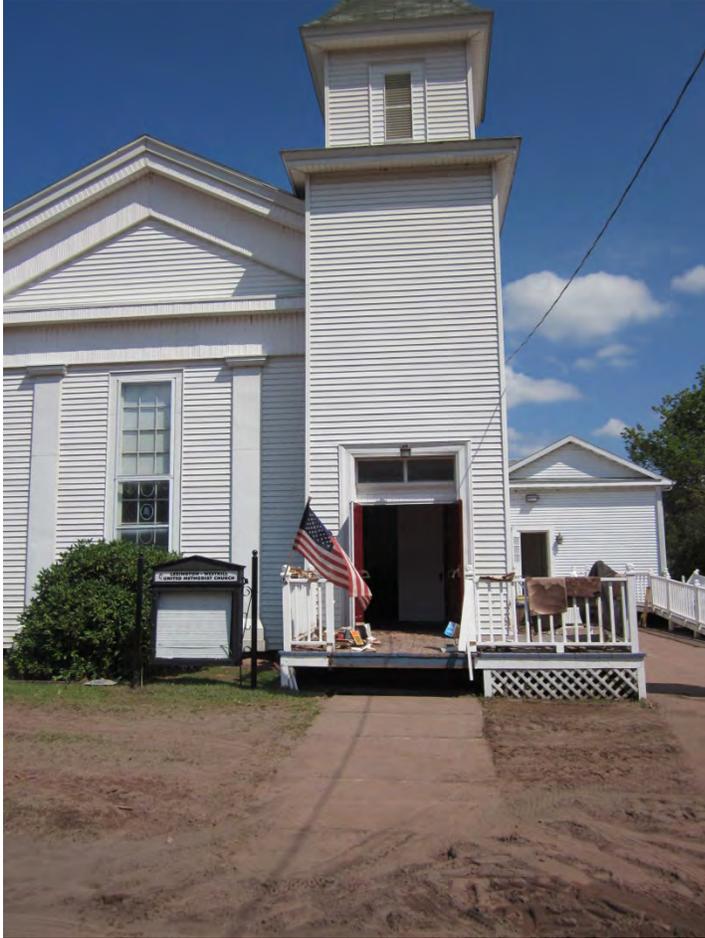
A mud line was observed on the Lexington-West Kill United Methodist Church, County Route 13A in Lexington, NY. The mud line was approximately 17 inches above the floor inside the building. The elevation of the mud line was surveyed at El. 1323.6 (Survey Point 571).

P11 (Survey Point 571), left – United Methodist Church, Lexington-Westkill. Mud line observed approximately 17 inches above floor inside. (Photo taken 9/2/2011)

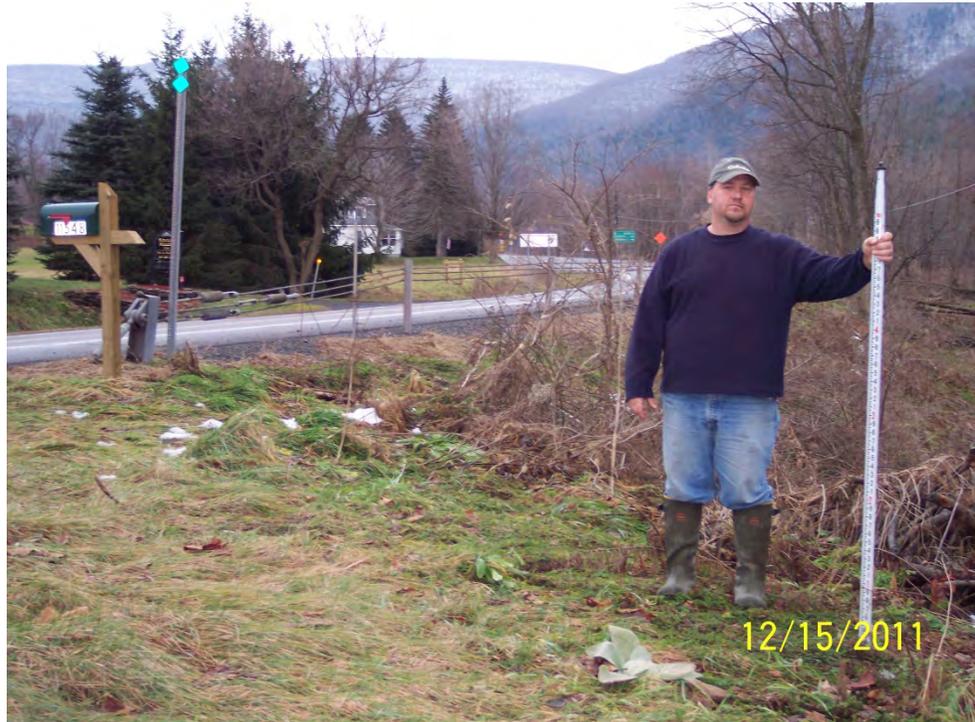
A debris line was observed on the right bank of the Schoharie Creek across the road from the Mountain Meadow Inn (11548 NYS Route 23A), in Lexington, NY. The elevation of the debris line was surveyed at El. 1314.7 (Survey Point 1034).

P12 (Survey Point 1034), below – Debris line observed on right bank of Schoharie Creek, across road from Mountain Meadow Inn, Lexington. Surveyor standing at approximate location (Photo taken 12/15/2011)

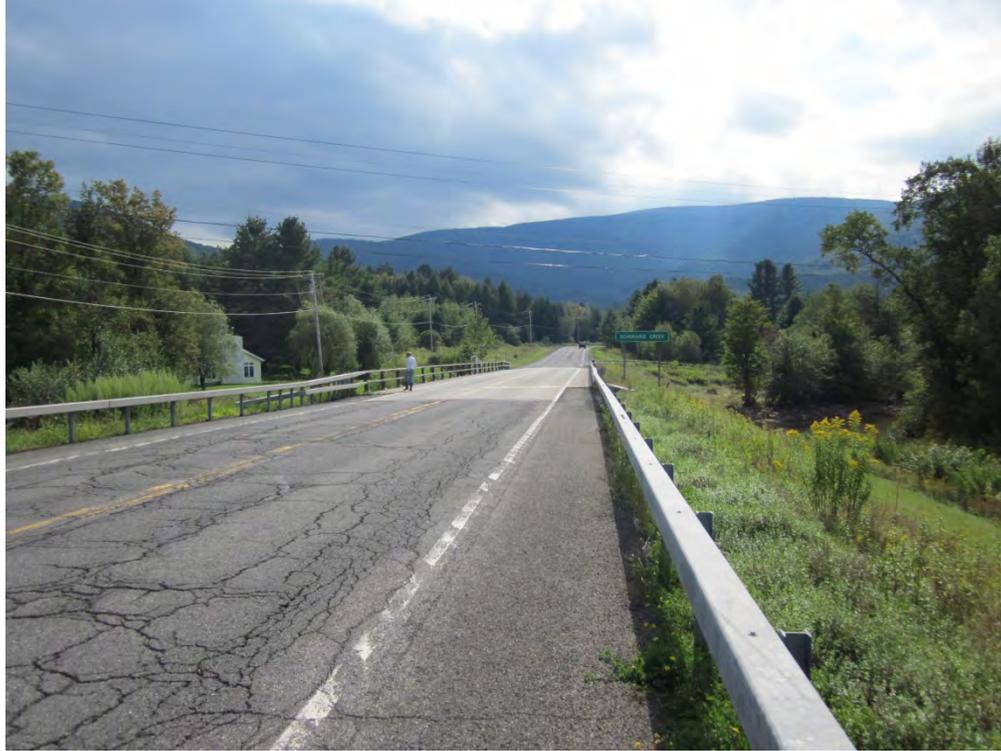
County Route 214 crosses the Schoharie Creek in Hunter, NY. A debris line was observed on the left bank, downstream of the bridge. The elevation of the debris line was surveyed at El.

1674.8 (Survey Point 1040), approximately 11.9 feet below the bridge deck. This was the furthest upstream high water mark surveyed for this study on the Schoharie Creek.

P13 (Survey Point 1040) – County Route 214 bridge over Schoharie Creek in Hunter, NY (photo taken from right side). Debris line was observed on left bank of creek near bridge, approximately 11.9 feet below bridge deck. (Photo taken 9/2/2011)

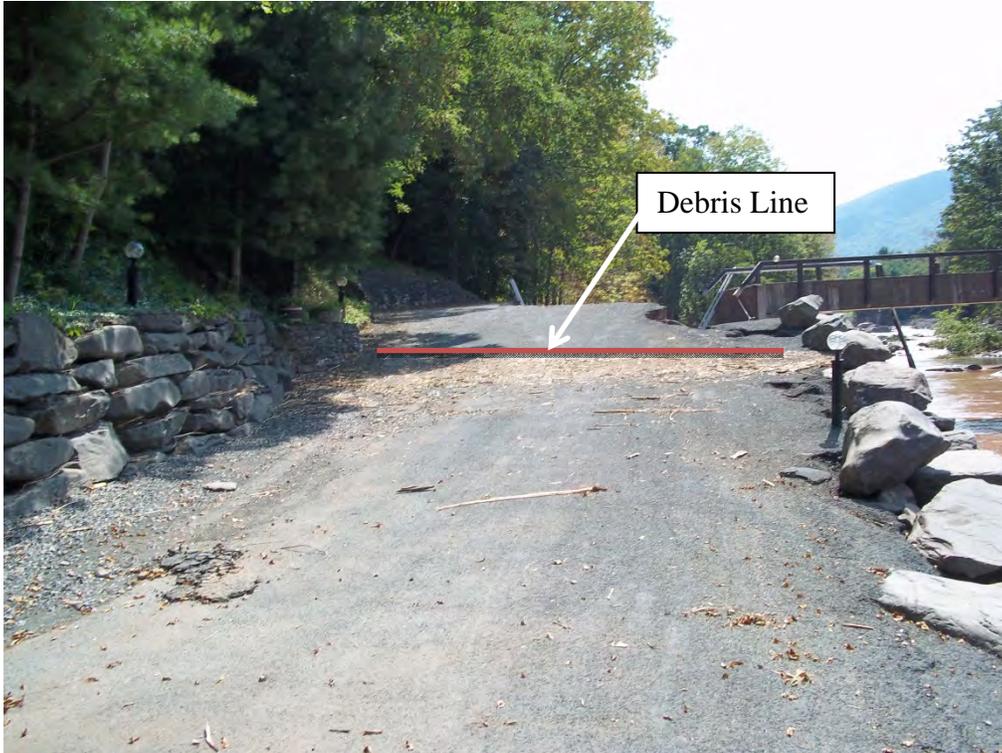
Two high water marks were identified in Ashland; one in the driveway of a residence (13291 NYS Route 23) and one in a field near Diamond Landscaping. A debris line was observed in the driveway at 13291 NYS Route 23 and a PK nail was driven into the pavement to mark this estimated high water level. The elevation of the estimated high water mark was El. 1333.0 (Survey Point 562).

P14 (Survey Point 562) - Debris line observed at entrance to 13291 NYS Route 23 in Ashland. PK nail driven into pavement to identify elevation of debris line (Photo taken 9/2/2011)

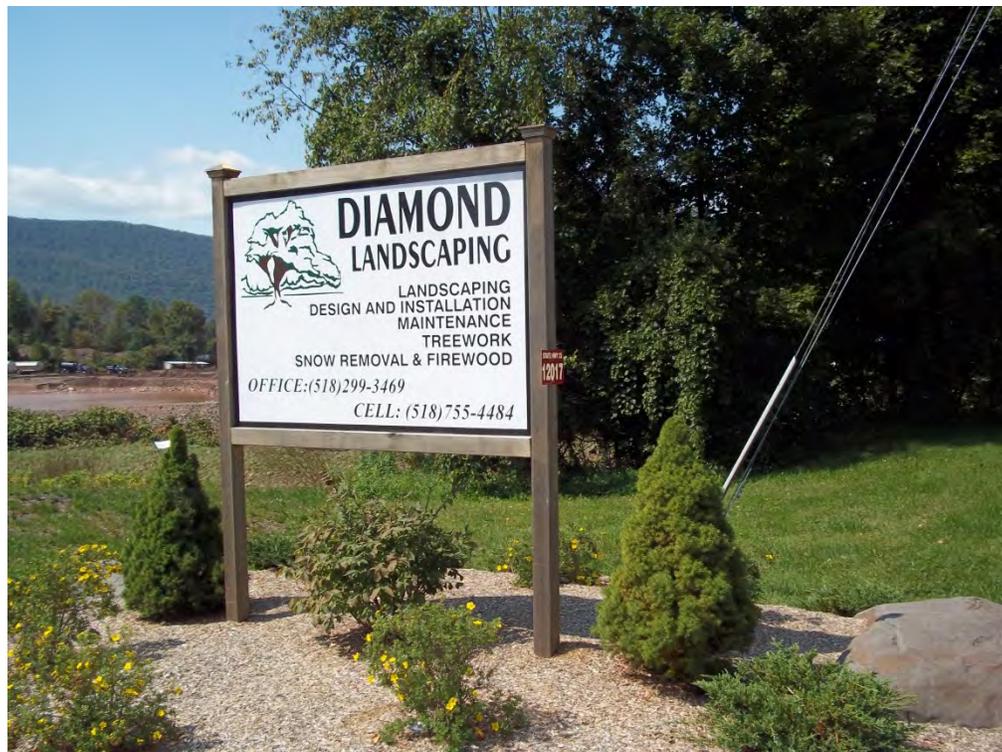
P15 (Survey Point 561) – Sign outside of Diamond Landscaping Building in Ashland (12017 NYS Route 23). High water was approximated based on depressed vegetation in nearby field (Photo taken 9/2/2011)

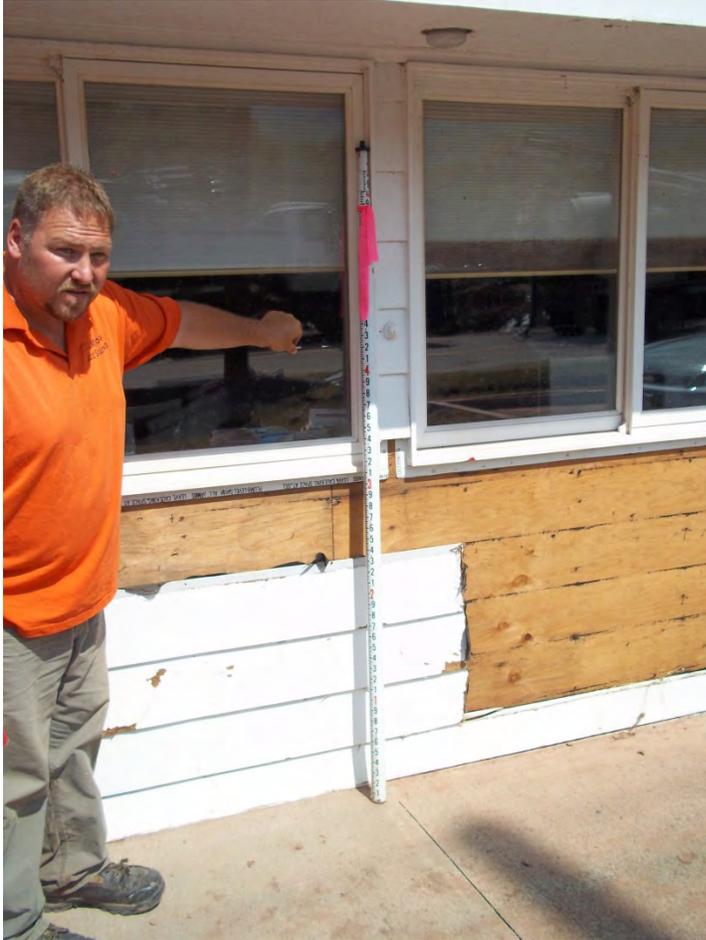
The mud line observed on the Ulster Savings Building in Windham was approximately 4.2 feet above the sidewalk in front of the building. The mud line was surveyed at El. 1501.8 (Survey Point 1042).

P18 (Survey Point 1042), left – Mud line observed on Ulster Savings Building in Windham. Mud line was approximately 4.2 feet above sidewalk, was more visible inside building (Photo taken 9/2/2011)

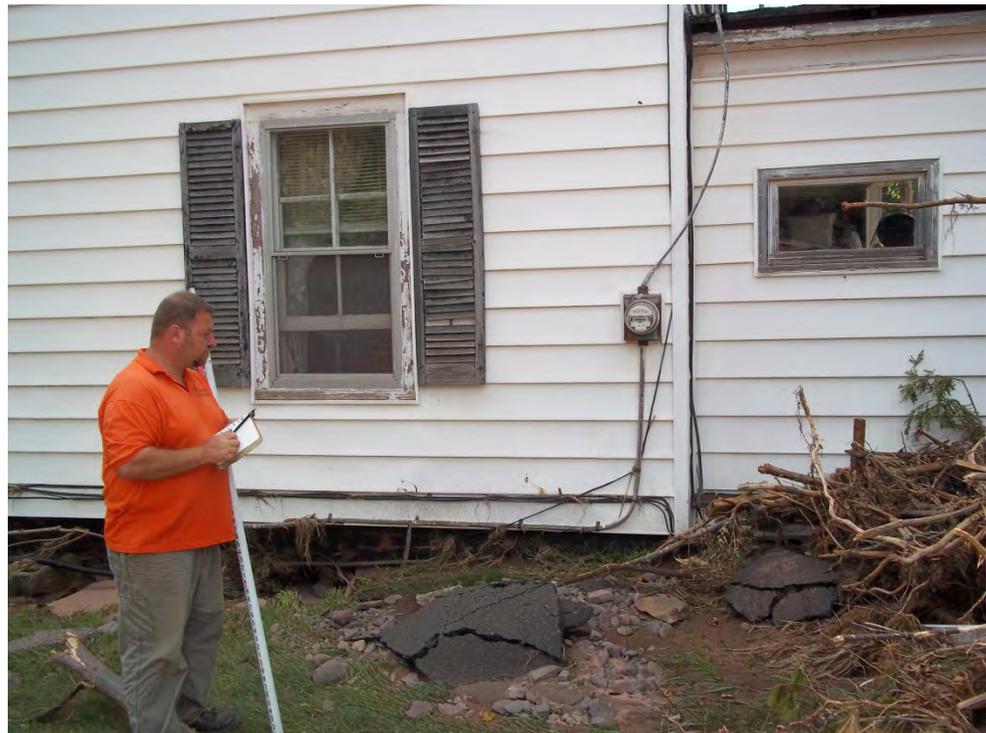
One high water mark was identified in Maplecrest, at the residence at 470 County Route 40. A definitive high water mark was not apparent, but we spoke to the resident who had noted that the water had reached just below the side window of her home, approximately 2.2 feet above the bottom of the siding. The estimated high water level was surveyed at El. 1748.1 (Survey Point 1041).

P19 (Survey Point 1041), below – Residence at 470 County Route 40 in Maplecrest. Mud line not observed, but resident approximated high water was just below side window of home, approximately 2.2 feet above the bottom of the siding (Photo taken 9/2/2011)

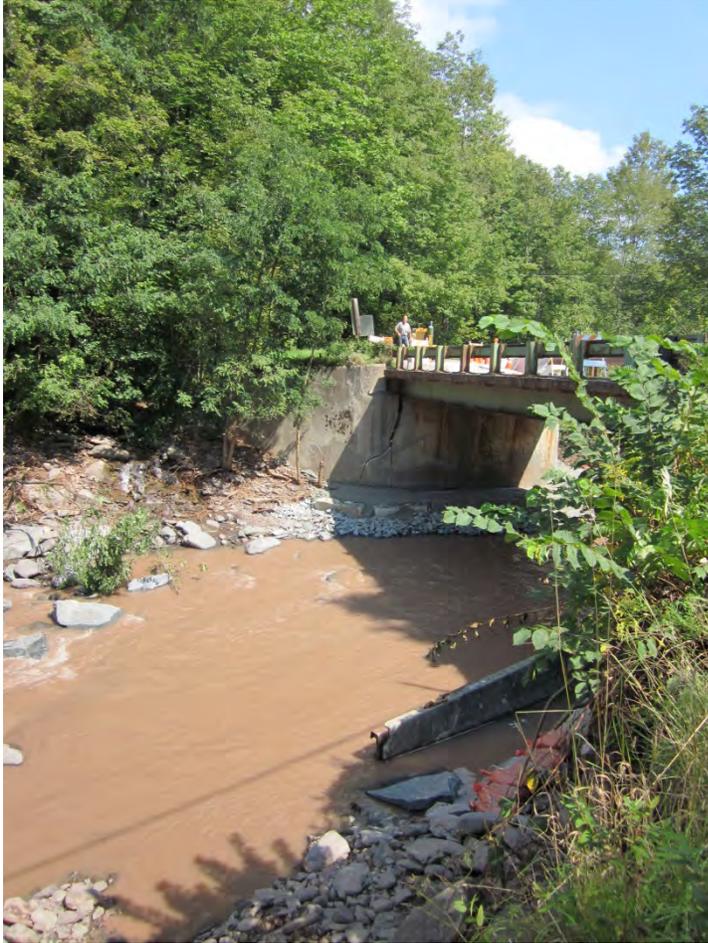
The high water mark in this area was estimated based on a debris line observed on the left bank of the West Kill, just downstream of the County Route 6 bridge over the stream. The elevation of the debris line was surveyed at El. 1517.8 (Survey Point 1035).

P20 (Survey Point 1035), left – Downstream face of County Route 6 bridge in West Kill. Debris line observed on left bank. (Photo taken 9/2/2011)

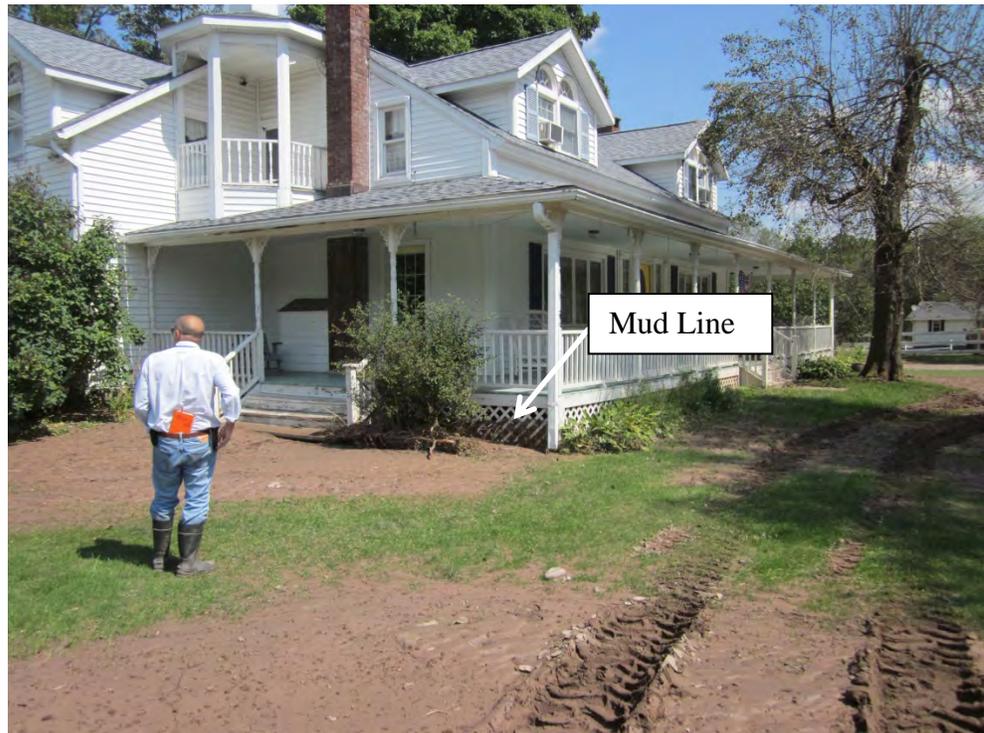
A mud/debris line was observed on buildings at the Bay Ridge Farm on NYS Route 42 near Lexington, NY. The mud/debris line was approximately 11 inches below the porch on the south side of the building. The mud line was also observed above the middle step on the west side of the building. The elevations of the mud/debris line at the locations described above were surveyed at El 1322.1 (Survey Point 573) and El. 1322.2 (Survey Point 574), respectively.

P21 (Survey Point 573), below – Porch on south side of building at Bay Ridge Farm. Debris/mud line observed approximately 11 inches below porch. (Photo taken 9/2/2011)

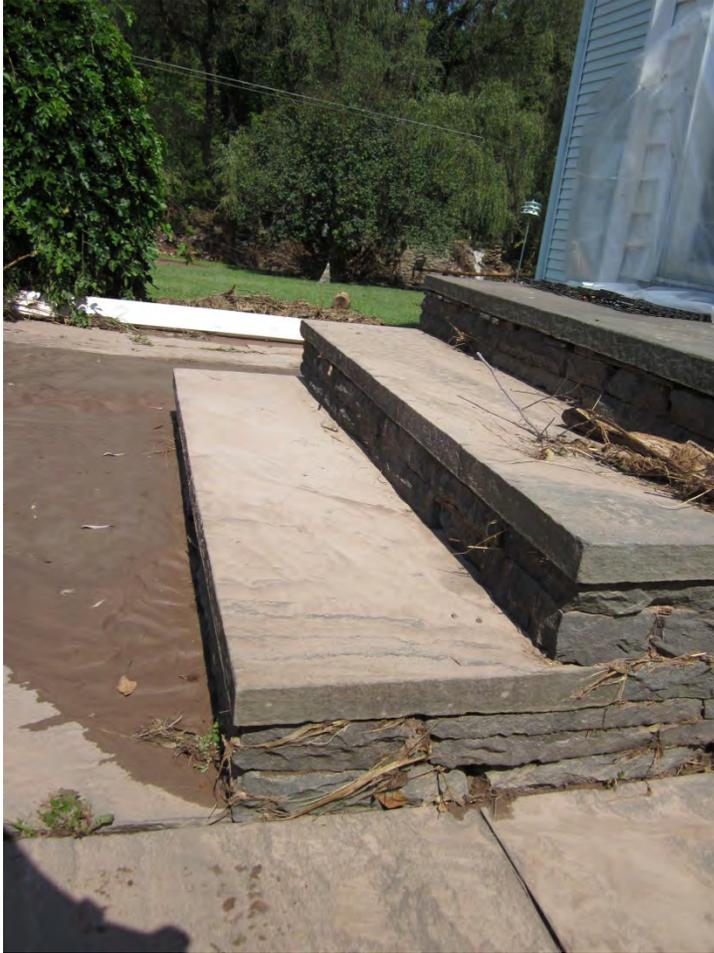
P22 (Survey Point 574), left – Stone steps on west side of building at Bay Ridge Farm in Lexington, NY. Debris and mud were observed on middle step, but not top step. (Photo taken 9/2/2011)

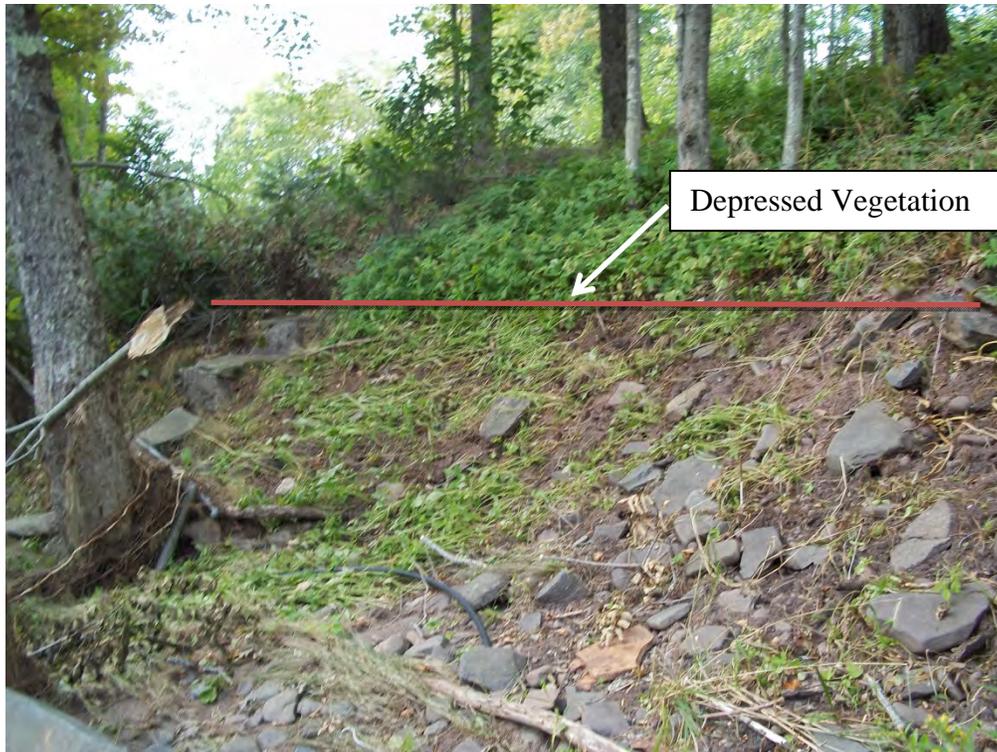
A debris line was observed behind the residence at 1363 County Route 23C in East Jewett. The residence is located just downstream of the County Route 23C bridge over the East Kill. The estimated high water level was measured to be approximately 11.7 feet below the road (a PK nail was driven into the pavement to mark the elevation). The elevation of the debris line and the PK nail were surveyed at El. 1910.0 and El. 1921.7, respectively (Survey Points 1039 and 566, respectively).

P23 (Survey Point 1039) – Area of depressed vegetation observed behind residence at 1363 County Route 23C in East Jewett, located immediately downstream of bridge over East Kill (Photo taken 9/2/2011)

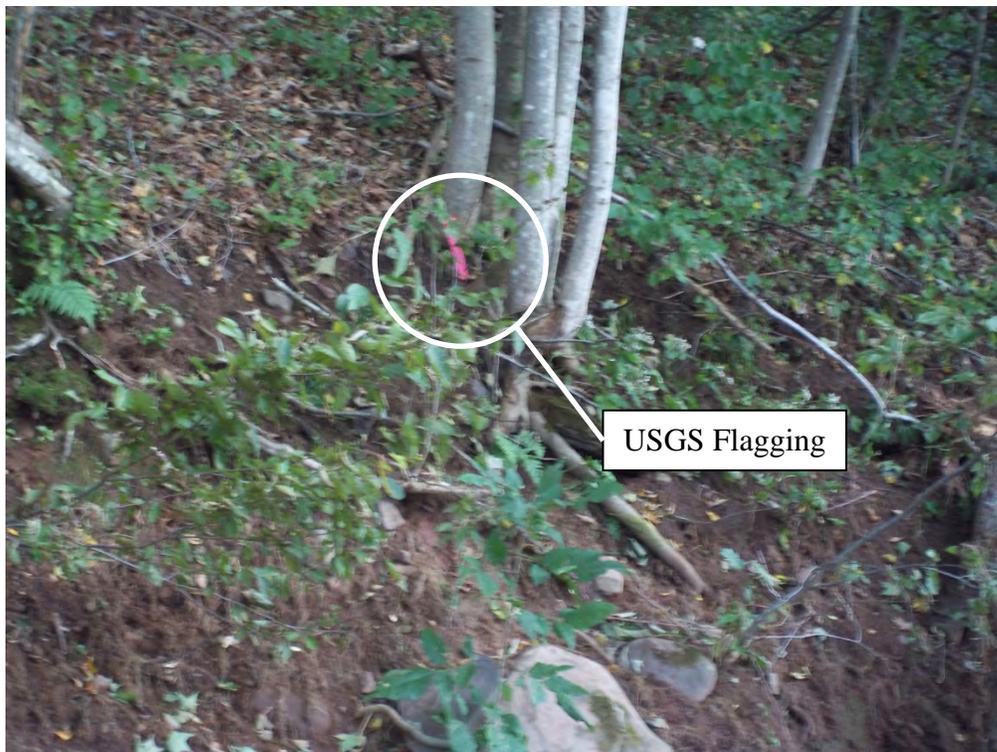
An area of depressed vegetation and debris was identified on the left bank of the East Kill near the Cloose Road bridge over the stream. At the time of the initial field visit (9/2/2011), we observed flagging at these estimated high water marks, which appeared to have been flagged by USGS. The estimated high water level was surveyed at El. 1477.4 (Survey Point 1038). This high water level is higher than the top of the upstream left bridge abutment (El. 1472.3, Survey Point 565), which was also surveyed.

P24 (Survey Point 1038) – Area of erosion and depressed vegetation near the Cloose Road bridge over the East Kill. Pink flagging assumed to be USGS high water marker. (Photo taken 9/2/2011)

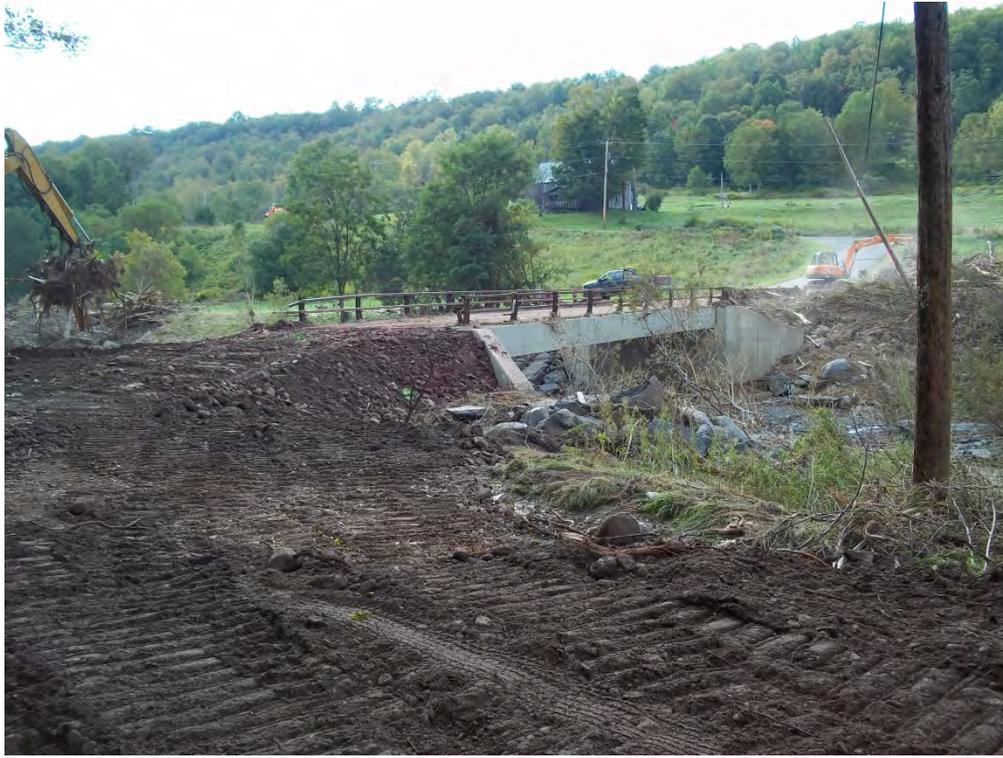
P25 (Survey Point 565) – Close Road bridge over East Kill in Jewett, NY, from left bank. Estimated high water elevation was measured in relation to elevation of left upstream abutment (Photo taken 9/2/2011)

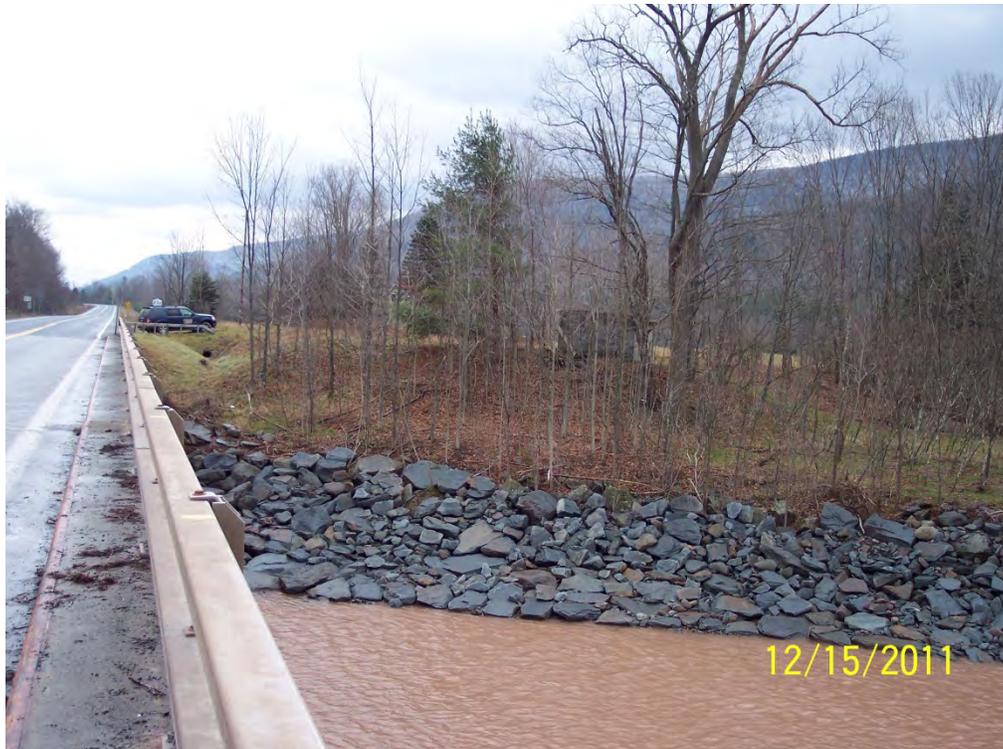
A debris line was observed along the left bank of the East Kill in Jewett Center, just downstream of the NYS Route 23A bridge. The bridge is located approximately 350 feet upstream of the East Kill confluence with the Schoharie Creek. The debris line was surveyed at El. 1396.2 (Survey Point 1037), approximately 10 feet below the road.

P26 (Survey Point 1037) – NYS Route 23A bridge over East Kill in Jewett Center, looking toward right bank. Debris line observed on left bank, downstream of bridge. (Photo taken 12/15/2011)

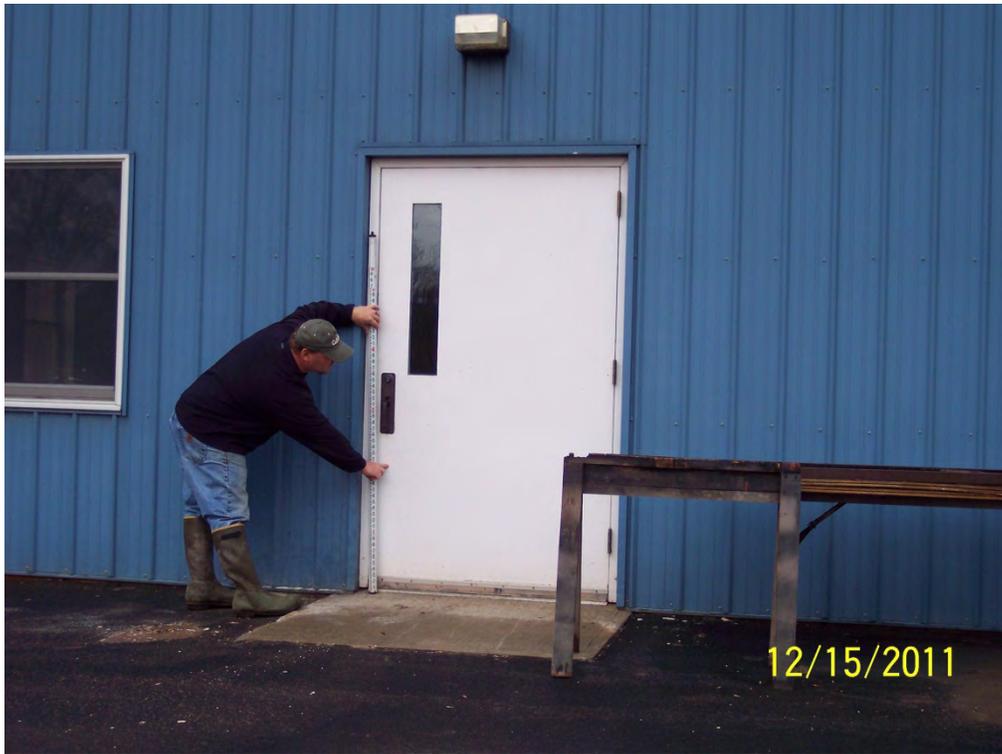
Survey Point 1030 represents a mud line that was observed on the southerly (rear) door of the post office/firehouse building. The mud line was surveyed at El. 812.0, approximately 2.2 feet above the door sill.

P27 (Survey Point 1030) – South (back) door of firehouse/post office in Blenheim, NY. Mud line observed approximately 2.2 feet above door sill (Photo taken 12/15/2011)

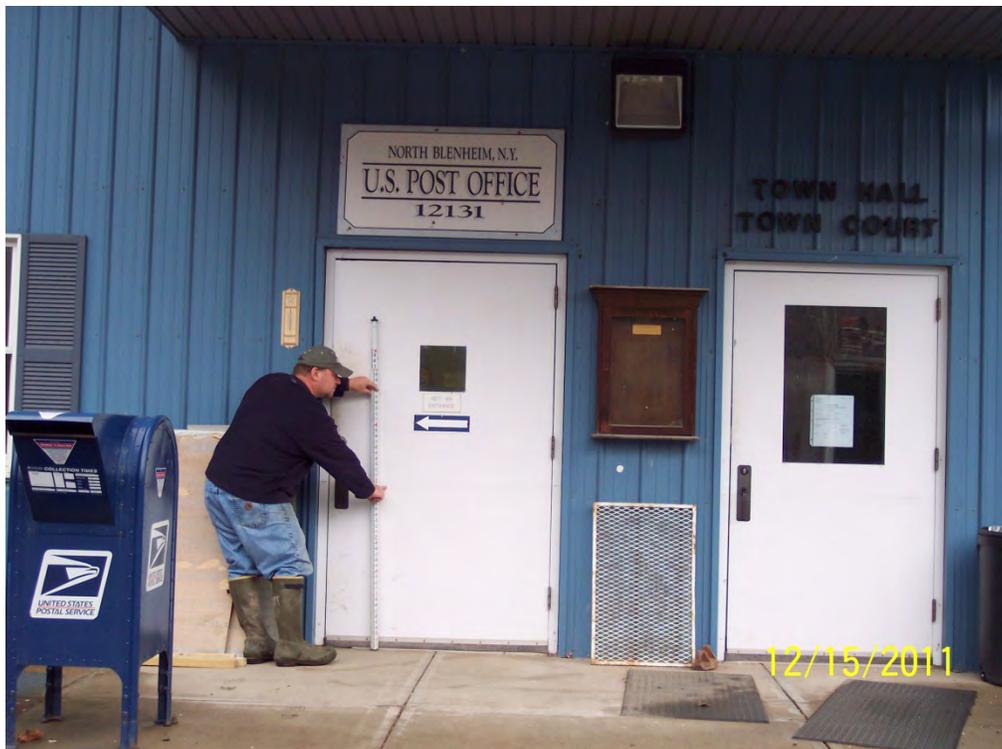
Survey Point 1031 represents a mud line that was observed on the westerly (side) door of the post office/firehouse building. The mudline was surveyed at El. 813.1, approximately 3.0 feet above the door sill.

P28 (Survey Point 1031) – West (side) door of firehouse/post office building in Blenheim, NY. Mud line observed approximately 3.0 feet above door sill (Photo taken 12/15/2011).

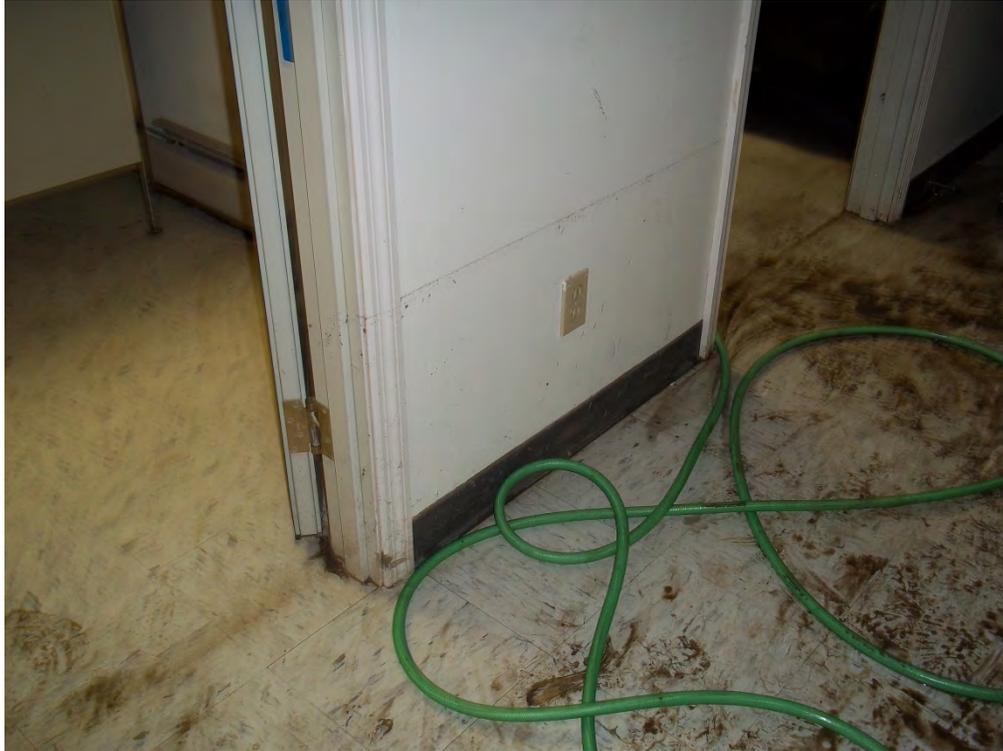
Survey Point 1032 represents a mud line that was observed along an interior wall at the post office. The mud line was surveyed at El. 811.4, approximately 1.8 feet above the first floor of the building.

P29 (Survey Point 1032) – Mud line observed on an interior wall at the Blenheim post office. Mud line was approximately 1.8 feet above the floor of the building. (Photo taken 8/30/2011)

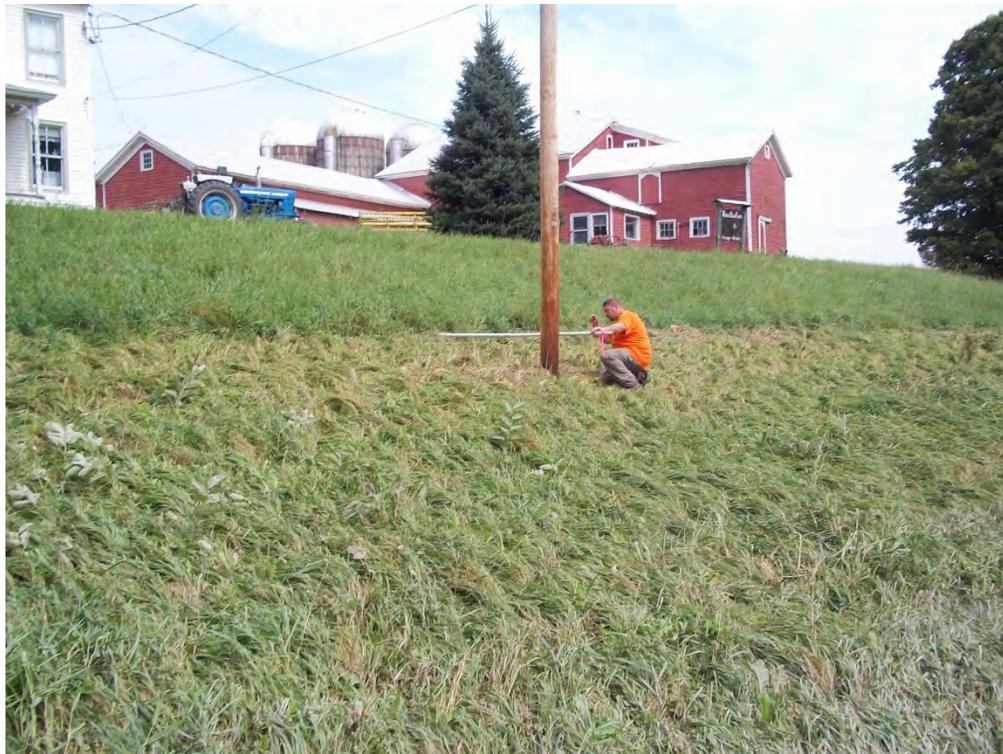
The Royal Oak Farm is located at 1829 NYS Route 30 in Blenheim, NY. The farm is located on the opposite side of NYS Route 30 from Schoharie Creek. High water elevations were estimated in this area based on an observed line of depressed vegetation in a field. The estimated high water mark was chronicled with a PK nail driven into a utility pole (pole number NM244, MT CO. 20-1) in the field. An elevation of El. 801.7 was recorded for this PK nail during the field survey (Survey Point 553).

P30 (Survey Point 553) – High water estimated by depressed grass in field. PK nail driven into utility pole at estimated high water level. Royal Oaks Farm in background (Photo taken 9/1/2011)
