# **2011 SCHOHARIE CREEK BASIN FLOODING**

## **Site Reconnaissance and Flood Evaluation**

*Prepared for:*  
New York Power Authority

**May 2012**

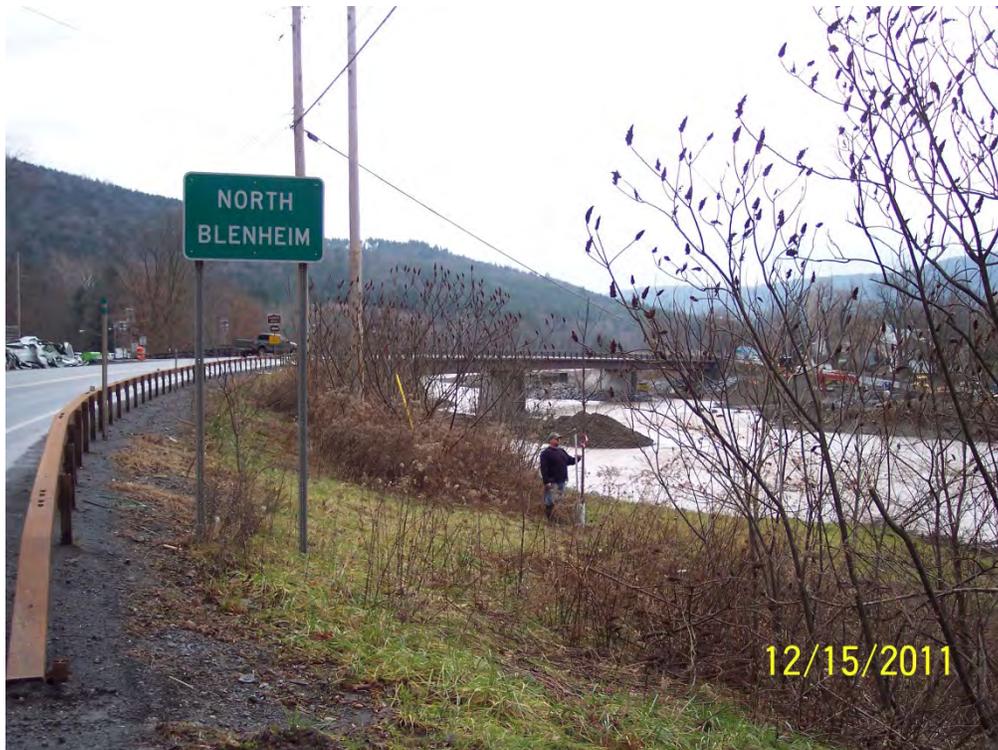
P32 (Survey Point 549) – Downstream side of NYS Route 30 bridge in Blenheim. Debris line observed on right bank, near surveyor in photo. (Photo taken 12/15/2011)

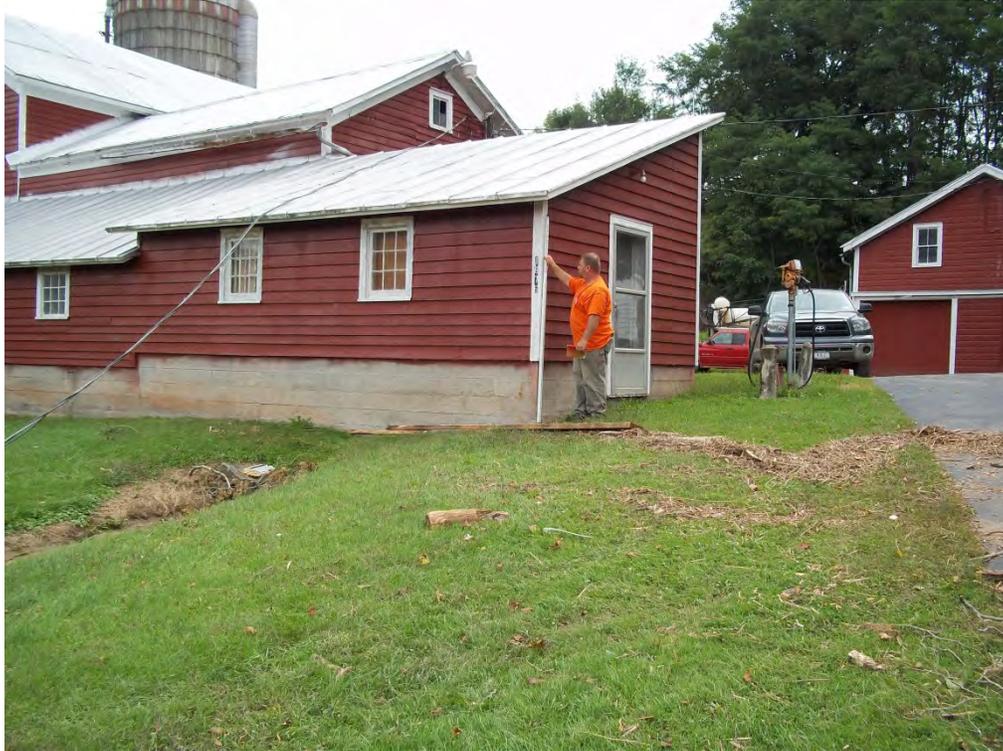
P33 (Survey Point 550) – Southwest corner of red barn at 1976 NYS Route 30 in Blenheim. Debris line indicates the base of the barn at this corner is the approximate high water level. (Photo taken 9/1/2011)

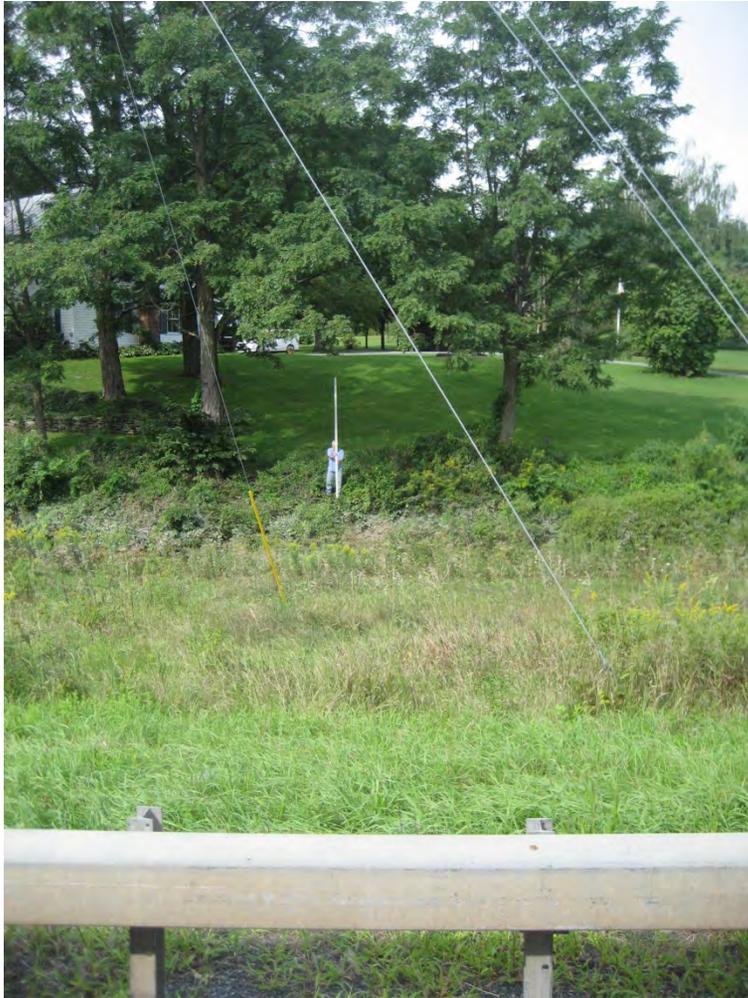
Estimated high water marks were located at the NYS Route 30 bridge in Breakabeen. The high water marks were estimated based on debris lines observed on the left bank both upstream (south) and downstream (north) of the bridge (Survey Points 1028 and 1027, respectively). High water elevations were surveyed at El. 705.7 and 704.6 upstream and downstream, respectively.

P34 (Survey Point 1028) – Debris line located south (upstream) of the NYS Route 30 bridge in Breakabeen, left bank. (Photo taken 9/1/2011)

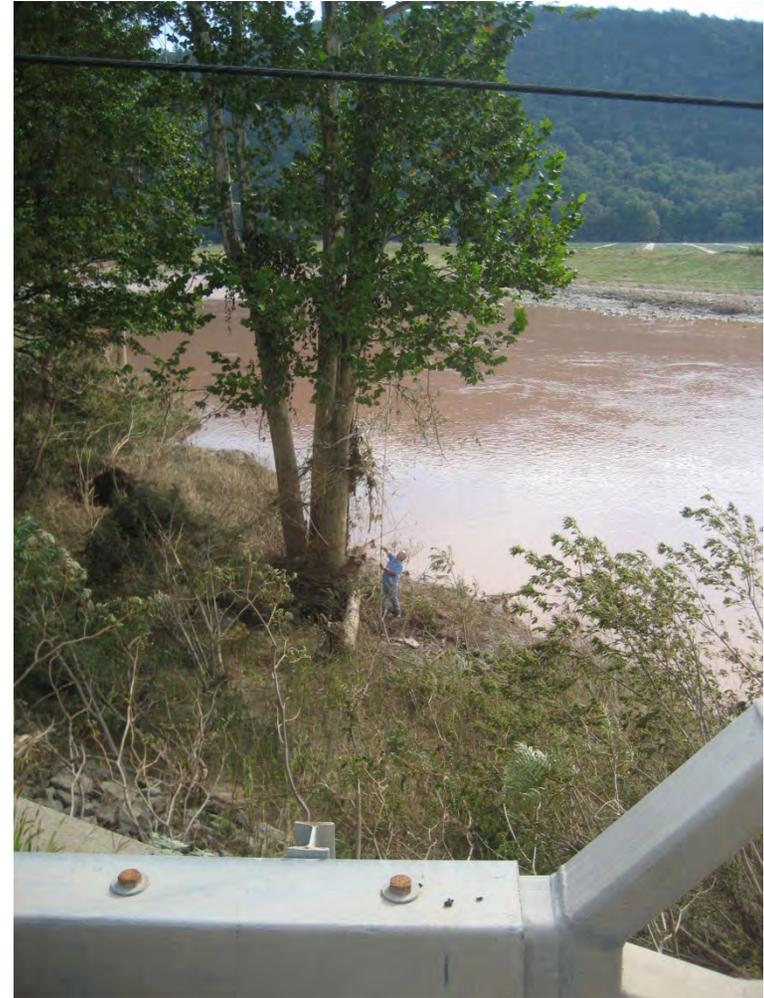
P35 (Survey Point 1027) – Debris observed in tree north (downstream) of the NYS Route 30 bridge in Breakabeen, left bank. (Photo taken 9/1/2011)

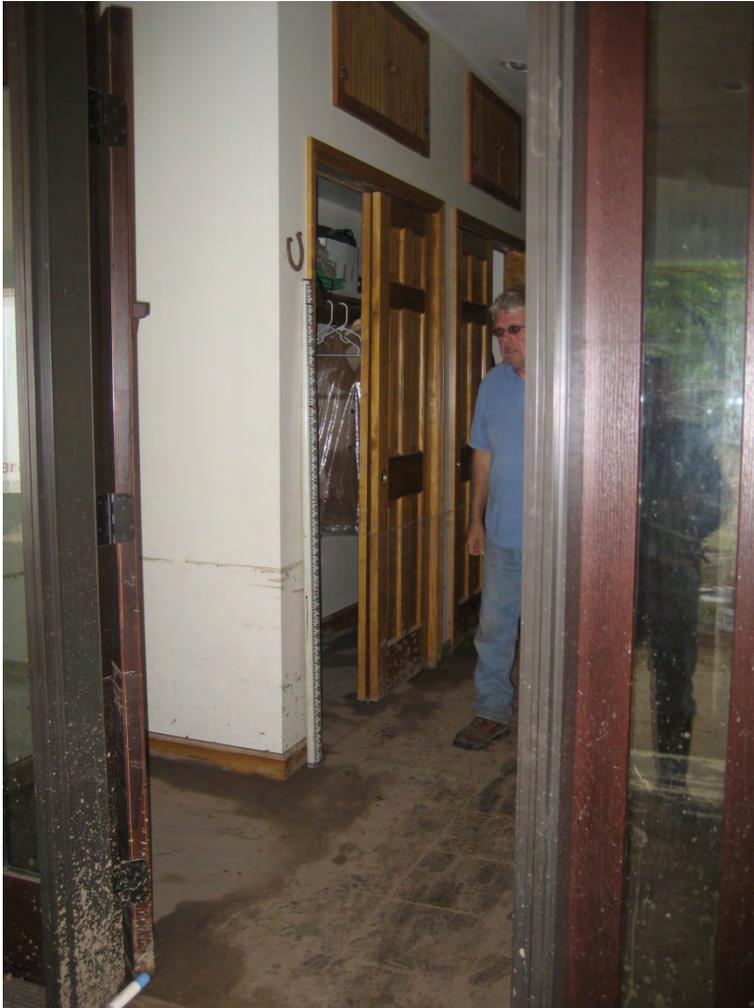
P37 (Survey Point 1026) – Mud line observed inside Shaul residence, Boucks Island. Approximately 2.35 feet above first floor elevation. (Photo taken 9/1/2011)

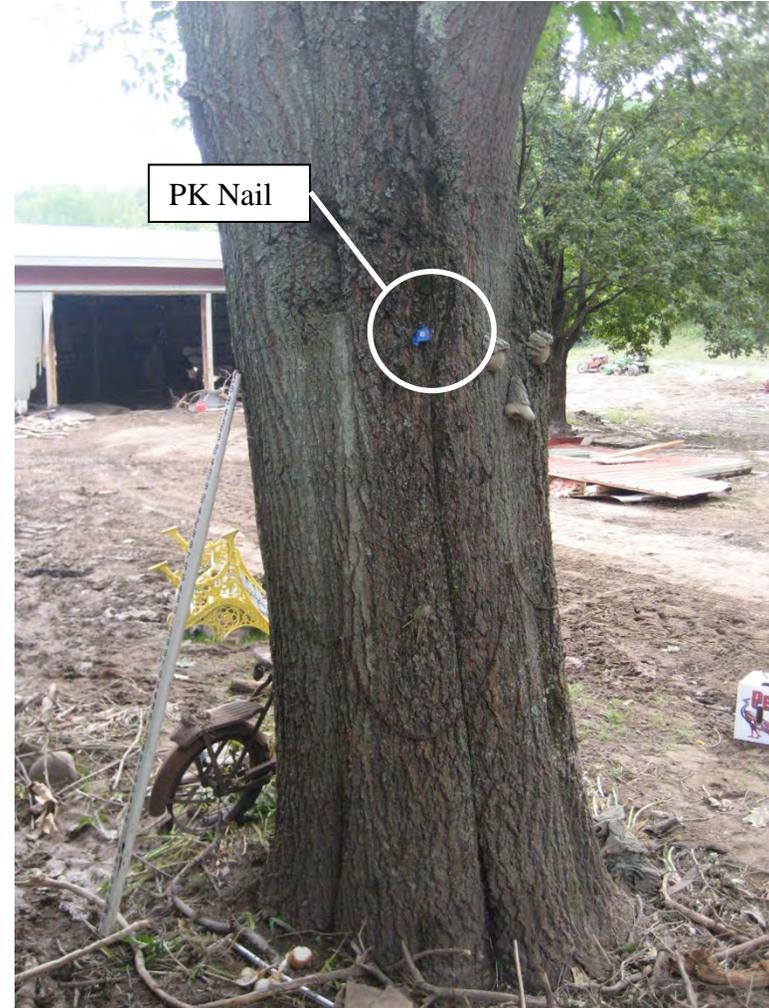
P38 (Survey Point 1025) – Tree outside Shaul residence, Boucks Island. PK nail driven into tree at elevation of mud line from home interior, note blue ribbon. (Photo taken 9/1/2011)

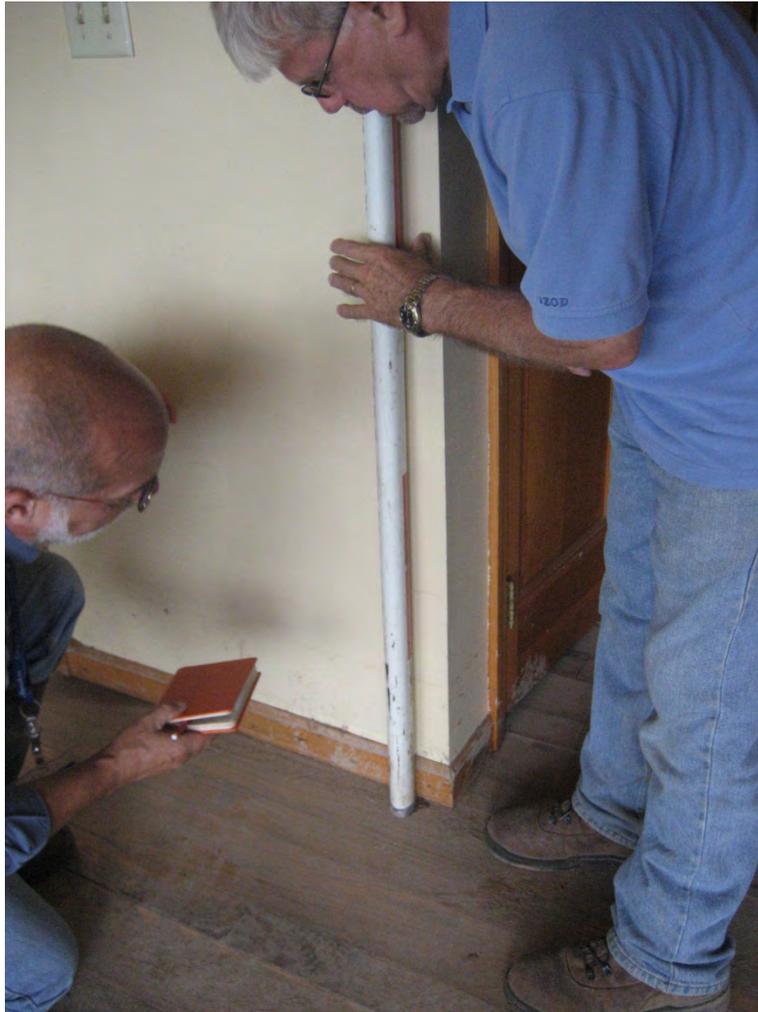
P39 (Survey Point 1024) – Mud line observed inside Pendergrast residence, Watsonville. Approximately 0.9 feet above first floor elevation. (Photo taken 9/1/2011)

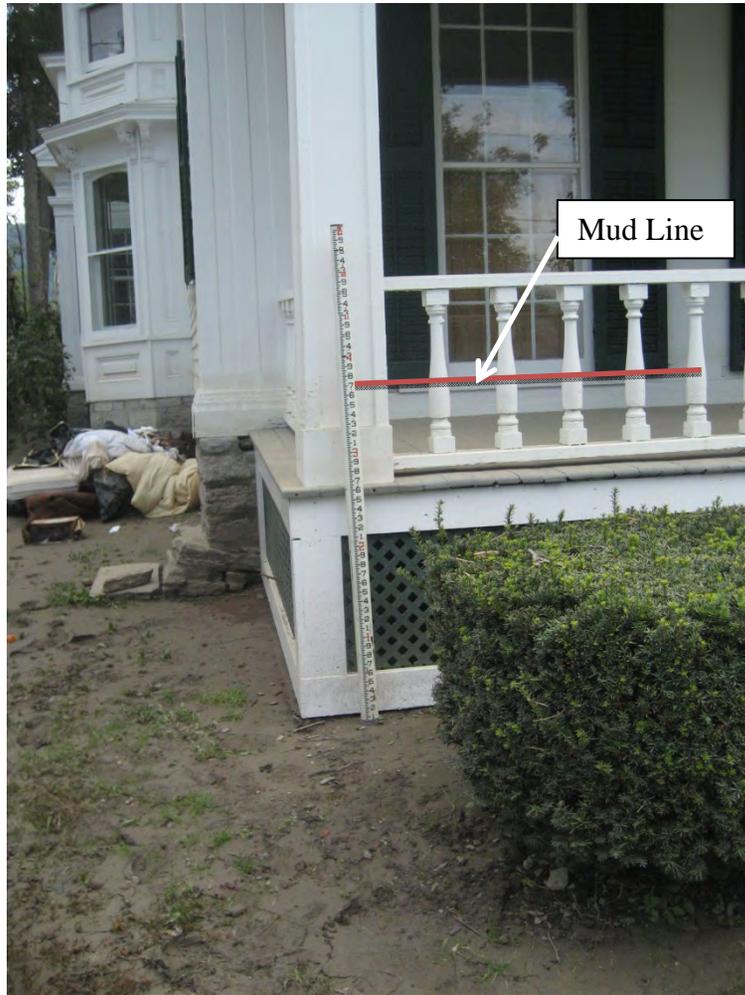
P40 (Survey Point 1021) – Mud line on exterior of residence at 106 River Street in Middleburgh. Mud line approximately 3.8 feet above ground level. (Photo taken 9/1/2011)

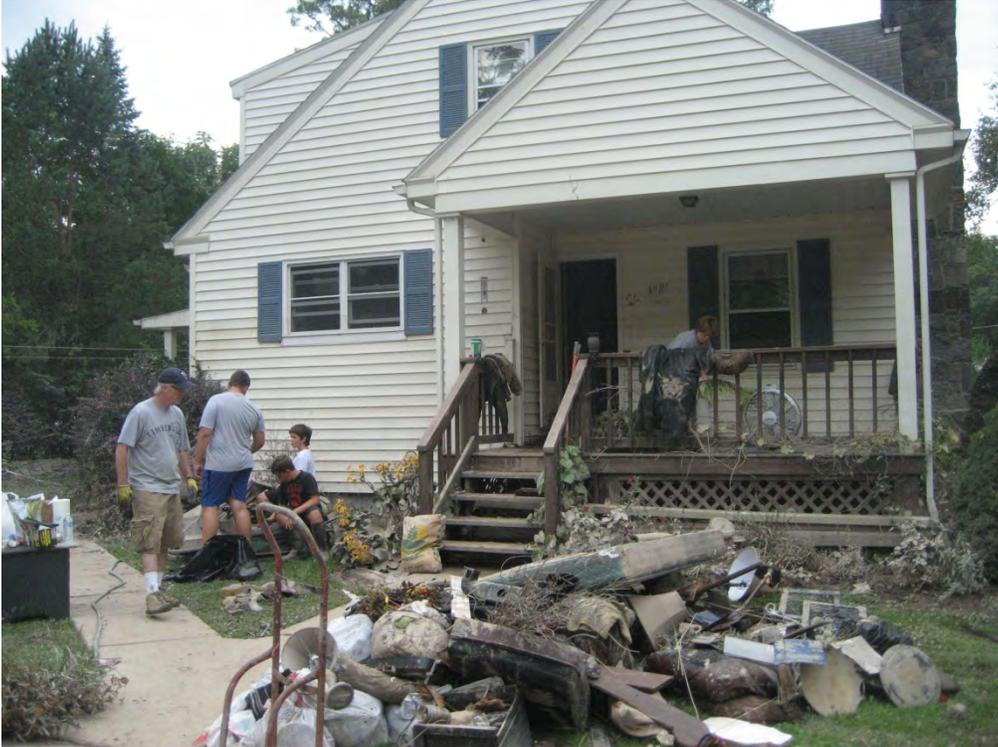
P44 (Survey Point 540) – Residence at 110 Hilgert Parkway, Schoharie. Mud line approximately 4.5 feet above porch, just above window sill. (Photo taken 9/1/2011)

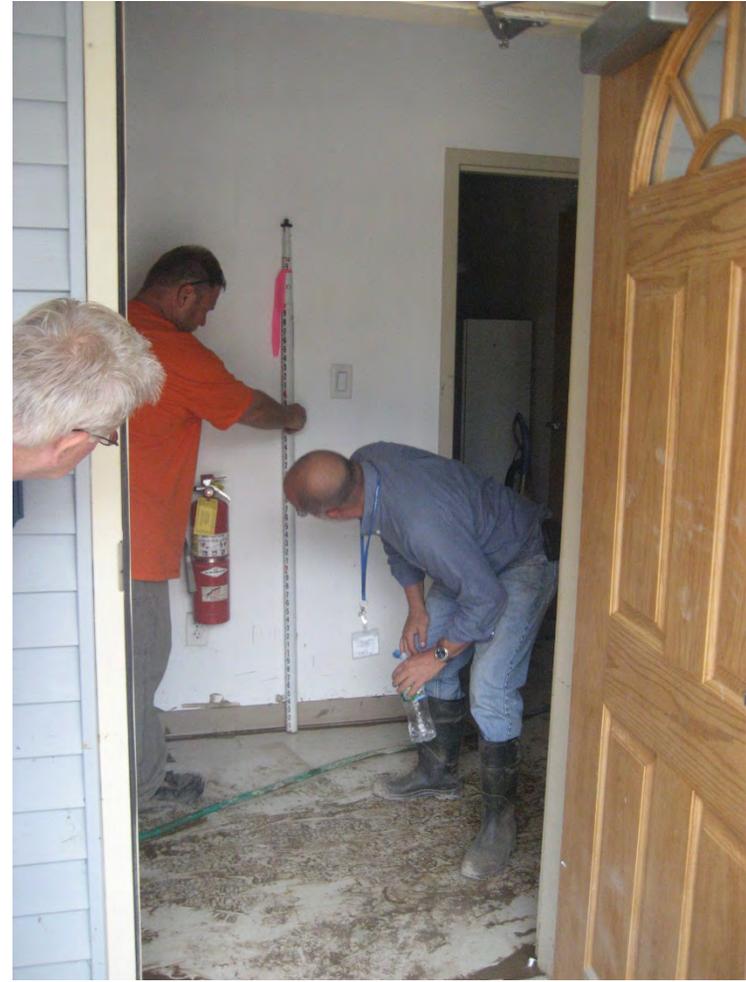
P47 (Survey Point 539) – Interior of Scho-Wright Ambulance Building (388 Main Street, Schoharie). Mud line was observed 2.3 feet above floor. (Photo taken 9/1/2011)

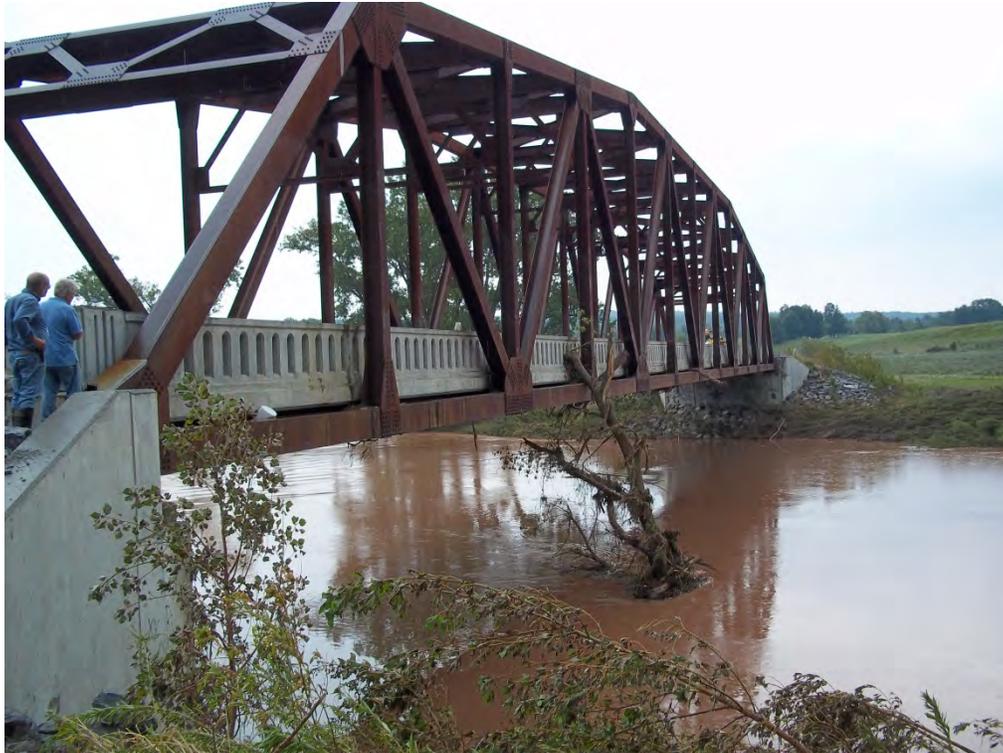
P48 (Survey Point 535) – Junction Road bridge over Schoharie Creek near Central Bridge. High water estimated to have been approximately 10.1 feet over bridge deck (Photo taken 9/1/2011)

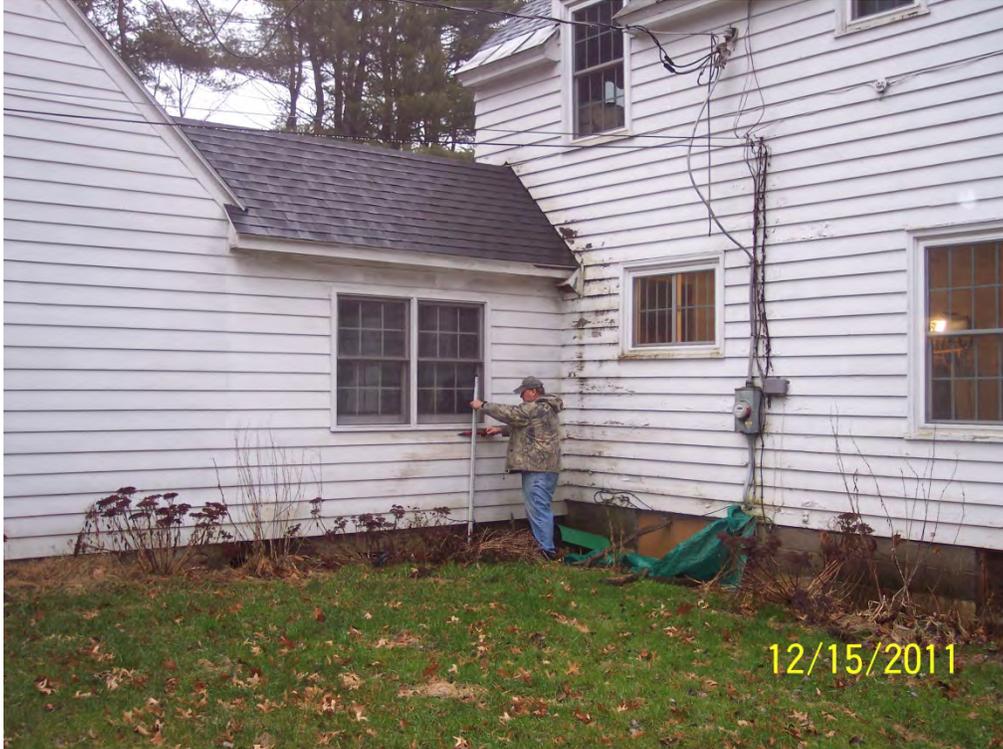
P51 (Survey Point 1018) – Residence at 102 Charleston Road in Esperance. Mud line observed approximately 2.4 feet above sill of foundation, near surveyor’s right hand. (Photo taken 12/15/2011)

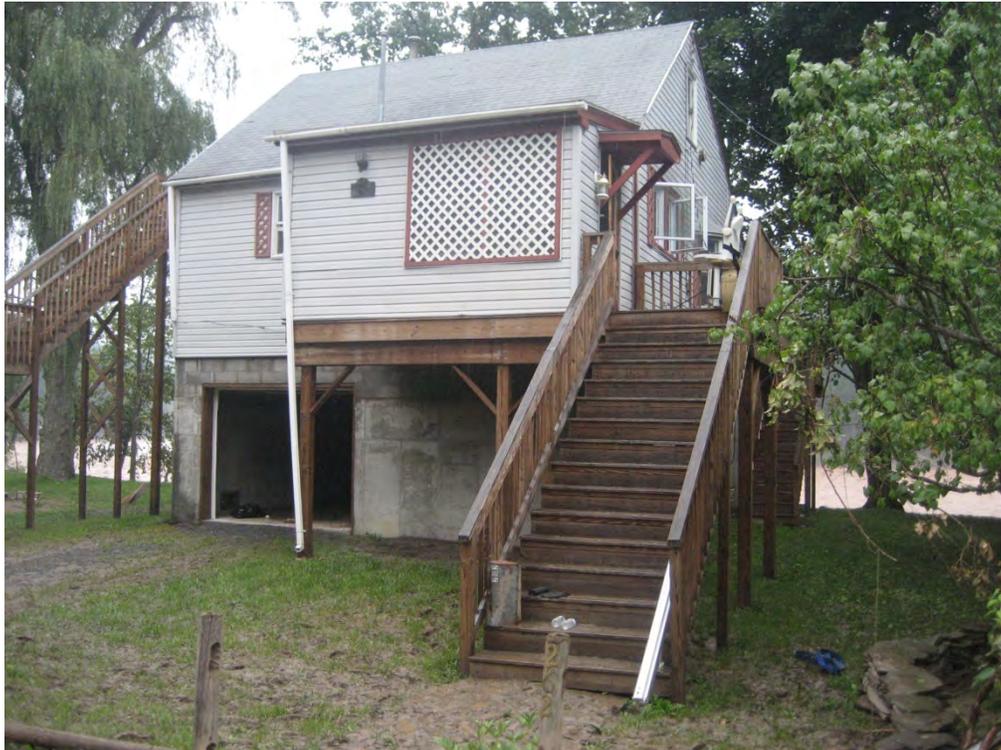
P53 (Survey Point 532) –38 Priddle Road, Priddle Camp. Mud line observed approximately 2.6 feet above residential floor elevation, above siding. (Photo taken 9/1/2011)

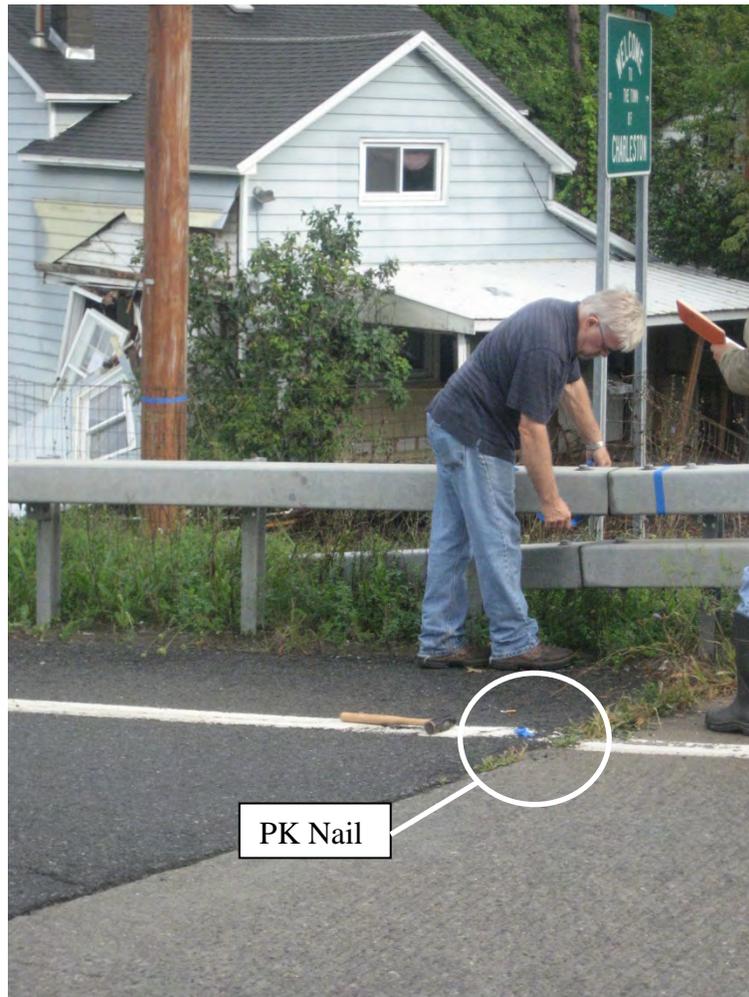
P54 (Survey Point 531) – PK nail driven into road (blue ribbon on white stripe) at approximate elevation of debris line. (Photo taken 9/6/2011)

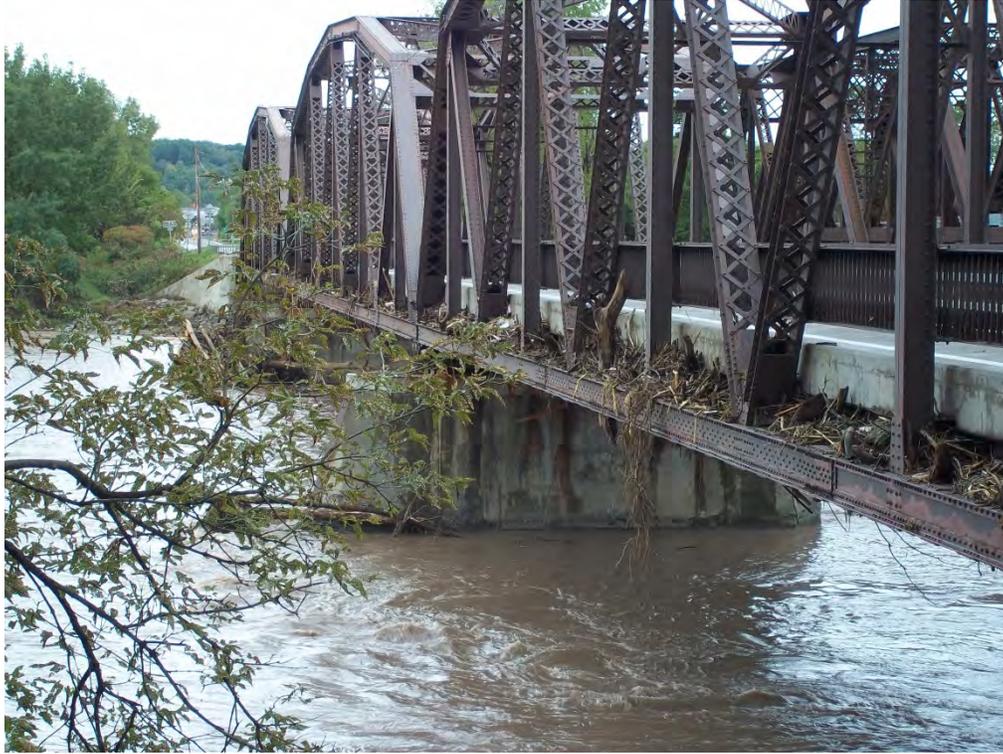
P55 (Survey Point 1016) – Upstream face of NYS Route 5S bridge over the Schoharie Creek in Fort Hunter. Water line observed on upstream railings (Photo taken 9/6/2011)

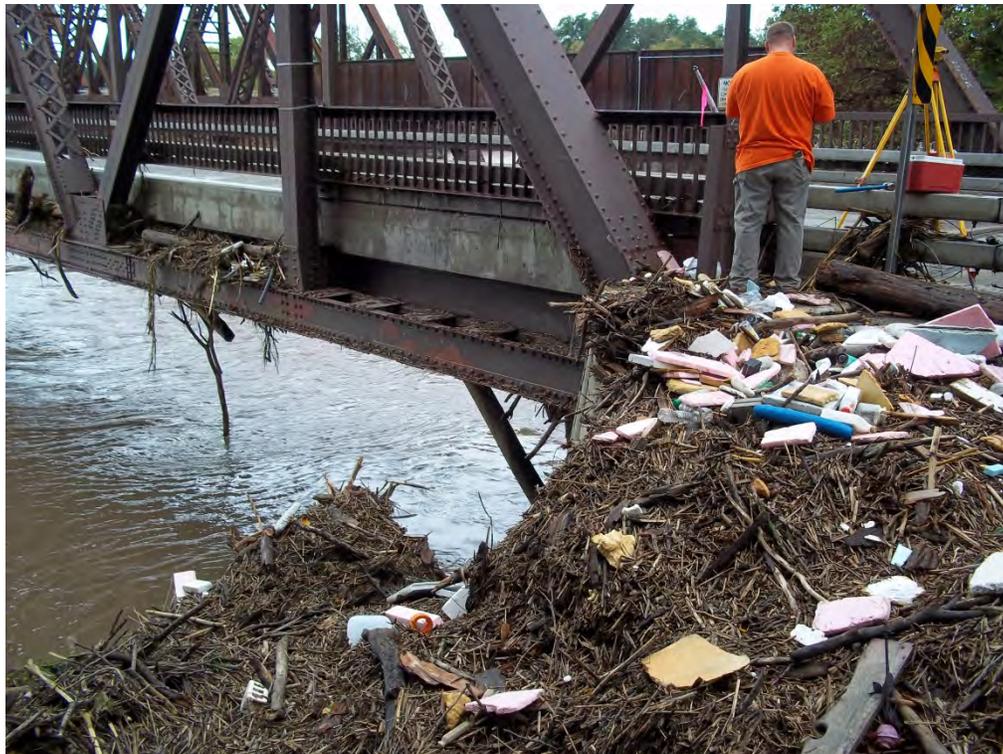
P56 (Survey Point 1015) – Debris line observed on right bank of NYS Route 5S bridge over Schoharie Creek. (Photo taken 9/6/2011)

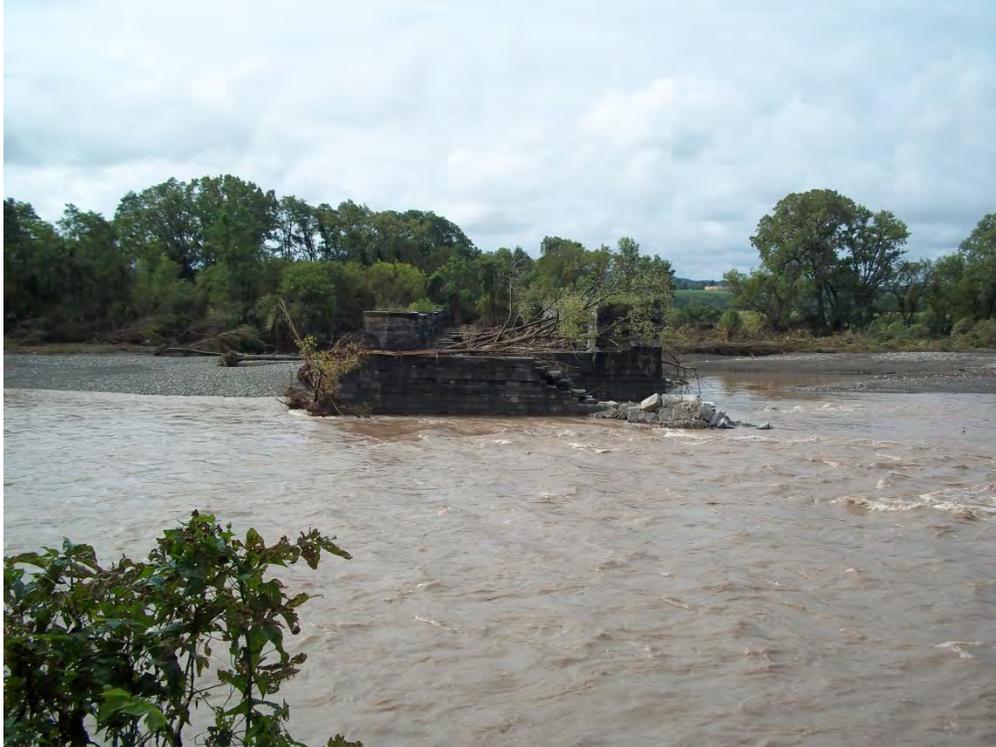
P57 (Survey Point 1014) – Stone laid aqueduct pier in Schoharie Creek. Debris line observed on right bank near pier, recent damage observed on pier. (Photo taken 9/6/2011)

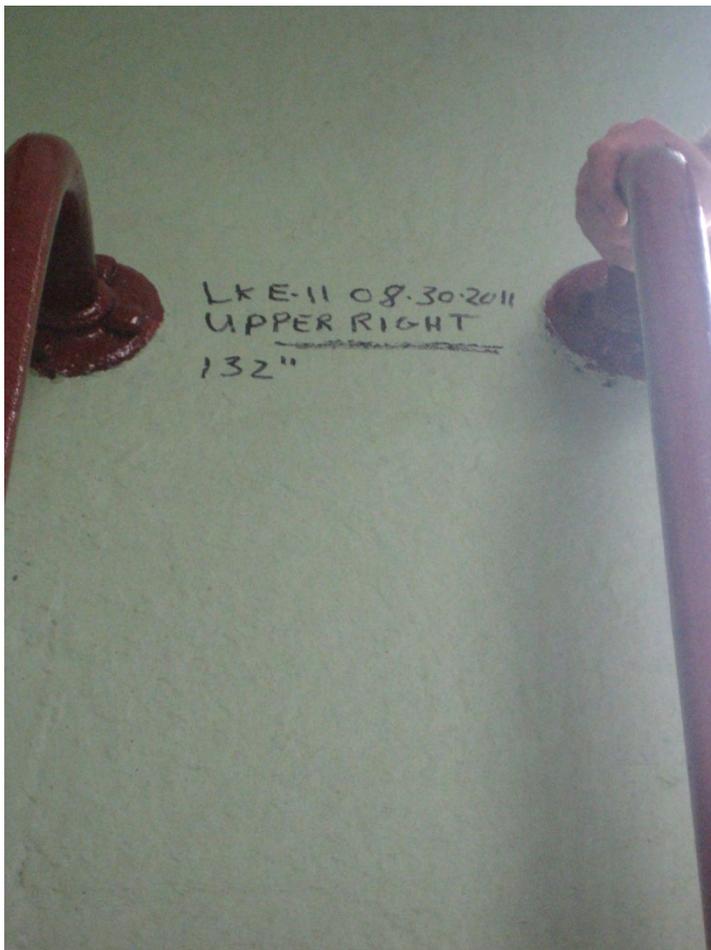
P59 (Survey Point 501), left – High water mark observed on west lock house (Lock 11) during 2011 flood reconnaissance (Photo taken 9/6/2011)

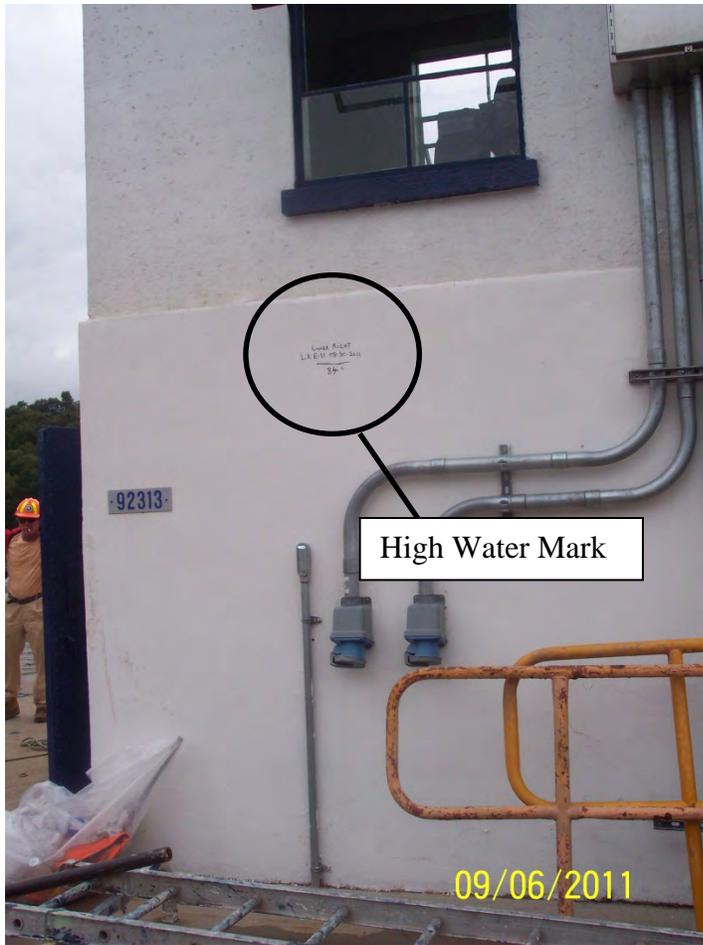
P60 (Survey Point 502), left – East lock house, Lock 11. High water mark from 2011 flooding located on exterior wall (Photo taken 9/6/2011)

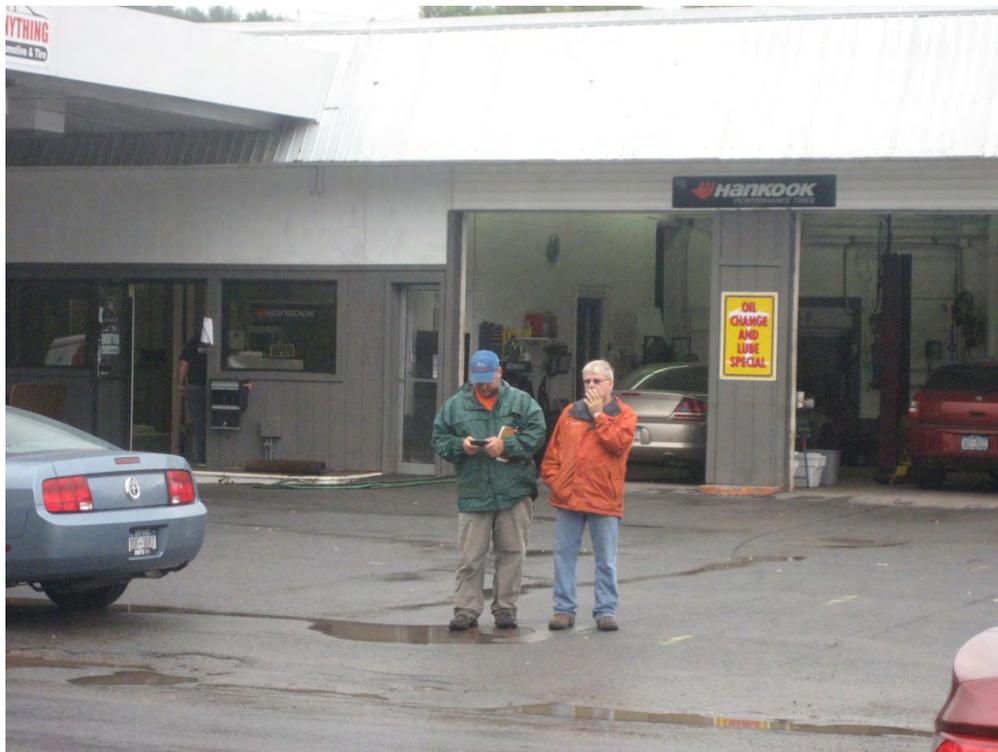
P62 (Survey Point 1013) – Anything Automotive garage in Amsterdam, NY. Mud line was observed approximately 4.25 feet above garage floor. (Photo taken 9/6/2011)

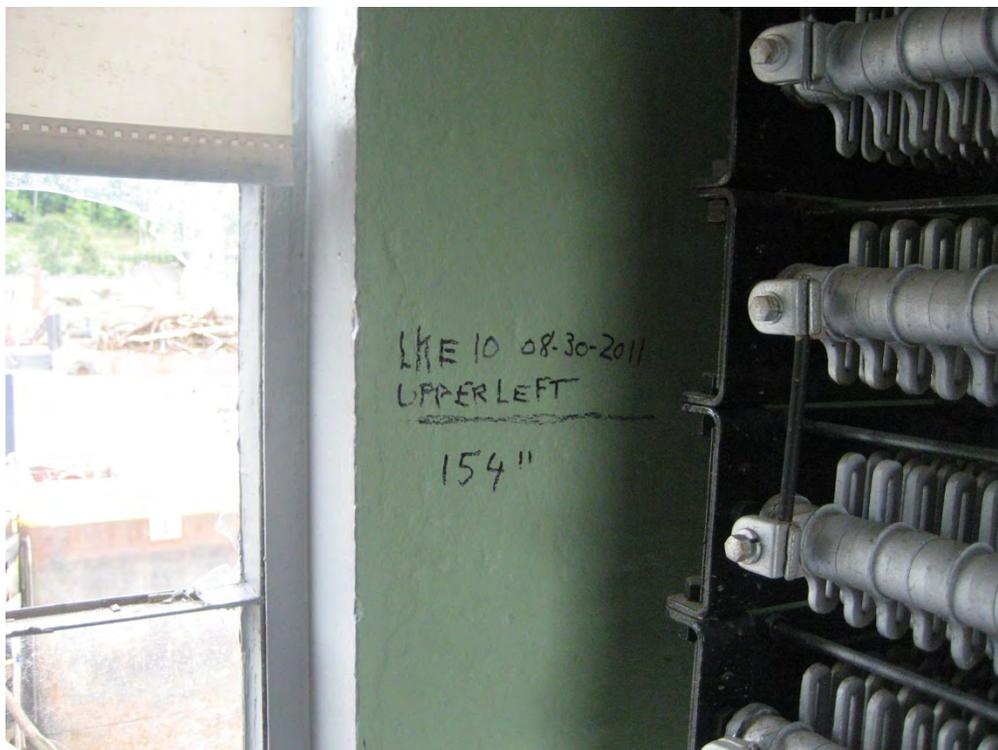
P63 (Survey Point 506) – High water mark identified inside west (upstream) lock building, Lock 10. (Photo taken 9/6/2011)

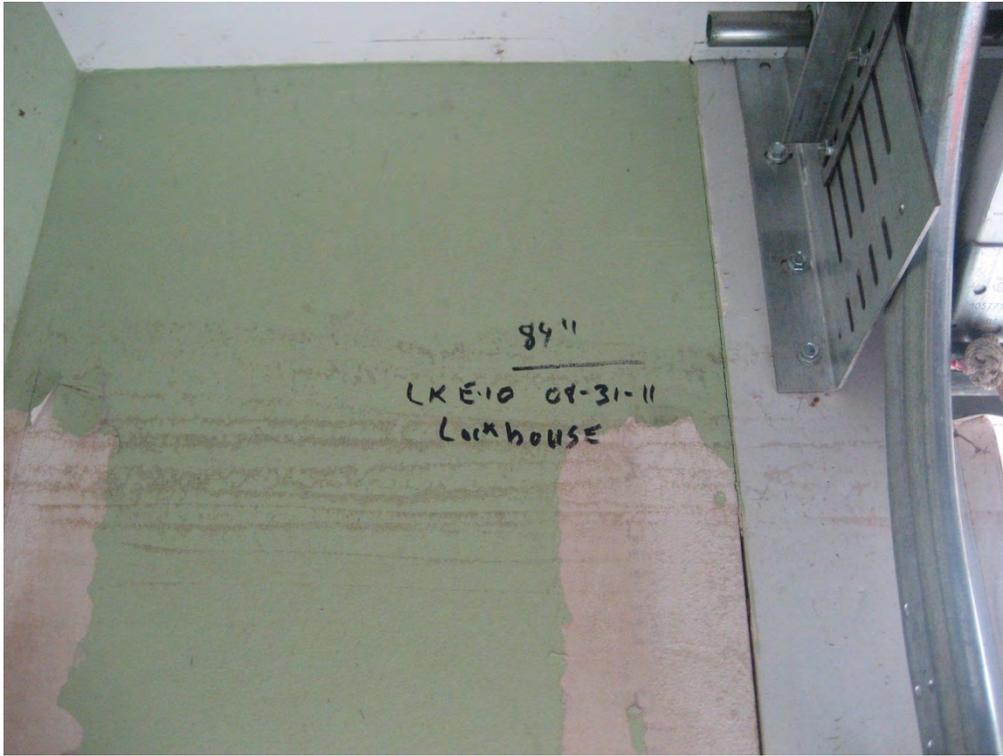
P64 (Survey Point 505) – High water mark identified inside east (downstream) lock building, Lock 10. (Photo taken 9/6/2011).

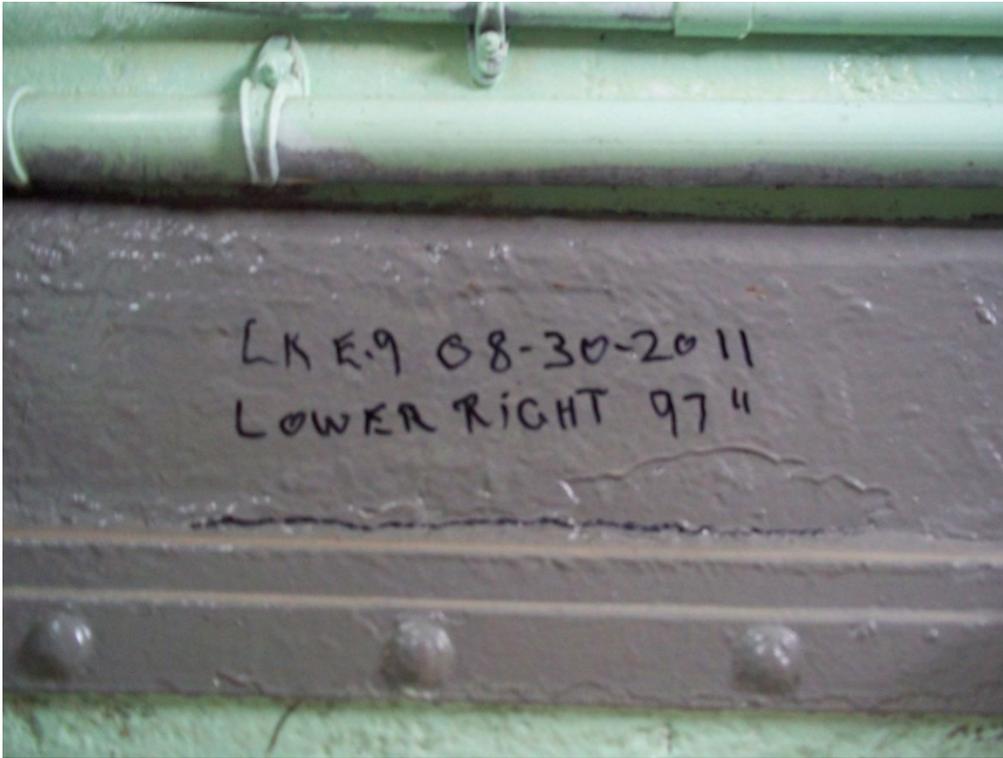
P66 (Survey Point 510) – High water mark identified inside east (downstream) lock building, Lock 9.  
(Photo taken 9/6/2011)

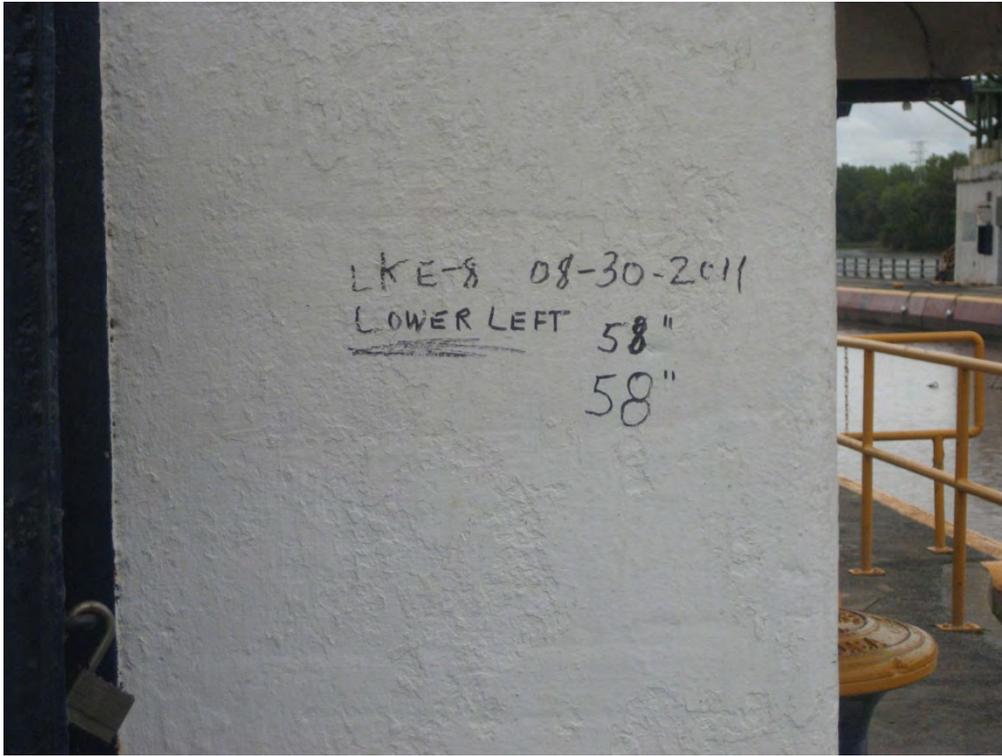
P68 (Survey Point 517) – High water mark identified outside of east (downstream) lock building, Lock 8. (Photo taken 9/6/2011)

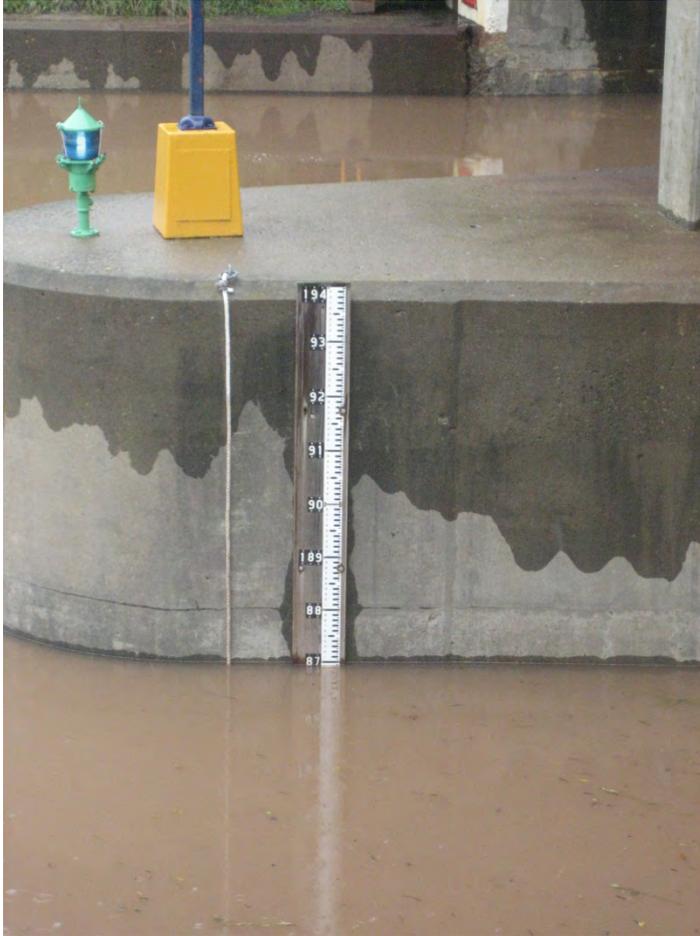
P72 (Survey Point 524), left – Staff gage (in Barge Canal Datum) located near Guard Gate No. 2. High water during 2011 flooding was approximately at El. 191.5, BCD (Photo taken 9/6/2011)

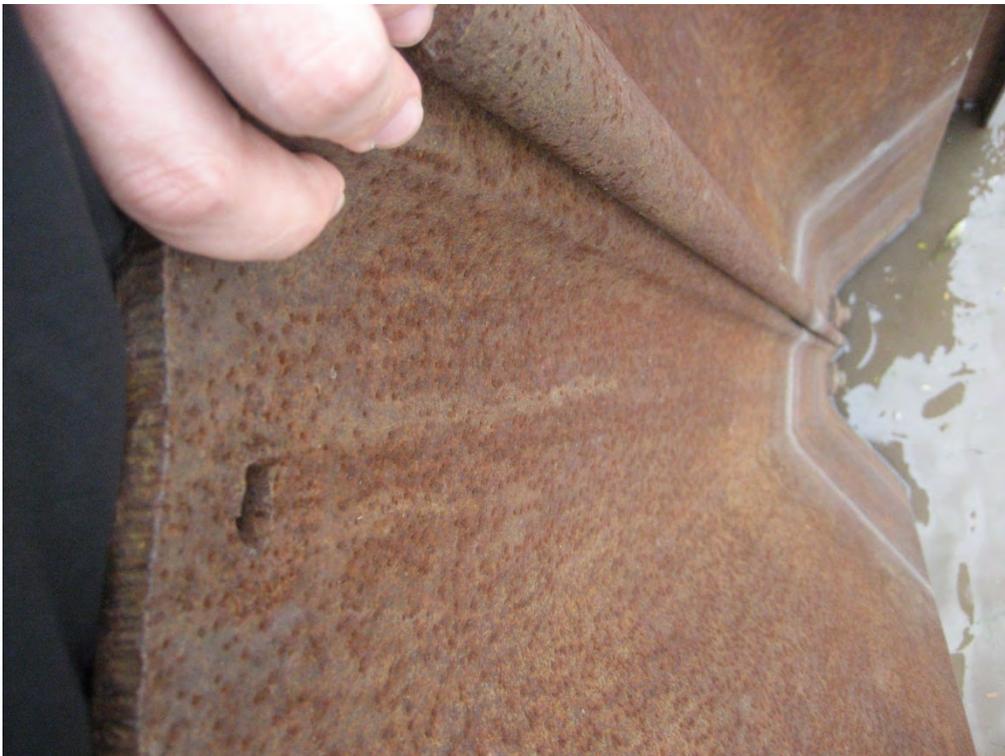
P75 (Survey Point 526) – Reservoir side of sheet piling from photo above. Note water line, approximately 56 inches below top of sheet piling (Photo taken 9/6/2011).
