**TRANSMITTAL
REPORT
SOUTH ACCESS ROAD SLIDE AREA EVALUATION
BLenheim-GILBOA PUMPED STORAGE PROJECT
NEW YORK POWER AUTHORITY
FERC PROJECT NO. 2685-NY**

**SOUTH ACCESS ROAD SLIDE AREA EVALUATION
BLENHEIM-GILBOA PUMPED STORAGE POWER PROJECT
NEW YORK POWER AUTHORITY
FERC PROJECT NO. 2685-NY
JANUARY 5, 1998**

**PROJECT NO. 97-1734
JANUARY 5, 1998**

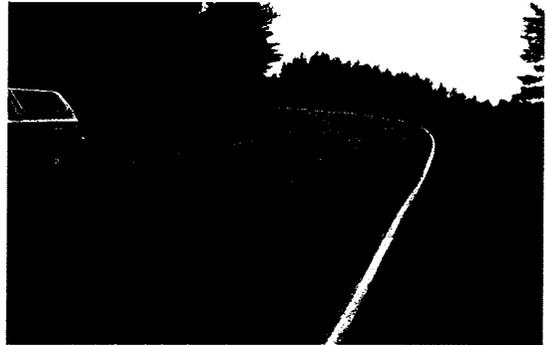
Similarly, vertical offsets associated with the bounding scarps are evident on the Lower Access

Road as illustrated below on Photograph Nos. 5 and 6.

Photograph No. 5 - View of Road Showing Several Cracks/Dips
(South Access Road, Southern Portion)

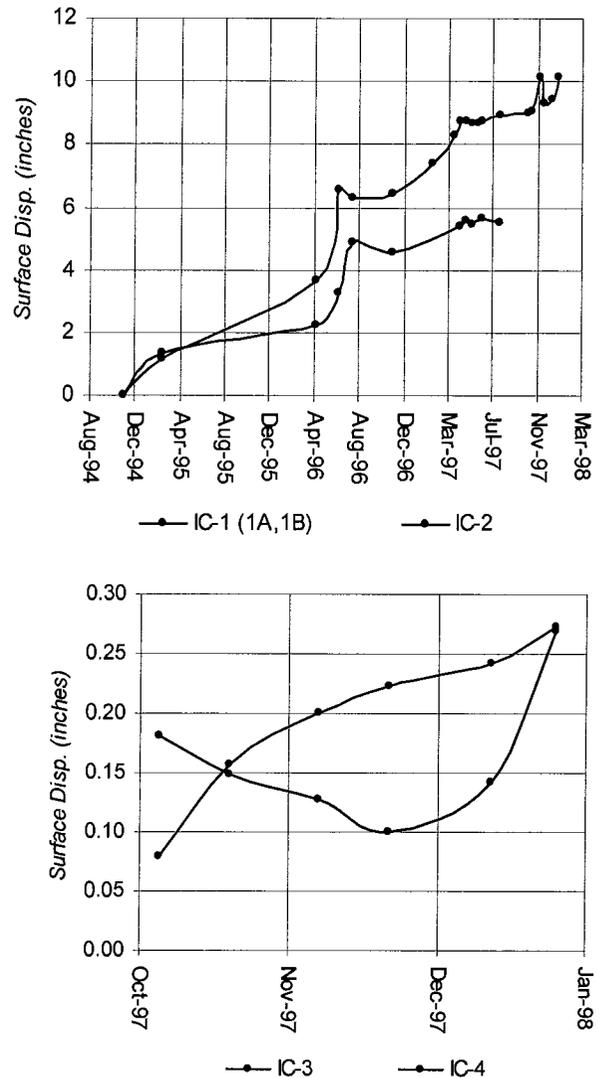
Figure 3-1 Surface Displacements obtained from Inclinometer Readings

Figure 3-1 shows inclinometer readings recorded over the last three years. The high rate of movement recorded from April through July of 1996 corresponds to unusually high precipitation during the spring thaw period. Surface movement in this period was recorded at a rate of nearly one inch per month. Inclinometers along Valenti Road Extension are moving less than inclinometer IC-1B and IC-2, which are closer to the South Access Road.
