Memorandum

June 10, 2004

SUBJECT: LANDSLIDE ALONG THE NORTH ACCESS ROAD
BLENHEIM-GILBOA POWER PROJECT

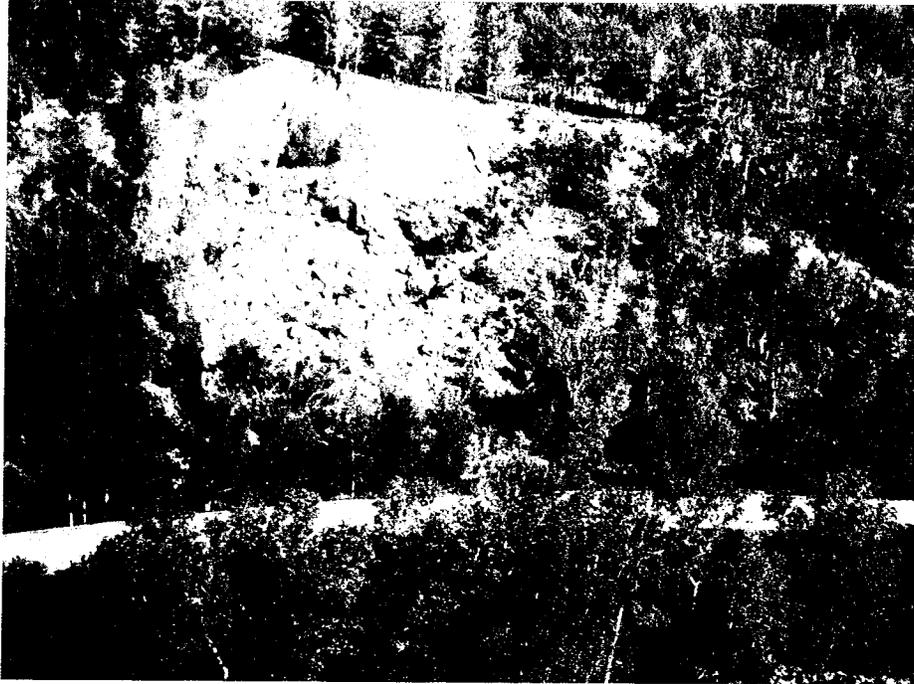
The landslide is located to the western side of the North Access Road, approximately 600 feet southwest of the intersection of Route 30 and North Access Road. The movement of the landslide was apparently in the west-to-east direction, namely in the direction towards the North Access Road. The landslide has a plan area of approximately 150 feet long (in the movement direction) and 80 feet wide. At the head of the landslide, the height of the scarp was estimated to be 20 feet or more. The geological settings in the landslide area are believed to be similar to those in the recently completed South Access Road Slide Remediation area. It should be noted that landslide activity is a common occurrence in the Schoharie Valley region, particularly in the Spring.

Site Civil Engineer, Ty Hinkley, indicated that the landslide occurred on May 29th, two days after a rain storm of the magnitude of 1.96-inch during a 24-hour period on May 27. No personal injury as a result of the landslide was reported. Since the landslide occurred at a location outside the main perimeter of the Project, it did not cause any interruption to the Project's normal power generation operations, nor does it represent any threat to project dams or spillways.

Photo 1 Looking West at the Landslide (North Access Road at Bottom of the Photo)
