Ref: Project Number: P-2685 NYPA Blenheim-Gilboa Pumped Storage Project Relicensing.

Town of Blenheim

Long-Term Community Planning Strategy

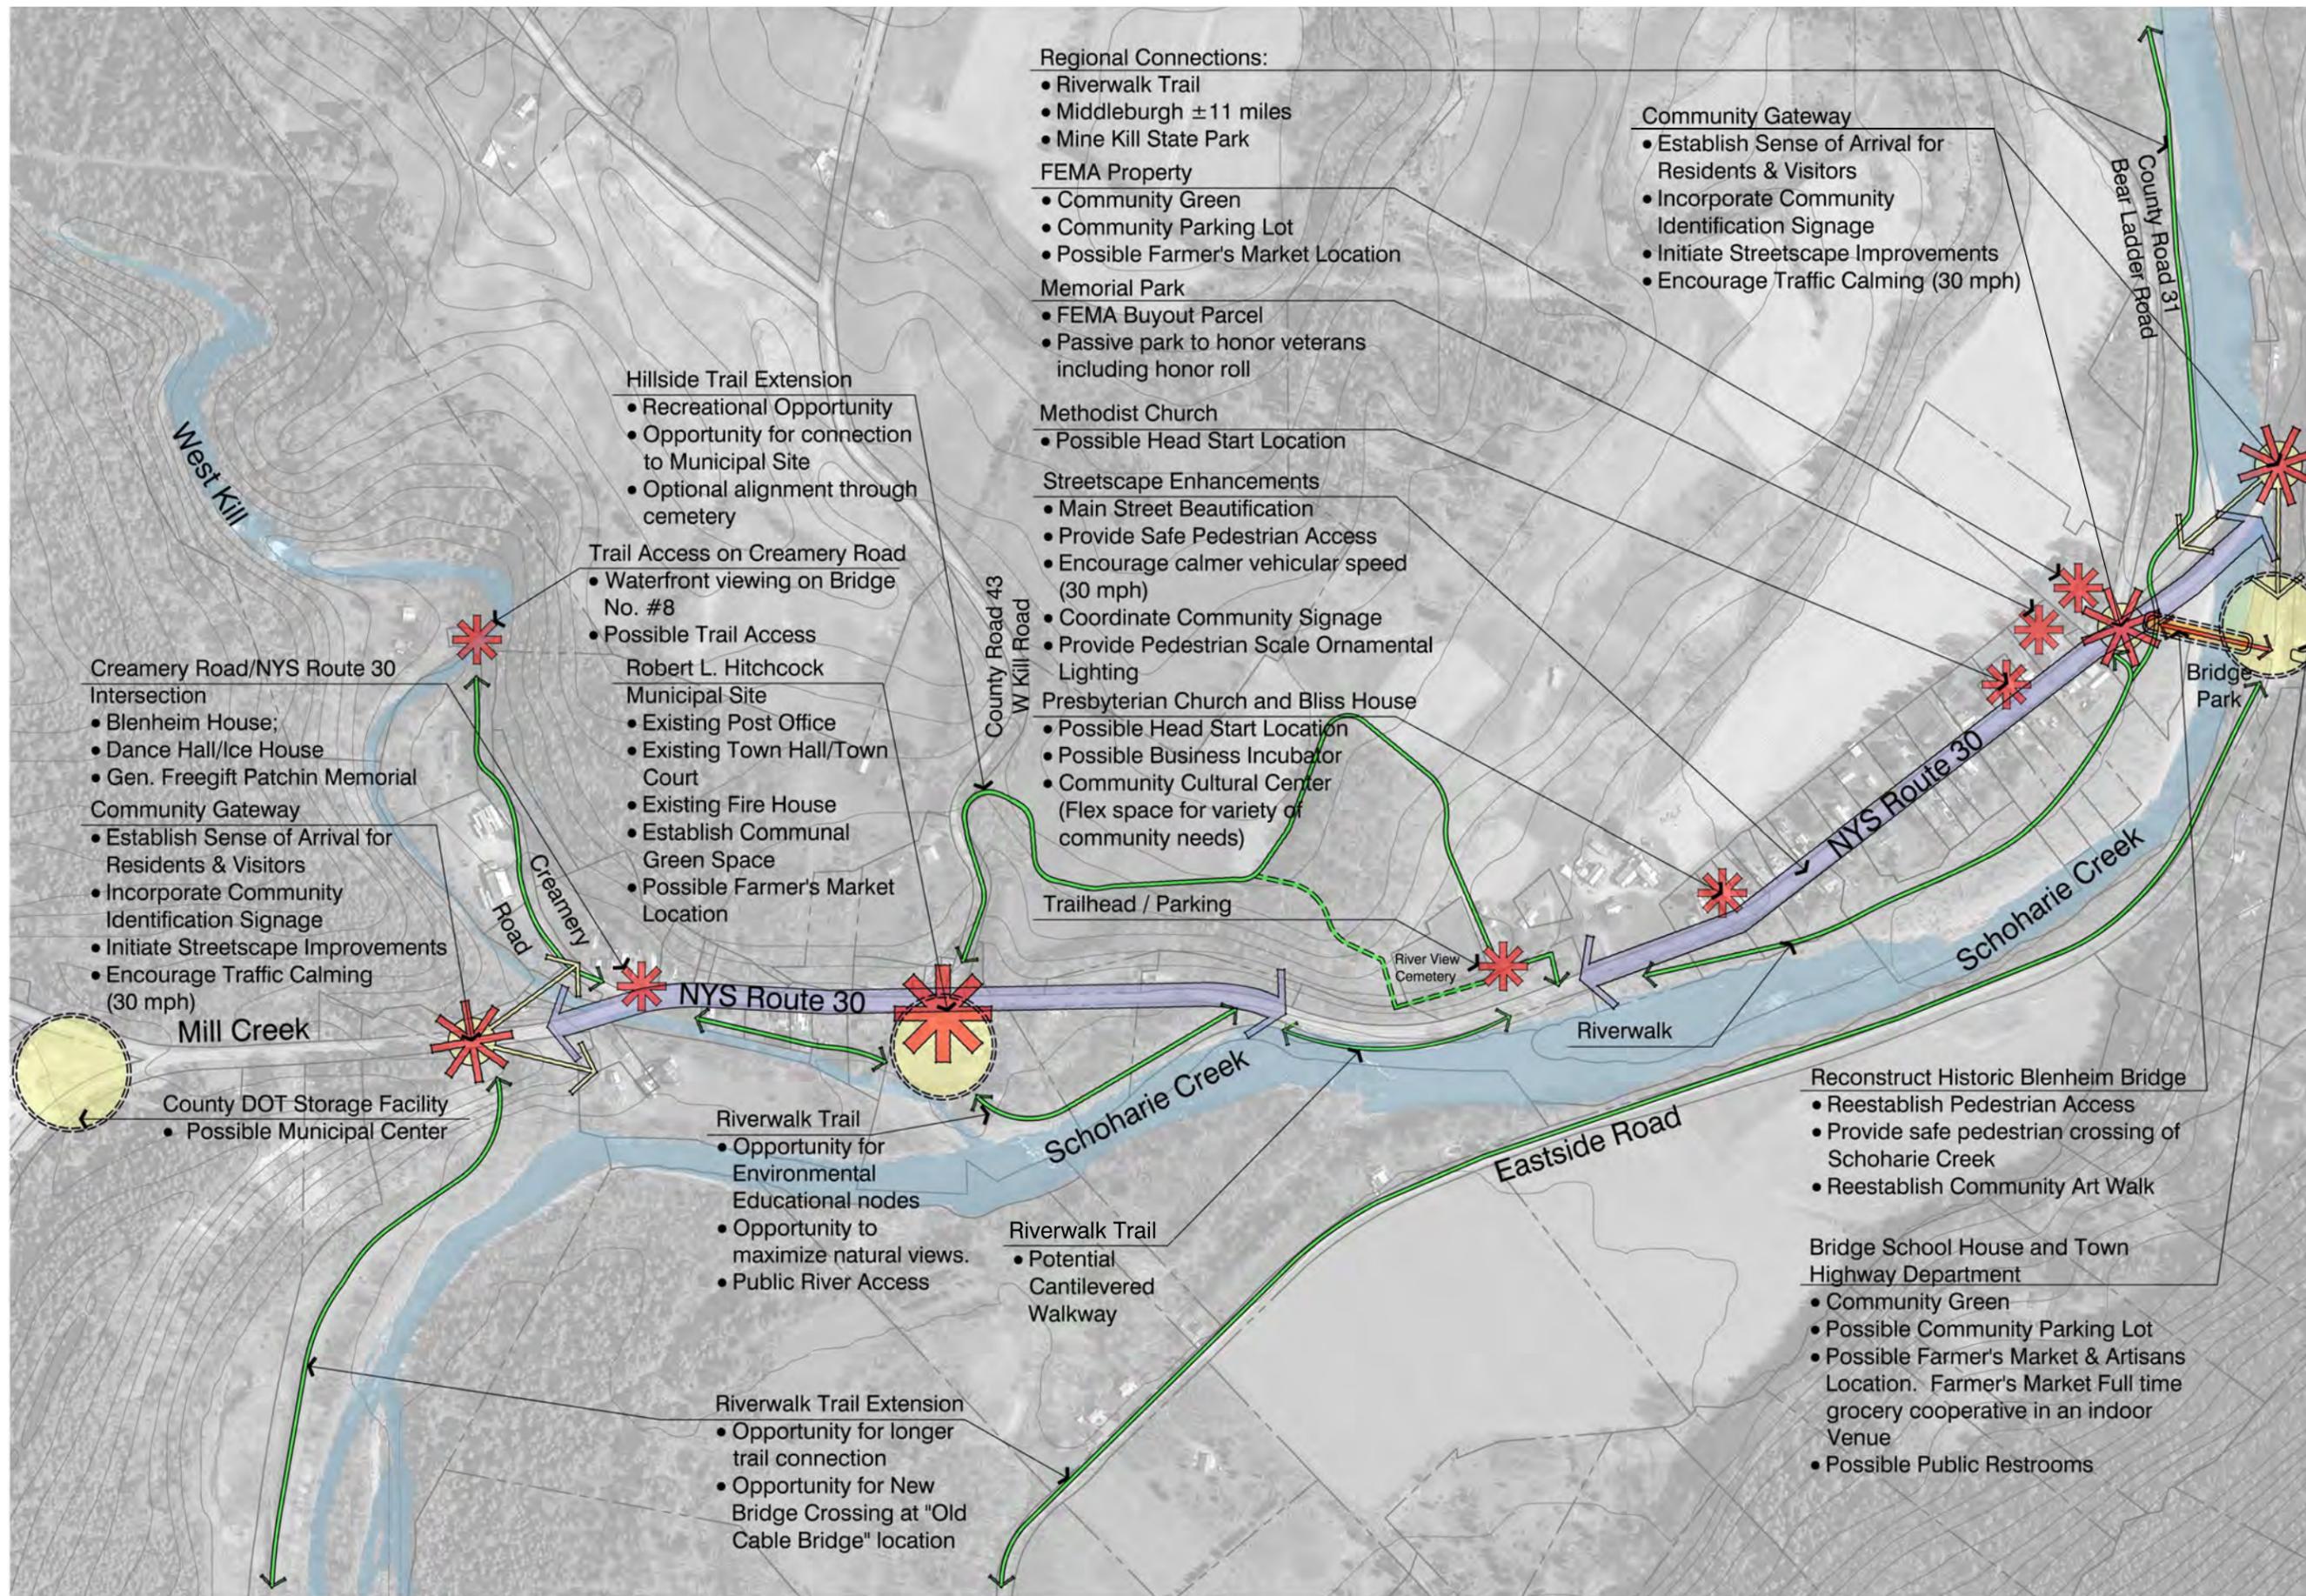
- A trail that extends through the hamlet area connecting the reconstructed bridge, the Schoolhouse Museum, the waterfront, Main Street (NYS Route 30), several new or revitalized park areas, public lands and a planned county-wide trail along the Schoharie Creek corridor;
- A new memorial park that provides a new strategic location for the Town's Honor Roll recognizing the those residents who served in the military;
- A reconfigured Blenheim Bridge Park at the entrance to the newly constructed Blenheim Bridge;
- A new multi-purpose community and cultural center in the center of the hamlet area;
- A full integration of the Schoolhouse Museum into the master plan for the hamlet area; and
- A new streetscape design for Main Street as it extends through the hamlet area.

Figure 3
North Blenheim Hamlet Master Plan

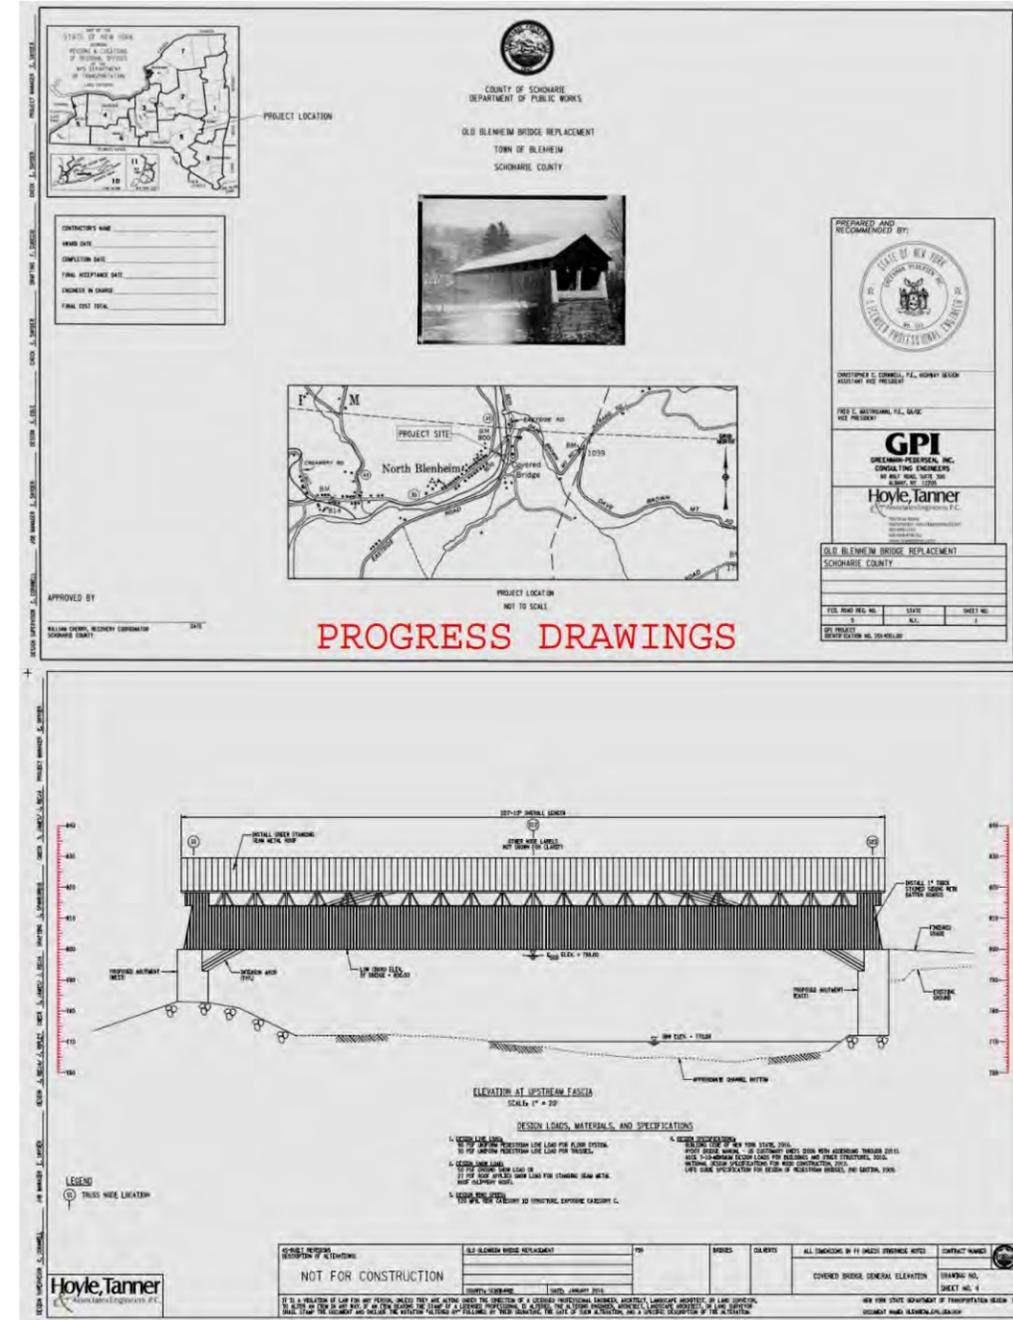
Figure 9 and Figure 10 – Excerpts from the Preliminary Plans for the Reconstruction of the Blenheim Bridge

- FEMA authorized the preparation of a feasibility study to reconstruct the Bridge and preliminary plans were prepared
- Reconstruction is anticipated in the 2017

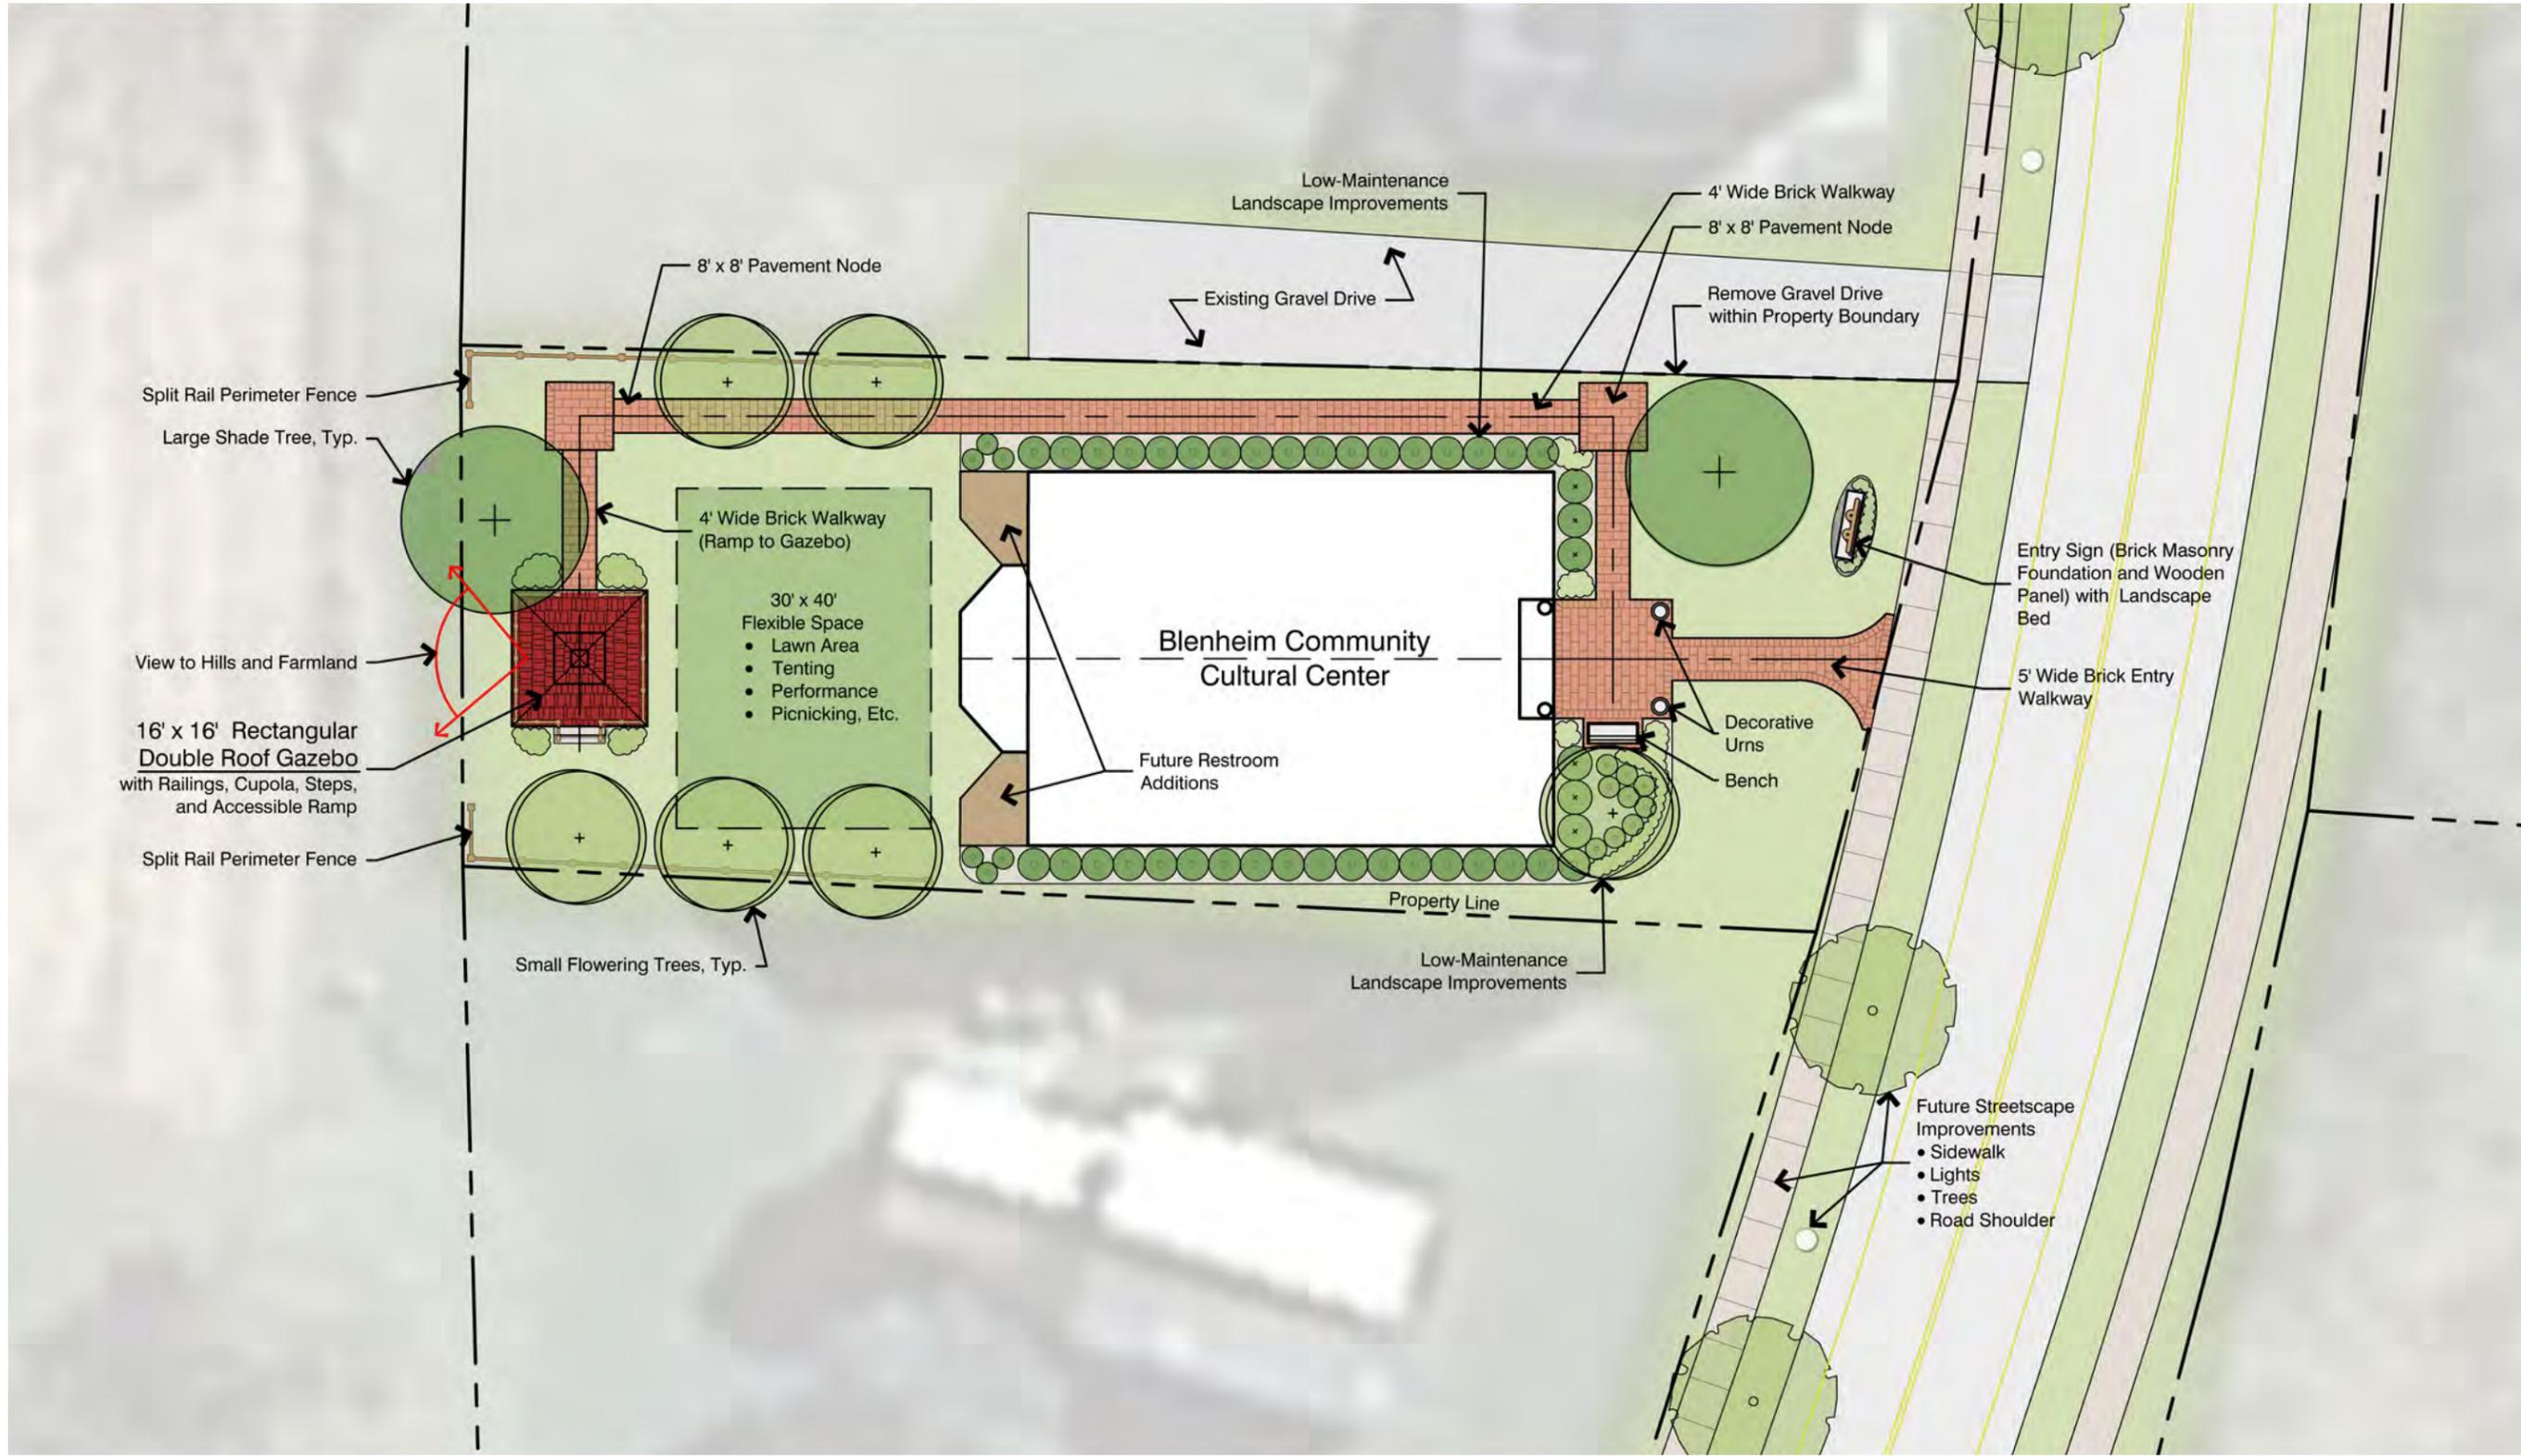
Figure 15
Concept Plan For Blenheim Community Cultural Center Option A

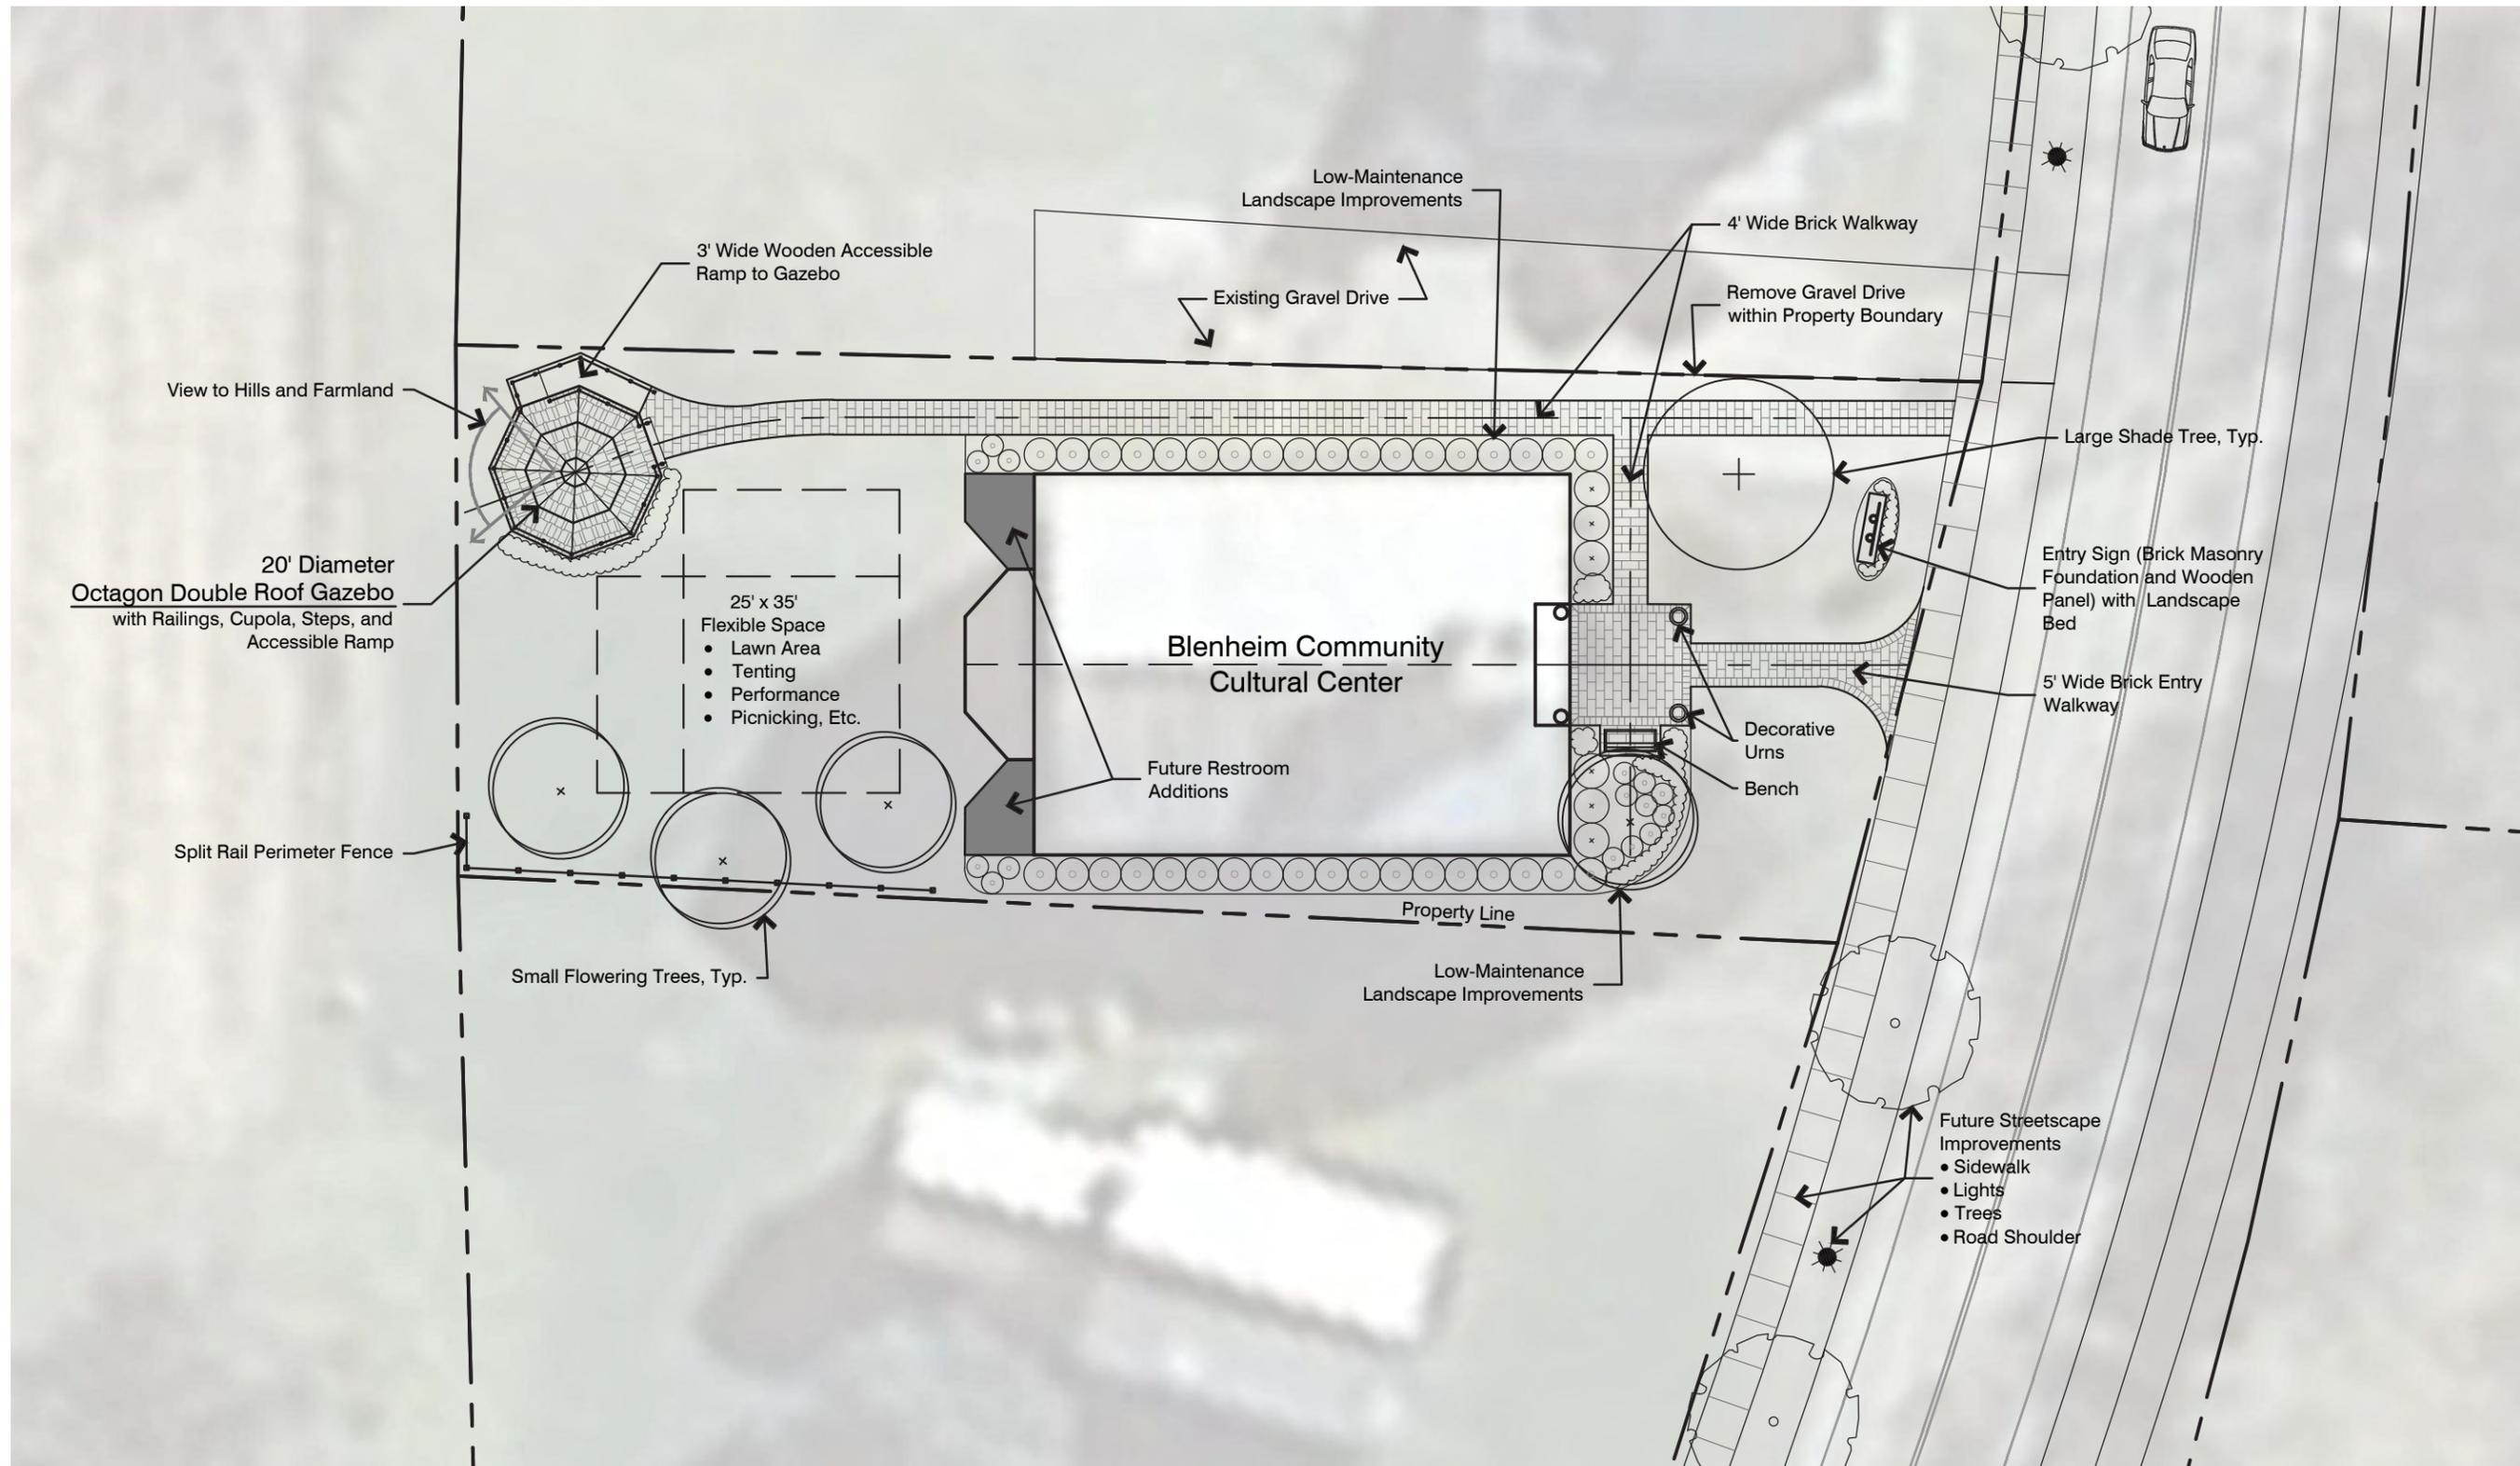
Figure 16
Concept Plan For Blenheim Community Cultural Center Option B

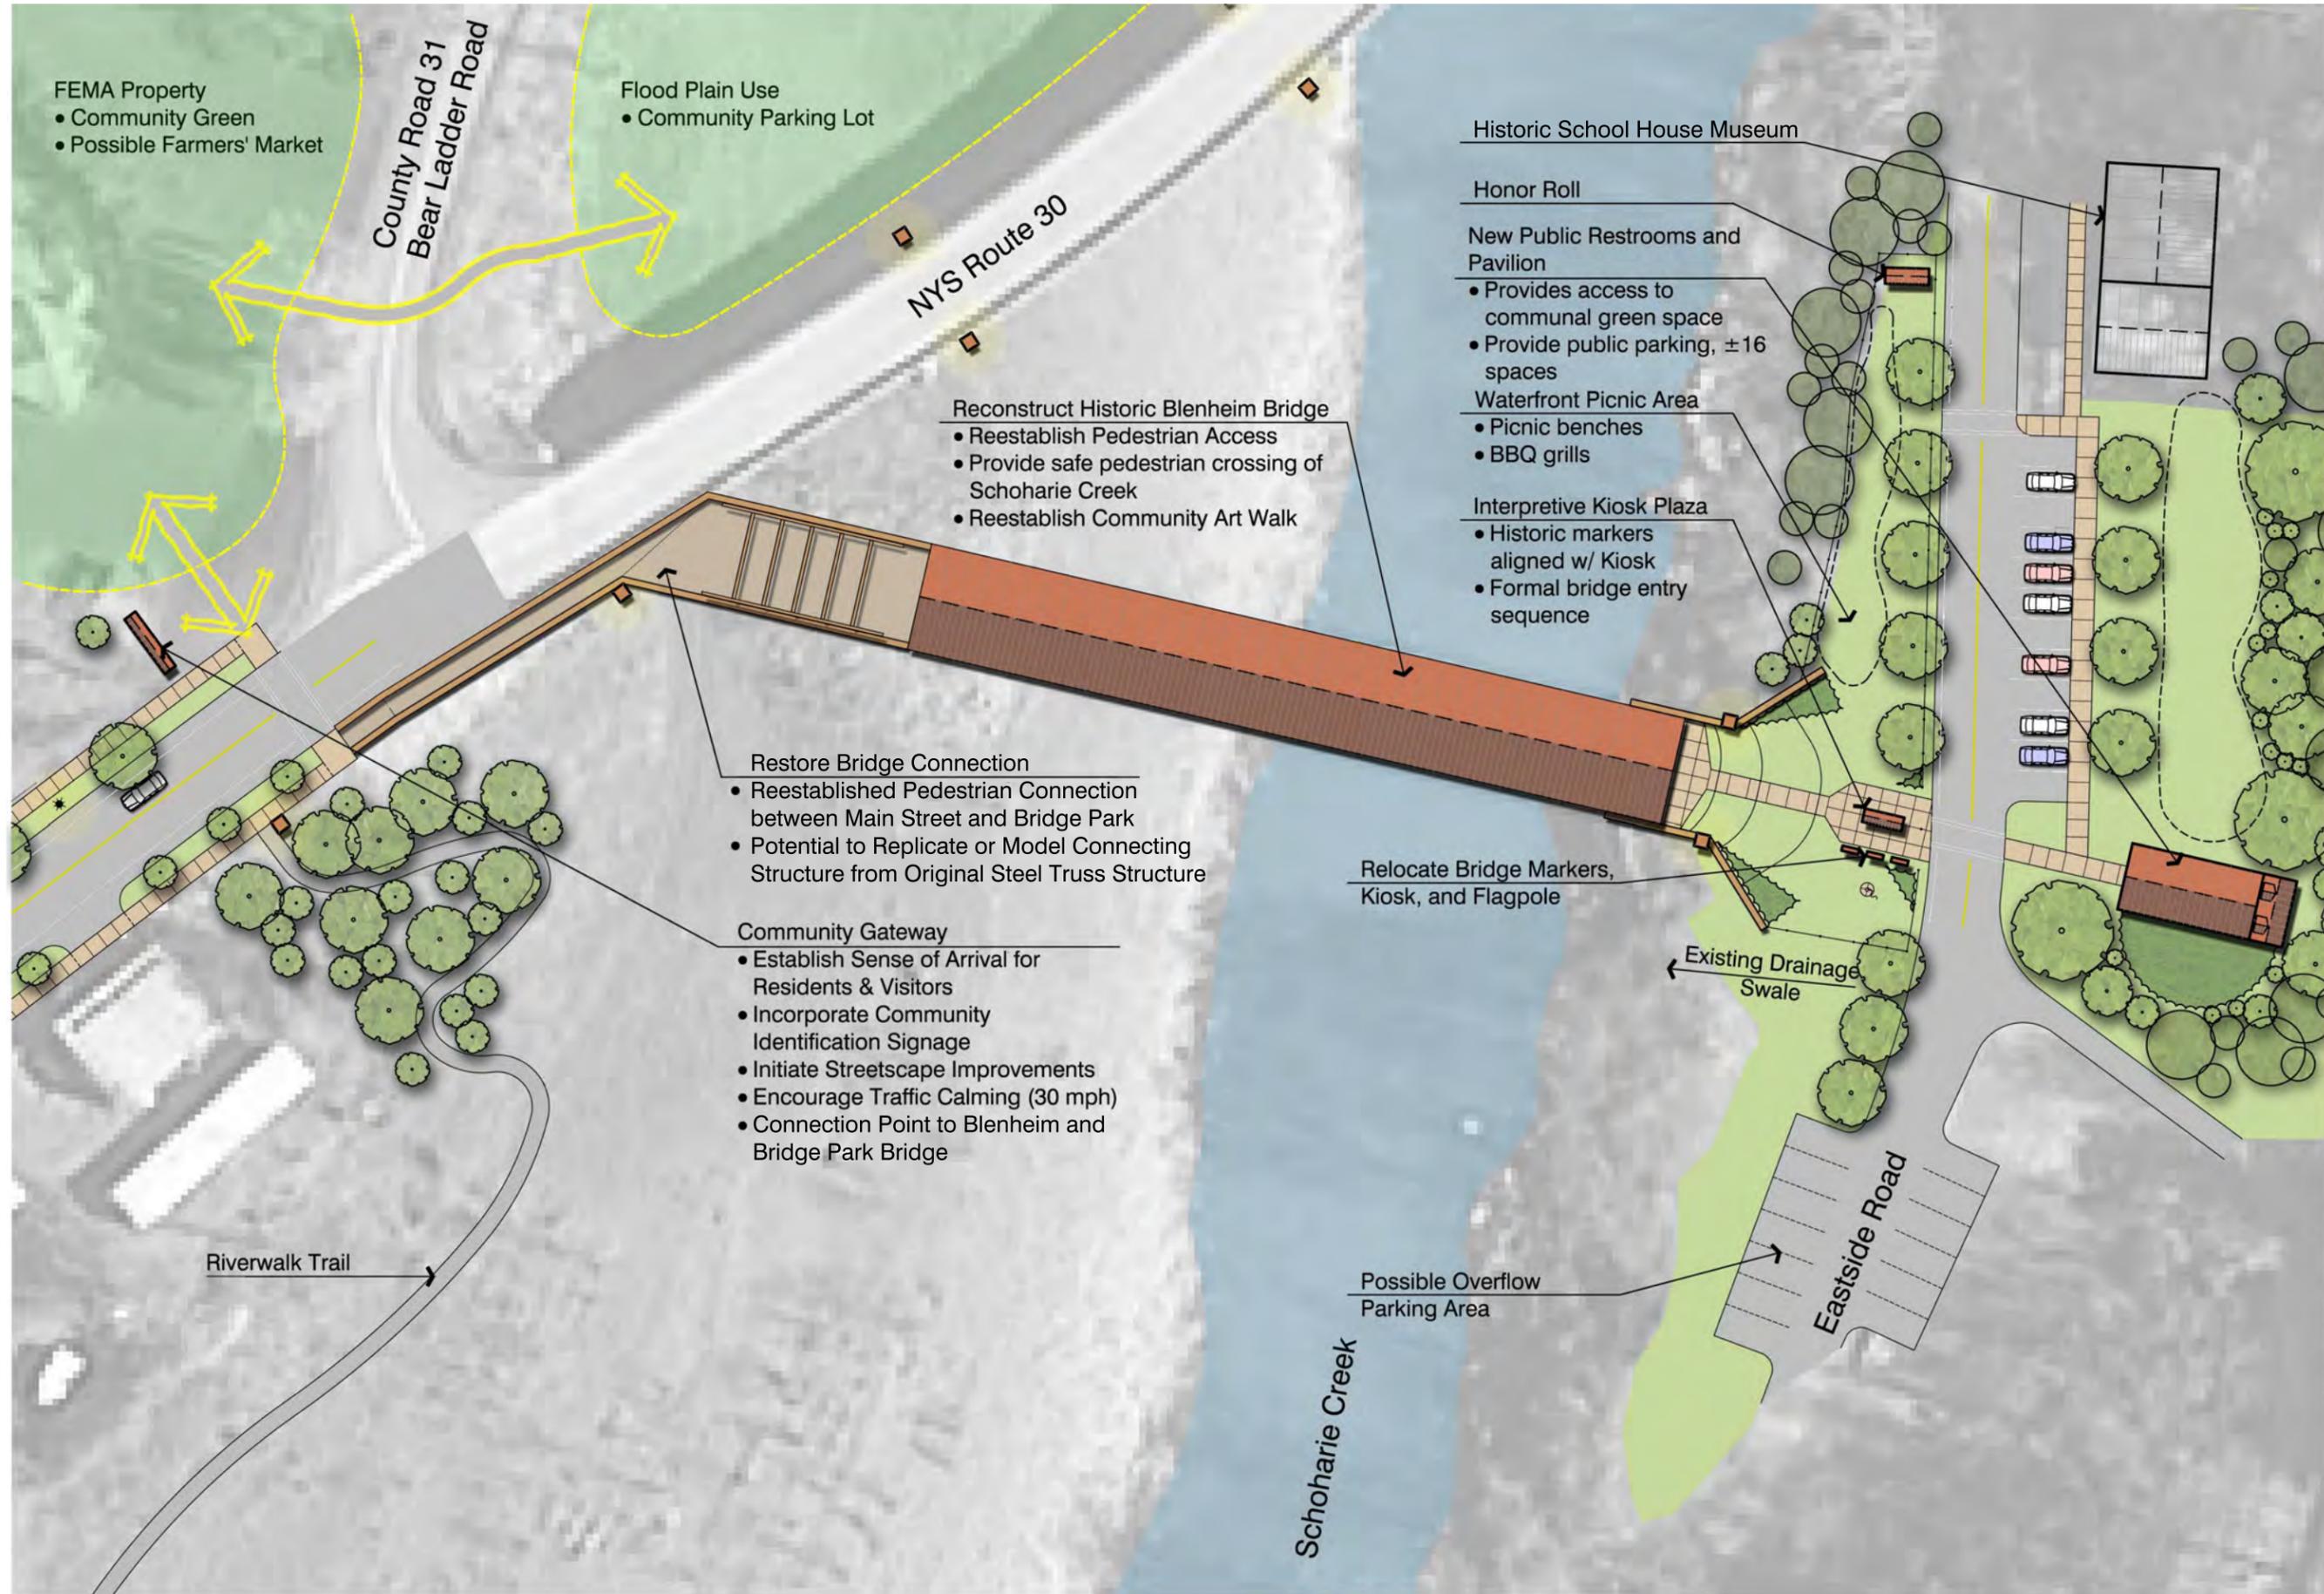
- The project is also inclusive of improvements to the school house museum building through removal of a non-historic addition to the original building and interior upgrades to the interior exhibit space (see Figure 20 – Next Page)

Figure 20
Bridge Park Engagement Plan

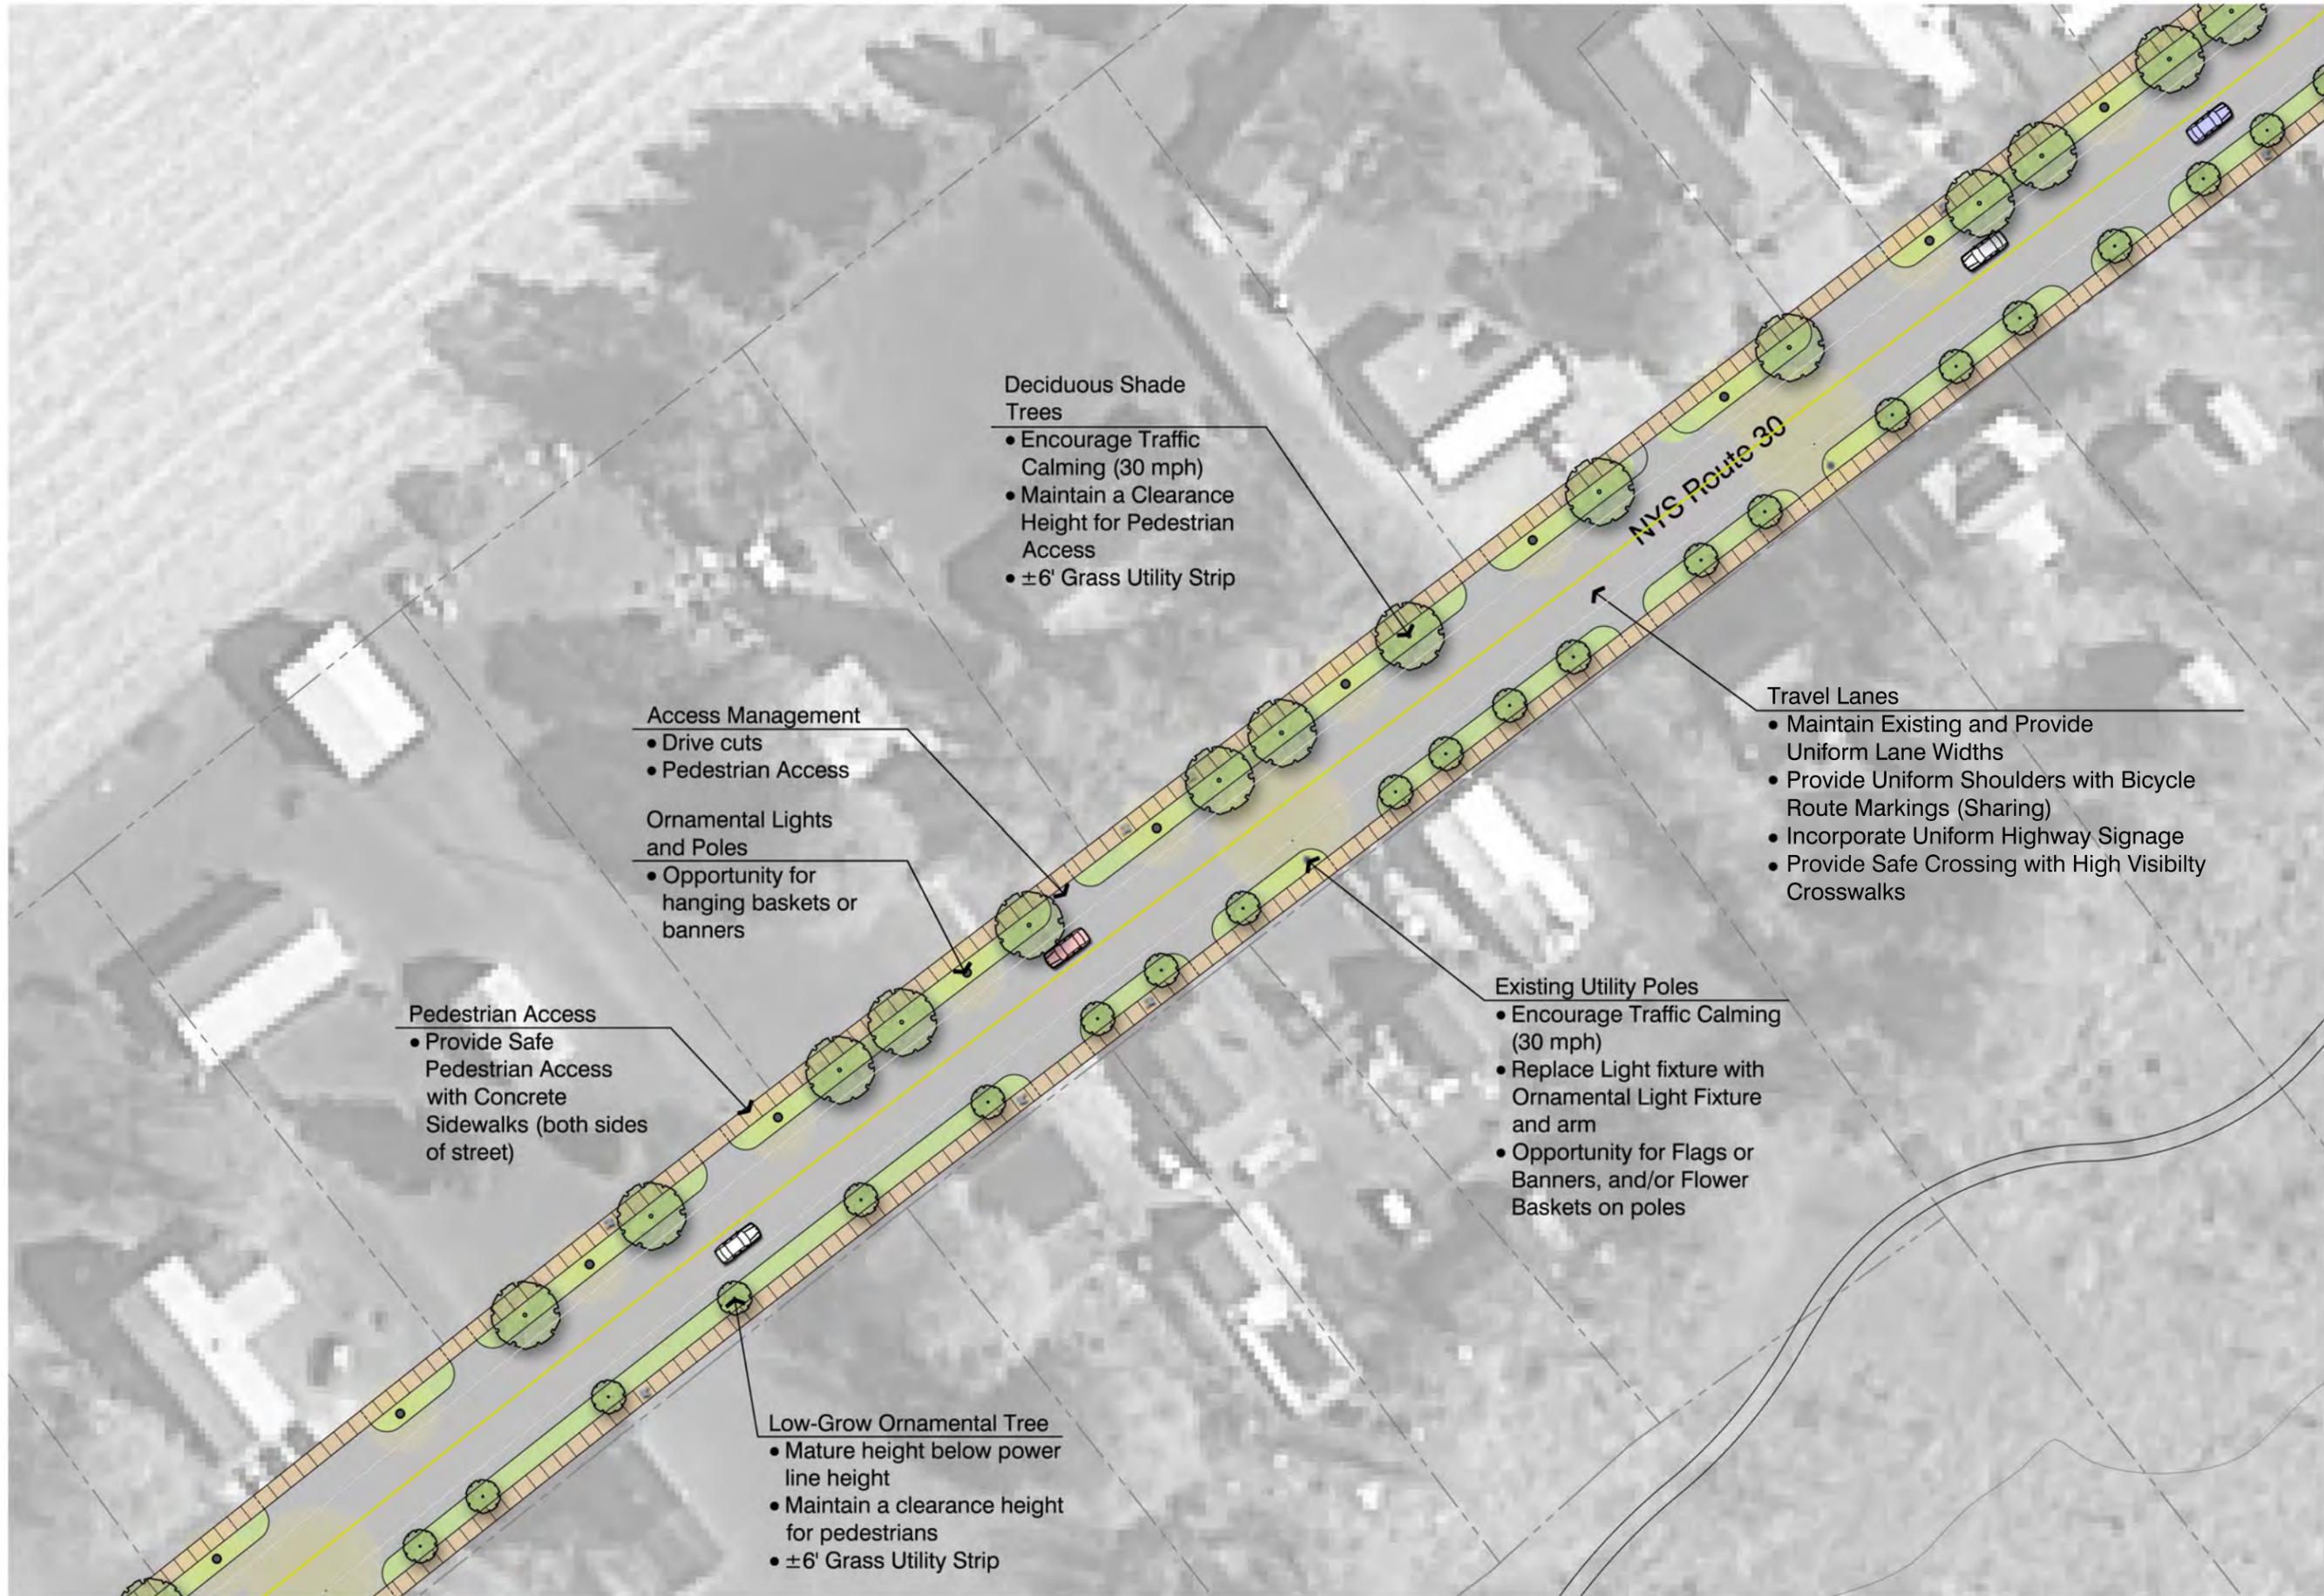
- Provides uniform travel lane and shoulder widths.
- Replaces utility pole highway lighting with decorative street lights and incorporates pedestrian scale ornamental light poles and fixtures with opportunities for celebratory and seasonal flags, banners and flower baskets

- Improves access management for residential and commercial properties
- Improved signage and streetscape amenities and encourages traffic calming
- The streetscape improvements are depicted in Figure 30 – Next Page

Figure 30
Main Street Streetscape Improvements Plan

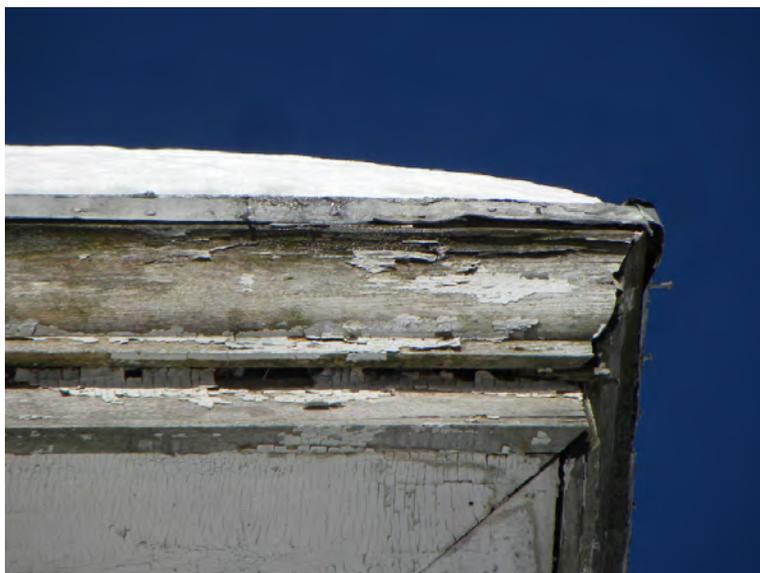
1. In general, most of the wood siding appears to be in fair condition. The exterior paint is peeling and flaking throughout.
2. There are several isolated locations at the trim details that appear deteriorated (Photograph 4).

Photograph 4 Deterioration and Peeling Paint at Exterior Wood Trim

2. Repair exterior wood trim and repaint.
3. Repair exterior wood trim and repaint.
4. Clean and repaint exterior columns and tower.
5. Perform tower repairs. Replace deteriorated wood framing and reinforce if necessary.

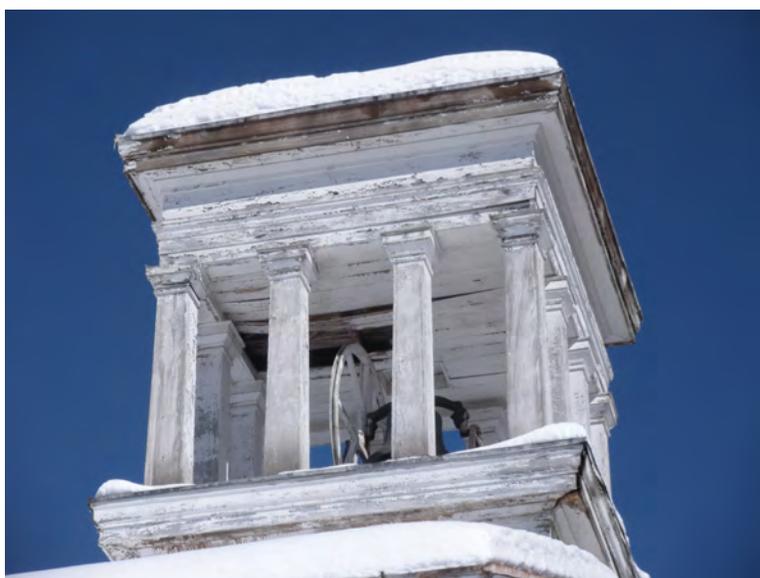
3. The wood framing at the tower is deteriorated and missing in some locations (Photograph 5). The tower was viewed primarily from the exterior because the interior was inaccessible due to the deteriorated framing.

Photograph 5 Tower Deterioration

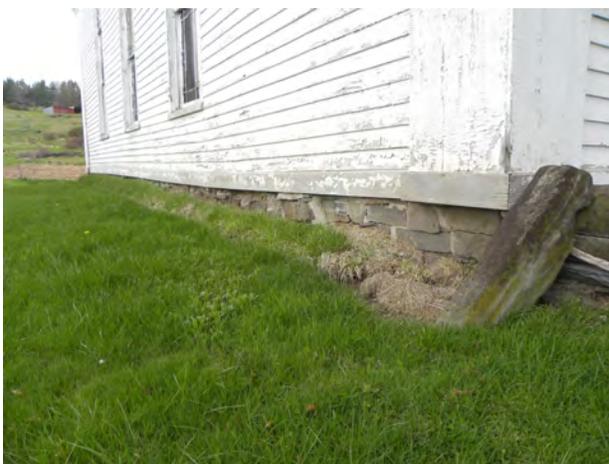
Photograph 7

4. The roof appears to be in good condition when viewed from the exterior. There are no obvious signs of bowing along the ridge line.
5. There is a significant amount of corrosion on the metal standing seam roof.
6. The floor line appears to have settled at the southwest corner of the building, as seen from the exterior (Photograph 6). The superimposed, horizontal red line illustrates the differential movement. There is localized deterioration of the stone foundation mortar joints (Photograph 7).

8. Perform repointing at deteriorated stone foundation mortar joints. The test pit from the geotechnical analysis will allow an evaluation of the mortar joints below grade.

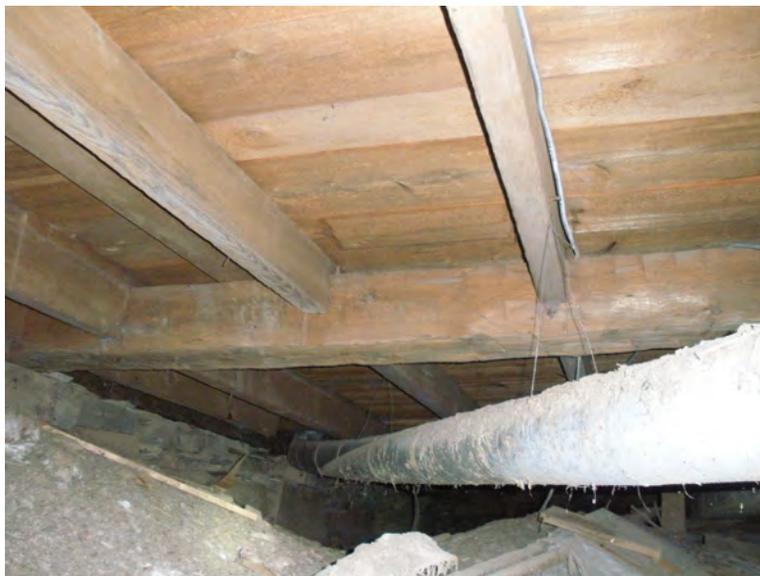
7. The floor framing was viewed from the crawlspace, which was accessed by a cellar door. The joists, beams, and decking generally appear to be in good condition (Photograph 8). The joists are connected to the beams using a mortise and tenon connection. There is localized deterioration of the wood beams at some bearing locations.

Photograph 8 Floor Framing
