Ref: Project Number: P-2685 NYPA Blenheim-Gilboa Pumped Storage Project Relicensing.

Town of Blenheim

Long-Term Community Planning Strategy

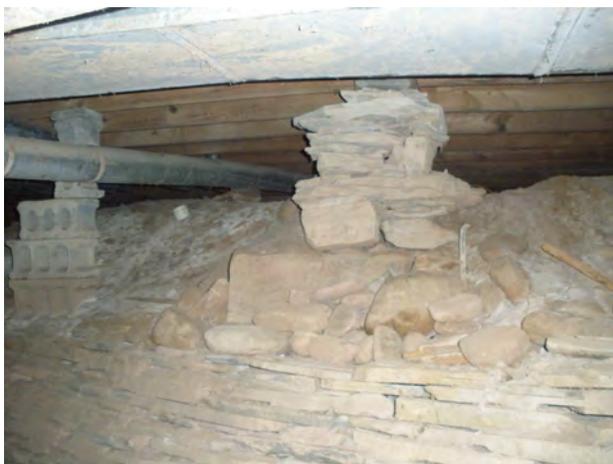
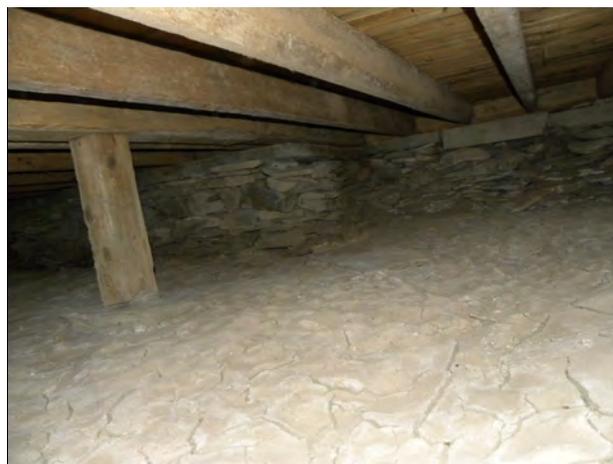
8. The existing interior footings consist of stacked stones, stacked concrete blocks or wooden posts (Photographs 9 and 10). The exterior foundation walls are constructed with stone. The depth of the footings is not known. The existing grade in the crawlspace has alligator cracking, indicating it once had a lot of moisture and recently has dried out. This is possibly from recent flooding.

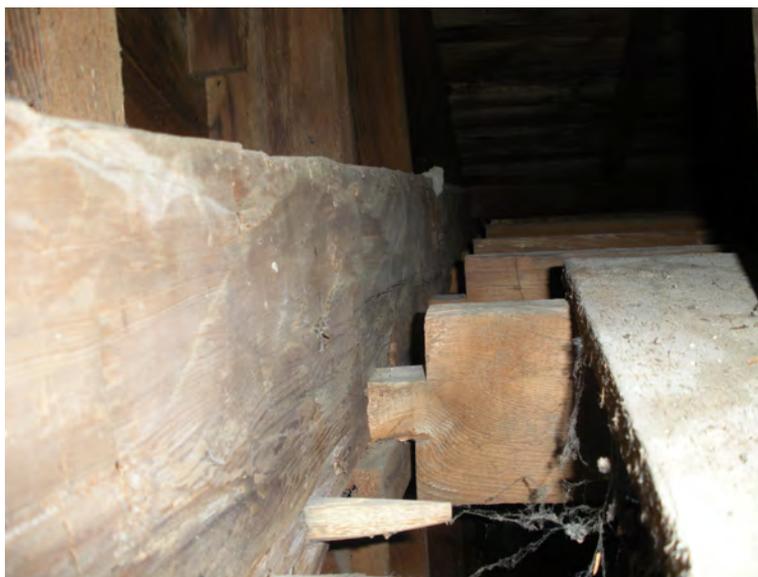
9. The roof framing was viewed from the attic and appears to be in fair condition. The ceiling joists are joined to beams and truss bottom chords with a mortise and tenon connection. **The ceiling joists along the front wall have separated from the beam showing the connection; the joists were notched considerably such that approximately only half of the cross section remains** (Photograph 11). The roof trusses appear to be in good condition (Photograph 12).

Photograph 11 Mortise and Tenon Joist Connection to Beam

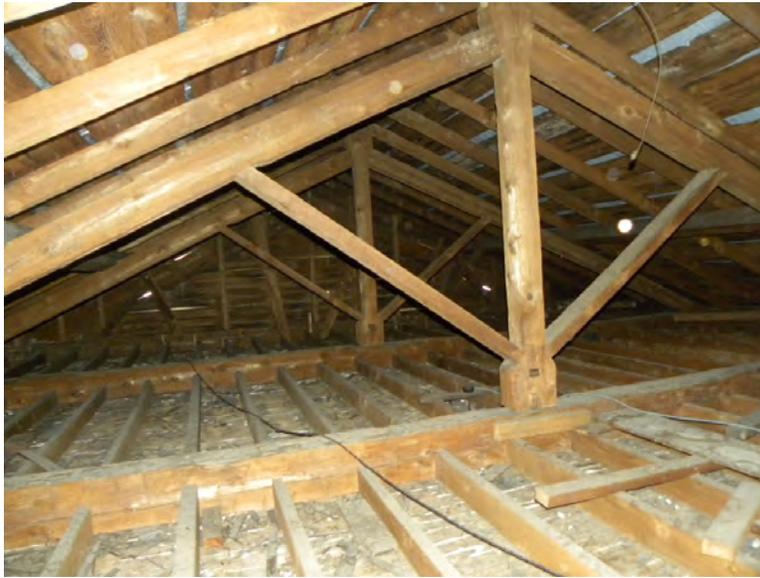
Photograph 12 Roof Trusses

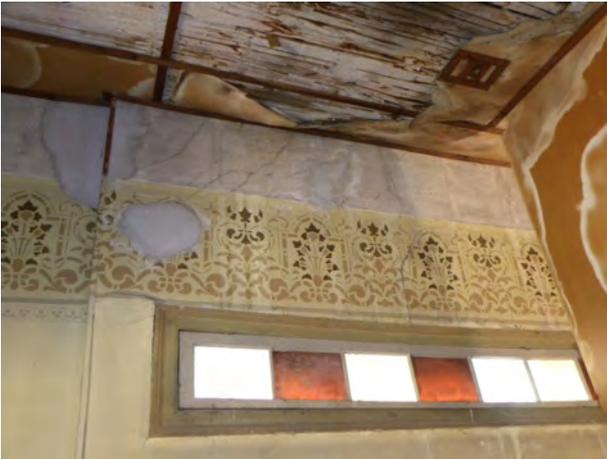
Photograph 13

10. Interior wall, ceiling, and floor finishes are in poor condition (Photograph 13). Numerous horizontal and diagonal cracks are present in the wall parging at the mezzanine level (Photograph 14).
