Semi-Annual Wetland Mitigation Area Status Report July 2003

Blenheim Gilboa Slide Area Remediation Project
Blenheim, New York

U.S. Army Corps of Engineers Permit No. 1998-0950

Semi-Annual Wetland Mitigation Area Status Report, July 2003
Blenheim-Gilboa Slide Area Remediation Project
Blenheim, New York

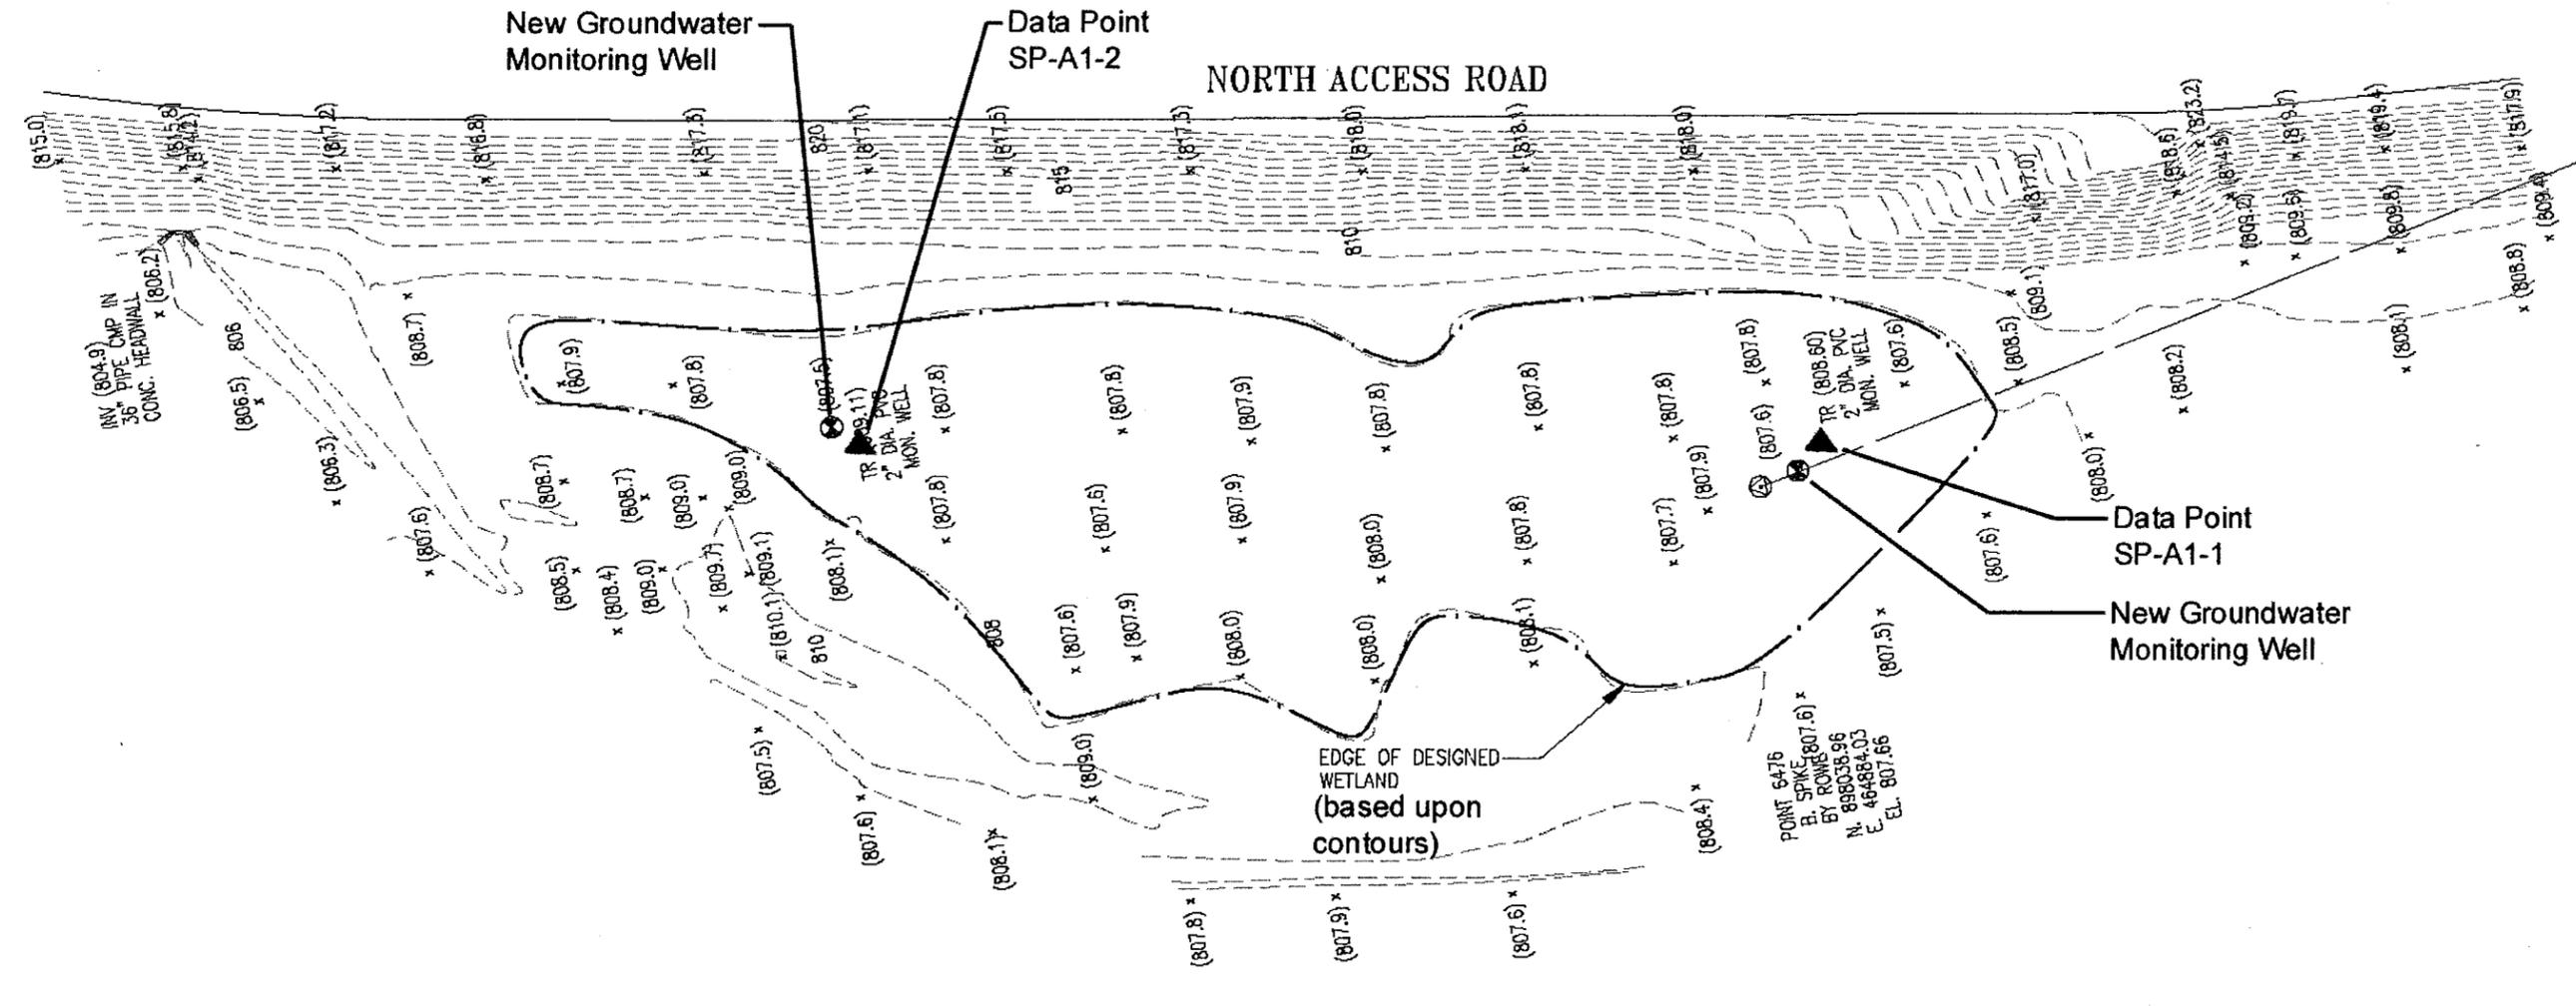
AS-BUILT SURVEY
MITIGATION AREA A1
BLenheim-GILBOA PUMPED STORAGE POWER PROJECT
SCHOHARIE COUNTY, NEW YORK
FIGURE 1, SHEET 1

SURVEY NOTES
 1. TOPOGRAPHIC INFORMATION FROM INSTRUMENT SURVEY COMPLETED BY SEAR-BROWN ON SEPTEMBER 19, 2001.
 2. HORIZONTAL AND VERTICAL DATUM SHOWN HEREON IS REFERENCED TO MAPPING PREPARED BY ROWE, WOODIN, PARSONS & BROVETTO ASSOCIATES AS PROVIDED BY THE NEW YORK STATE POWER AUTHORITY .

Remedial Plan: A post-construction survey performed by Sear Brown Associates on September 21, 2001 indicated the desired elevation of 808' was generally achieved throughout Mitigation Area A1. However, in most locations around the edge of the designed area, the 808' contour was well within the edge of the work area, which suggested a smaller acreage of wetland, would develop than designed. Additionally some areas at the north end of the mitigation area were higher than designed by as much as 12." It was estimated based solely upon as-built contours that the area anticipated to develop into wetland was between 0.75 and 0.94 acres. Remedial efforts were undertaken in the fall of 2001 including spot corrections to grades, to increase the size of the area anticipated to develop into wetland. Approximately one acre of wetland has developed and the present pattern of hydrology supports a preponderance of wetland vegetation within the 808' contour. Emergent wetland vegetation has become firmly established.

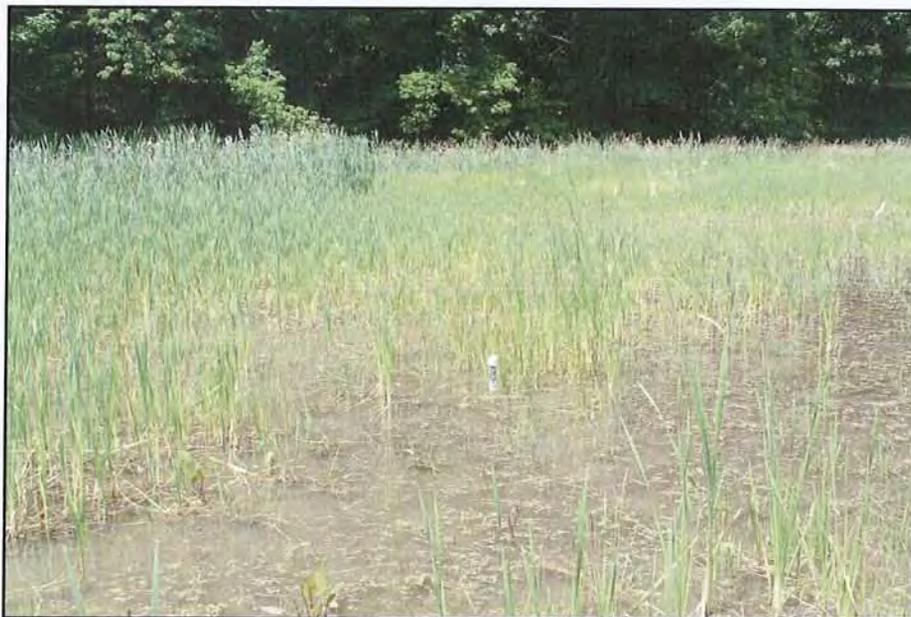
Photo 1. Mitigation Area A1 with groundwater monitoring well.

Groundwater Monitoring Well Data: Groundwater data was not collected directly from the existing wells, since they were not in a vertical position due to heaving caused by environmental stresses (i.e. frost heaving, wind, etc.). Therefore, visual indicators of hydrology were noted. The ground surface is inundated in pockets up to 3-4" in the area of SP-A1-1, and from 1-2" in the area of well point SP-A1-2. In most areas throughout the wetland, the upper 12" of soil are saturated. While this mitigation area appears dryer than the other 3 mitigation areas, it appears to have the most seasonally appropriate hydrology. The outlet at the north end of the area

appears to be functioning properly, as well. Two new monitoring wells were installed (6/25/03) to replace the heaved wells.

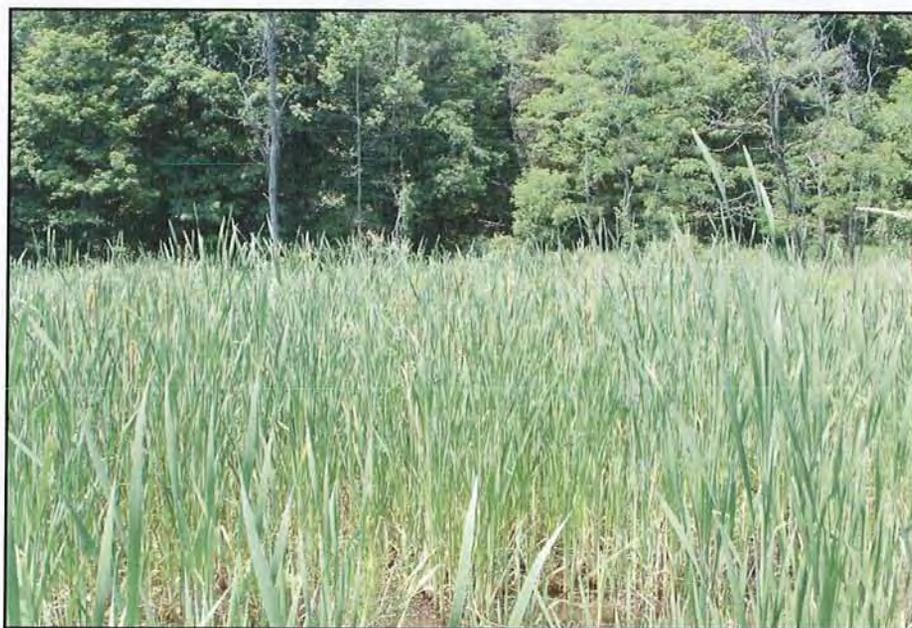
SP-A1-2 taken adjacent to northern monitoring well. 14

Photo 2. Mitigation Area A1 southwest view, at sample point SP-A1-2.

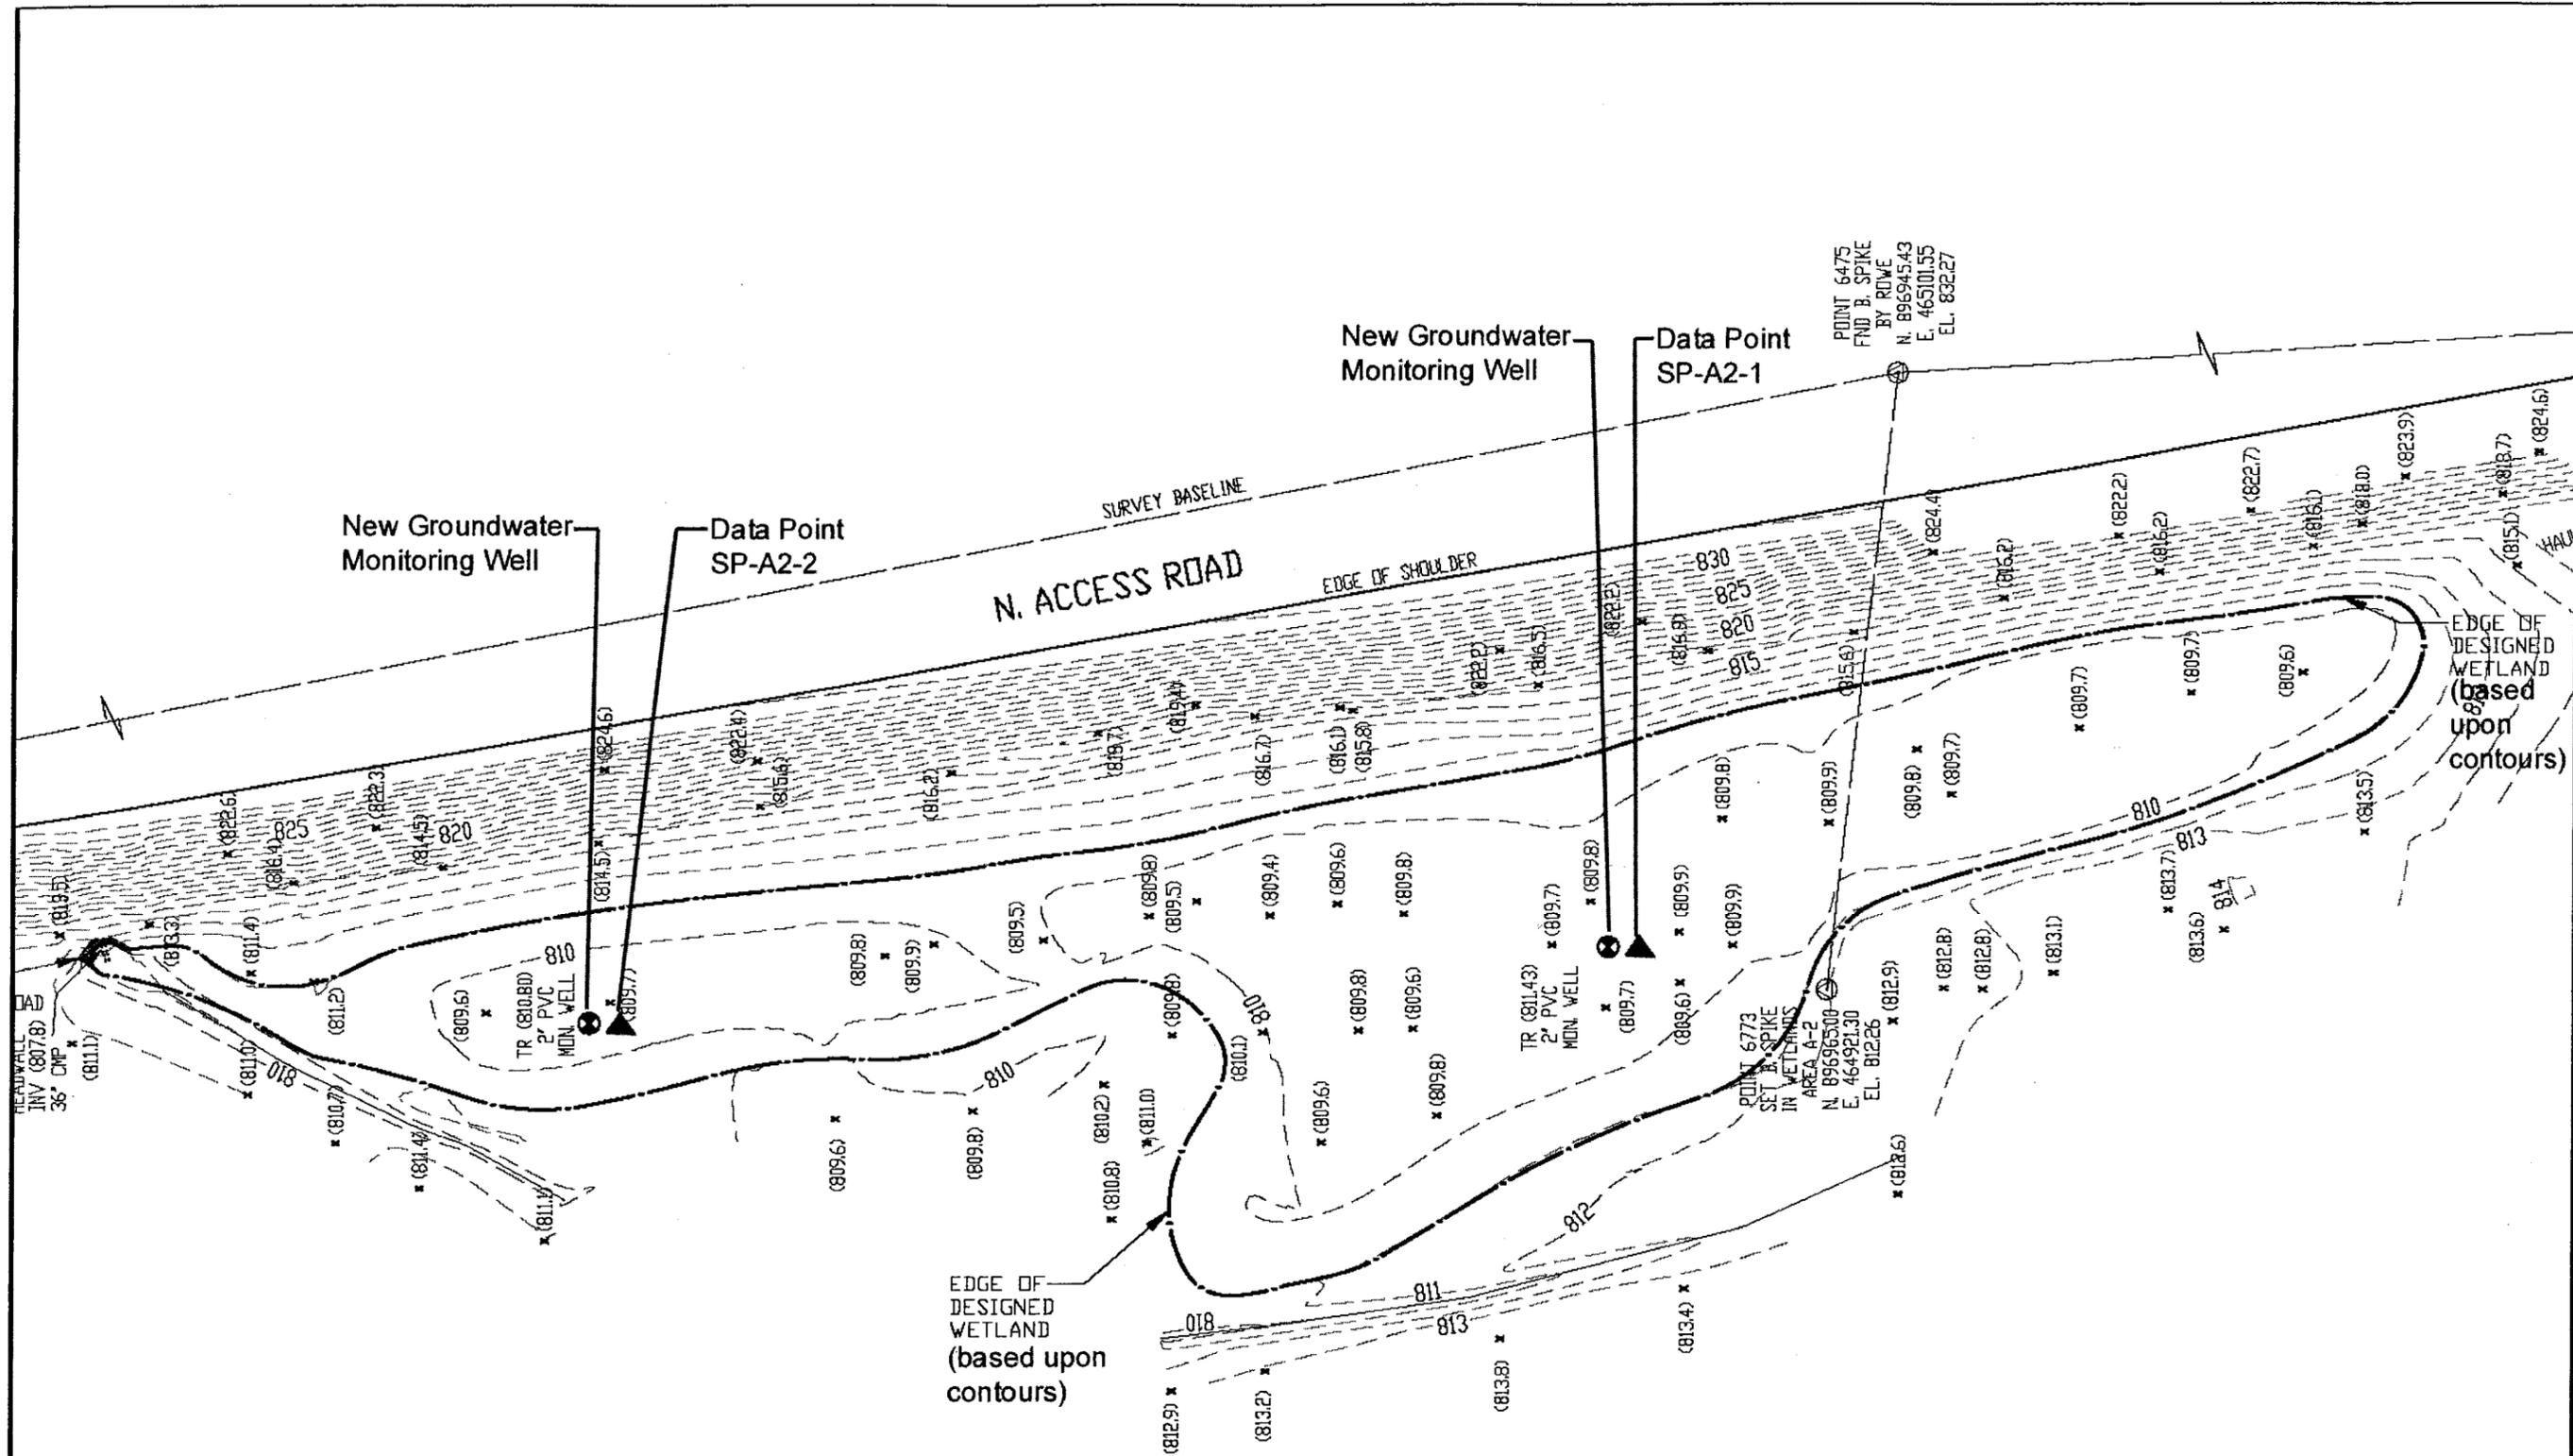
AS-BUILT SURVEY
MITIGATION AREA A2
BLENHIM-GILBOA PUMPED STORAGE POWER PROJECT
SCHOHARIE COUNTY, NEW YORK
FIGURE 2, SHEET 1

1. TOPOGRAPHIC INFORMATION FROM INSTRUMENT SURVEY COMPLETED BY SEAR-BROWN ON SEPTEMBER 19, 2001 AND UPDATED BY US ON SEPTEMBER 11, 2002
2. HORIZONTAL AND VERTICAL DATUM SHOWN HEREON IS REFERENCED TO MAPPING PREPARED BY ROWE, WOODIN, PARSONS & BROVETTO ASSOCIATES AS PROVIDED BY THE NEW YORK STATE POWER AUTHORITY .

Remedial Plan: A post-construction survey performed by Sear Brown Associates on September 21, 2001, indicated that the desired elevation of 811' was generally achieved throughout Mitigation Area A2. As with Mitigation Area A1, the basin was designed to hold the 811' contour to the edge of the mitigation area, then rise abruptly rather than having a gradually sloping edge. The post-construction survey shows the 811' contour enclosed a smaller area than designed, suggesting a smaller acreage of wetland would develop than desired. Additionally, the contractor installed a supplemental basin at the south end of the main basin that was not originally designed. While the elevations in the center of the supplemental basin indicate a wetland would develop, it was not hydrologically connected to the main basin of A2. Based upon recommendations made following the November 2001 Status Report, the contractor added a 0.22-acre area, which includes the isolated supplemental basin, at the south end of the main mitigation area. The grading and stabilization of this area was completed in June 2002. In September 2002, Sear Brown Associates re-surveyed the mitigation area. The as-builts indicate that the 811' contour, the designed wetland edge, encloses an area of approximately 1.02 acres (see Figure 2). Emergent wetland vegetation has become firmly established and the pattern of hydrology supports the full development of the designed wetland.

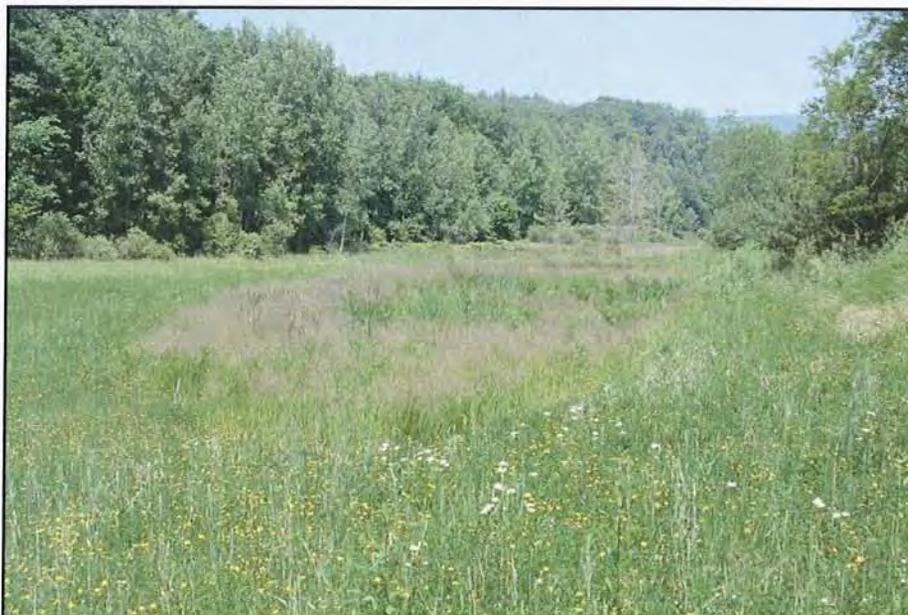
Groundwater Monitoring Well Data: Groundwater data was not collected from the installed wells since they were not in a vertical position due to heaving caused by environmental stresses (i.e. frost heaving, wind, etc.). Surface water conditions were inspected during the June 25, 2003 site visit. In the data plot located adjacent to the south well (SP-A2-1), the ground surface was inundated up to 1-2" in pockets. The open water area at the southern end of the mitigation area (remediated area) is inundated to approximately 4 to 6 inches. Given the recent above average precipitation, inundation in this area may still be too excessive for optimal wetland shrub growth.

Photo 1. Mitigation Area A2 facing south.

A trench was excavated at the west end of the mitigation area to alleviate excessive inundation, as previously recommended. Water level in the area is higher than during the November 2002 site evaluation. However, this may be a function of recent above average precipitation and the effectiveness of the trench should be reviewed weekly throughout the 2003 growing season (May – September). Two new monitoring wells were installed adjacent to the existing monitoring wells in Mitigation Area A2 on June 26, 2003.

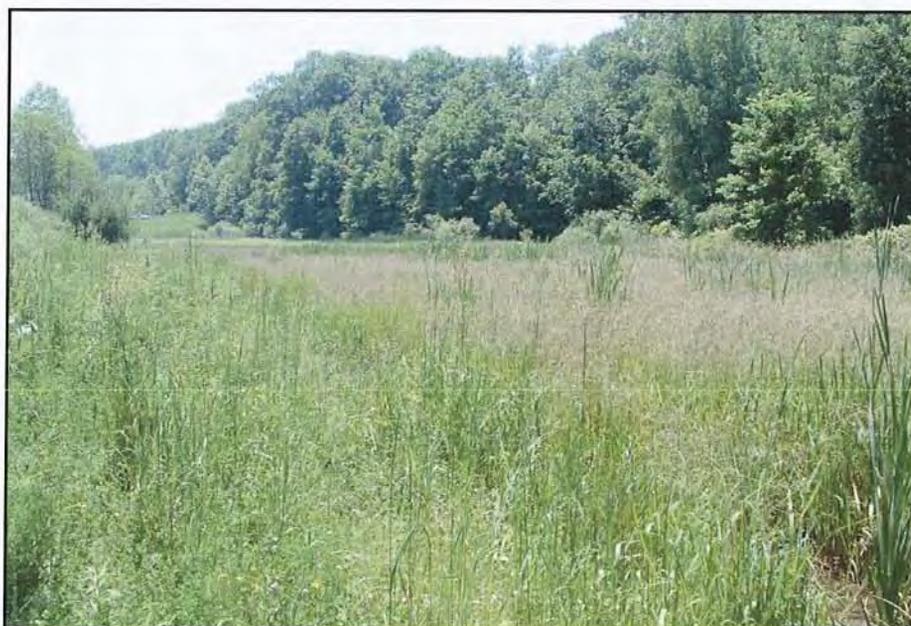
Photo 2. Mitigation Area A2 facing northeast.

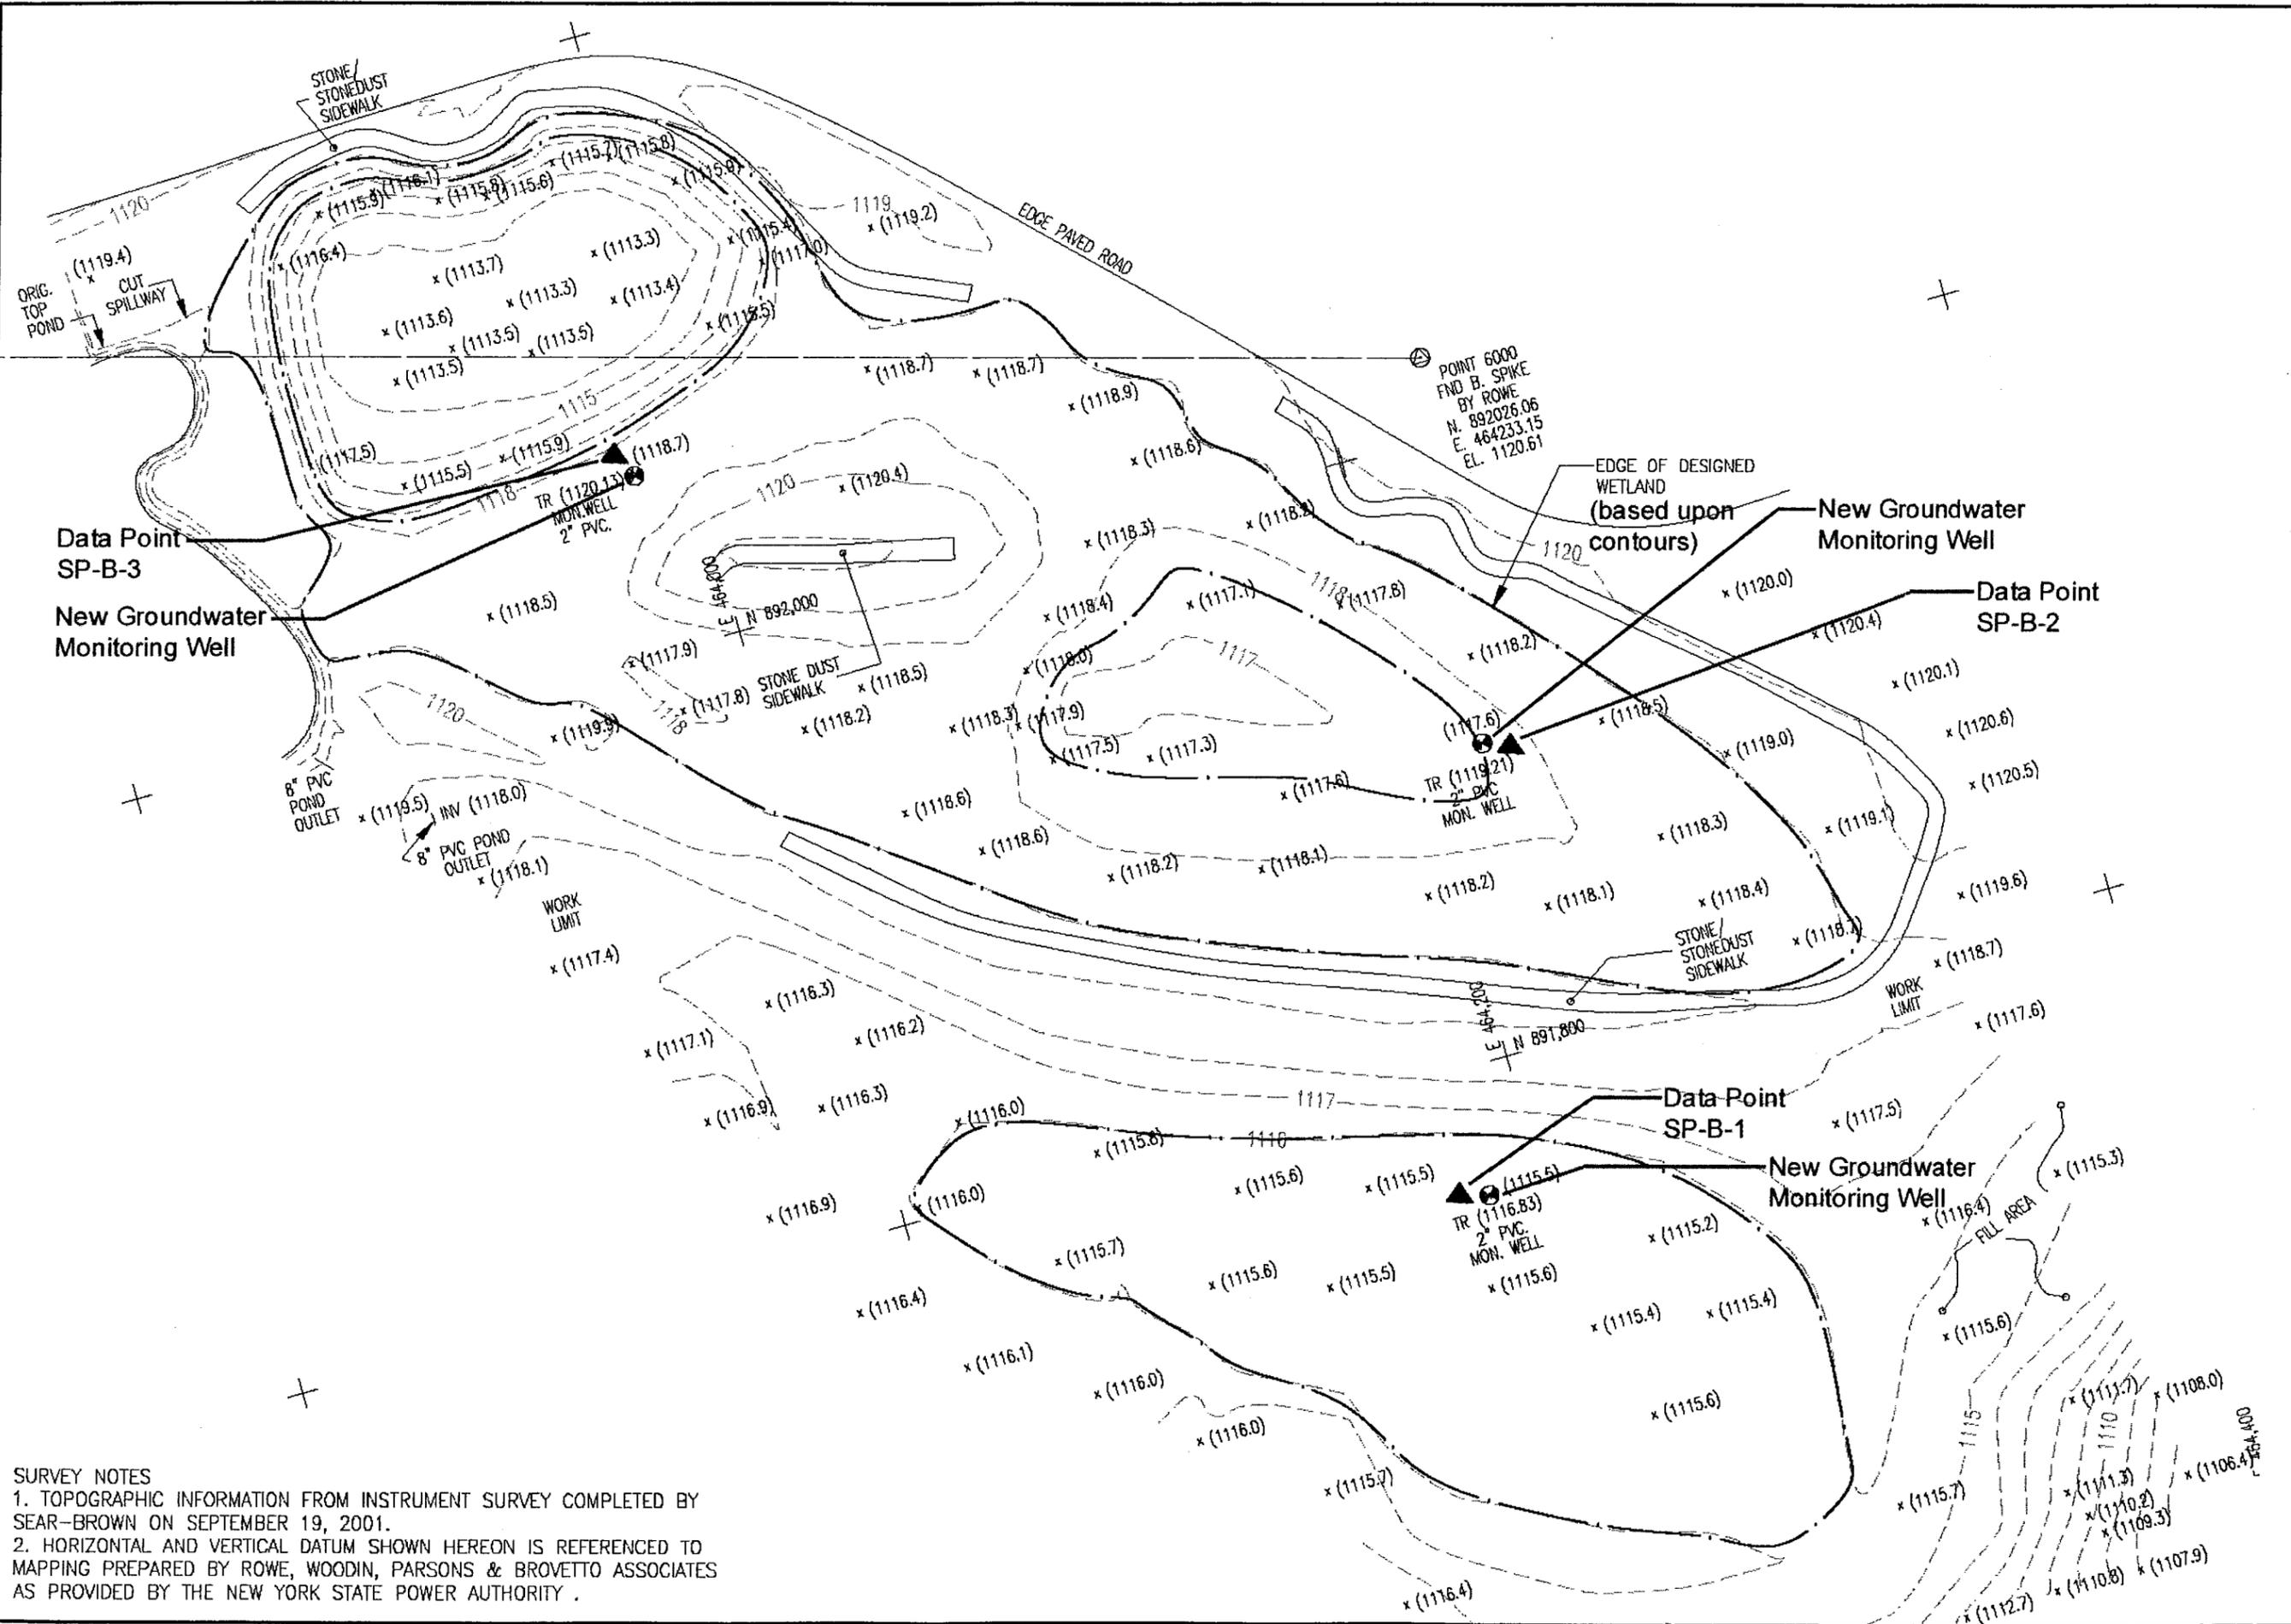
AS-BUILT SURVEY
MITIGATION AREA B
 BLENHEIM-GILBOA PUMPED STORAGE POWER PROJECT
 SCHOHARIE COUNTY, NEW YORK
 FIGURE 3, SHEET 1

SURVEY NOTES
 1. TOPOGRAPHIC INFORMATION FROM INSTRUMENT SURVEY COMPLETED BY SEAR-BROWN ON SEPTEMBER 19, 2001.
 2. HORIZONTAL AND VERTICAL DATUM SHOWN HEREON IS REFERENCED TO MAPPING PREPARED BY ROWE, WOODIN, PARSONS & BROVETTO ASSOCIATES AS PROVIDED BY THE NEW YORK STATE POWER AUTHORITY.

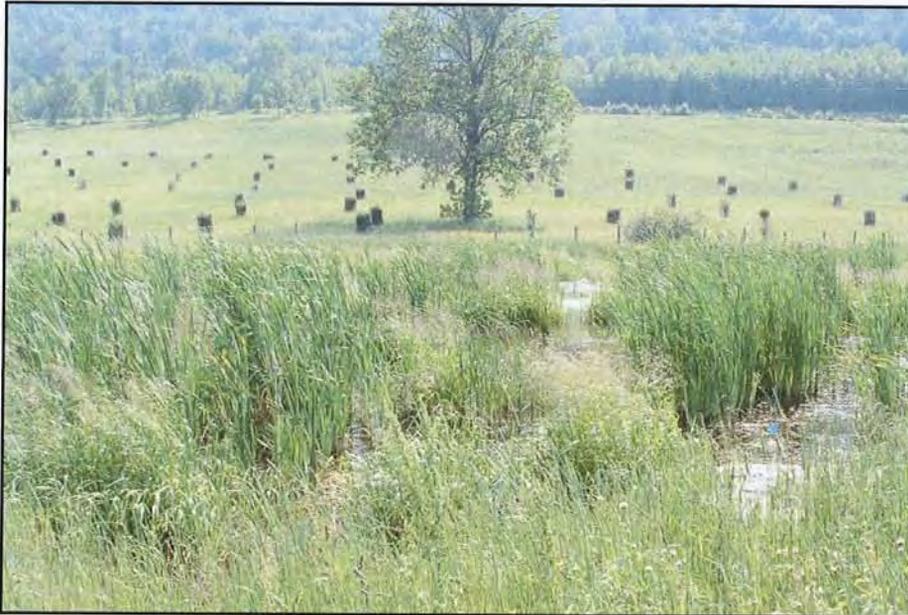
The lower basin is taking on a more wet meadow condition and is dominated by sedges, cattails, blue vervain, narrow-leaved goldenrod (*Euthamia graminifolia*), and smartweed. Shrub species are sparse and not hardy in the lower basin. Species observed include winterberry and cranberry viburnum.

Photo 1. Mitigation Area B (Lower basin) facing west.

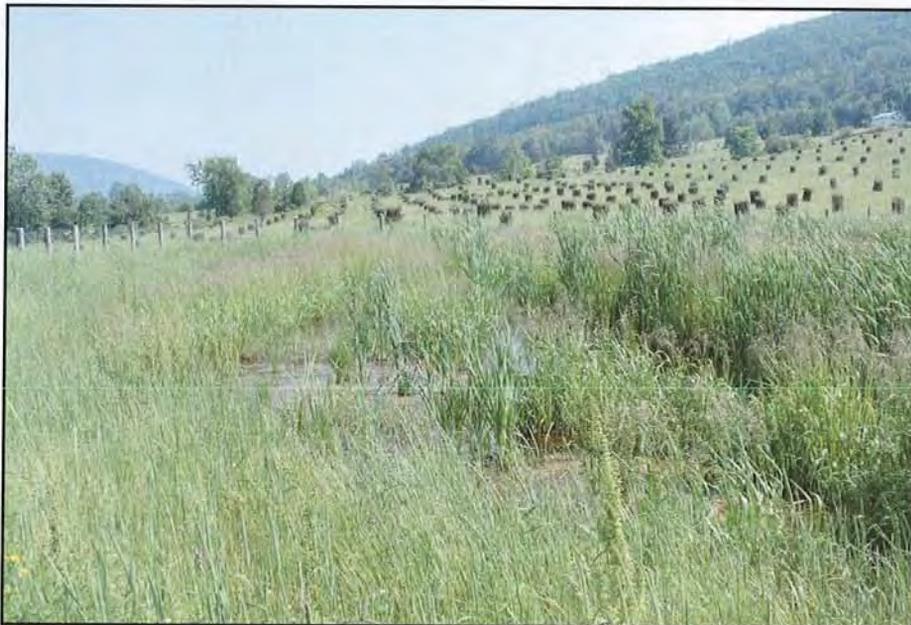
Photo 2. Mitigation Area B (Lower basin) facing southeast, near sample point SP-B-1.

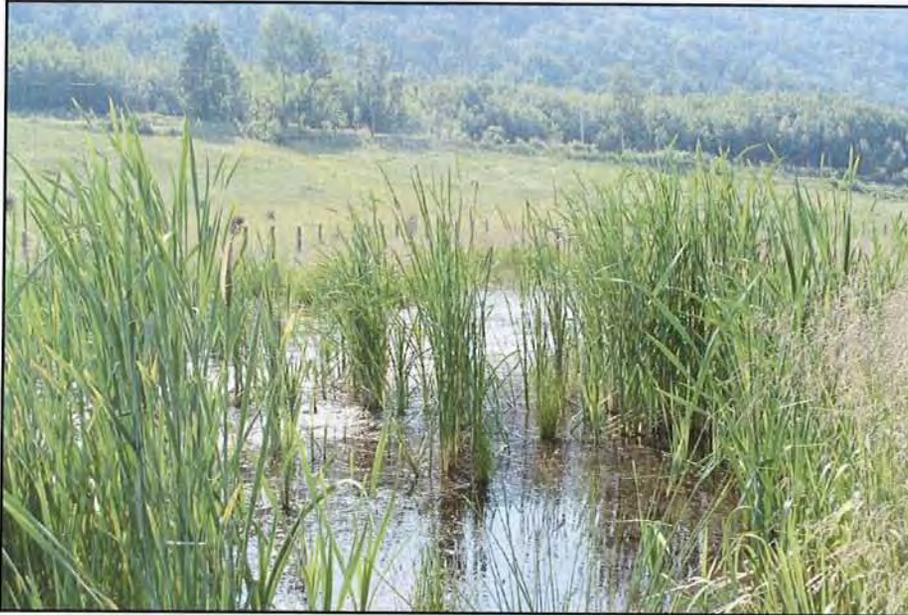
Photo 3. Mitigation Area B (Upper basin) facing northwest, near sample point SP-B-2.

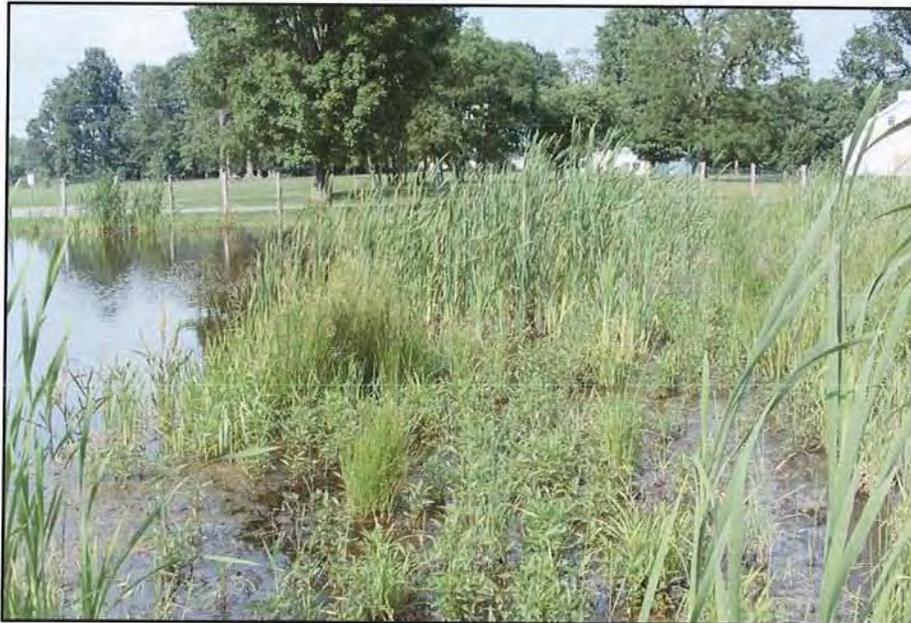
SP-B-3 taken in the upper basin of Mitigation Area B, near the northernmost water level monitoring well and ~20' north of wooden boardwalk.

Photo 4. Mitigation Area B (Upper basin) facing east, near sample point SP-B-3.

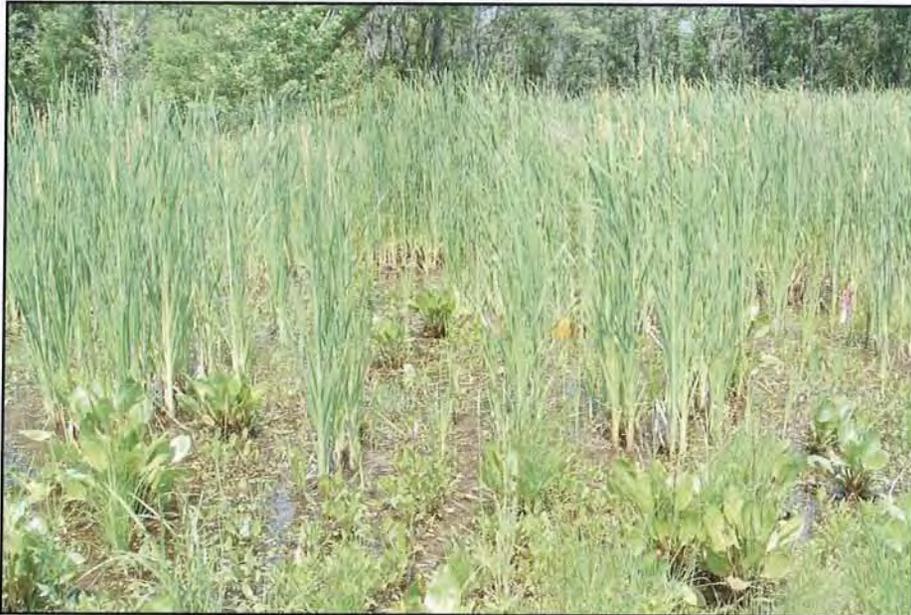
Sample plot D-2 was taken adjacent to the existing well in the western area of Mitigation D. Vegetation in this location is 100% upland old-field species including chickory, (*Chichorium intybus*), timothy (*Phleum pratense*), red top (*Agrostis alba*), and red clover (*Trifolium pratense*). However, this is not indicative of the entire area. The central basin is doing well and is dominated by emergent species such as spike rush, cattails, sedges, and water plantain. The area surrounding the central basin is covered with smartweed, bur marigold, alder, and cattails. No evidence of invasion by common reed or purple loosestrife was found. A robust population of common reed is established immediately to the south end of Mitigation Area D. It has not been

Photo 1. Mitigation Area D facing northeast, near sample point SP-D-2.

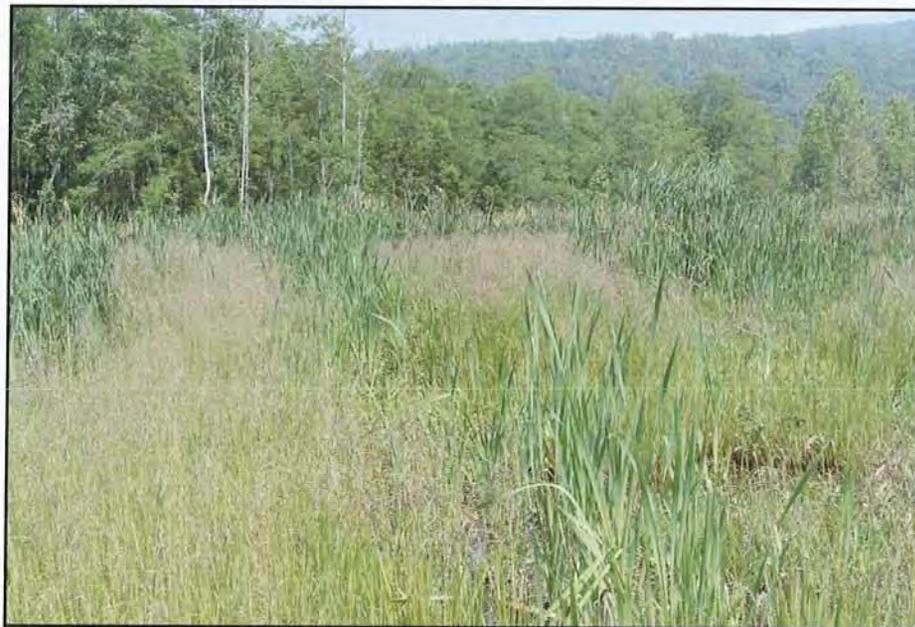
Photo 2. Northeast corner of Mitigation Area D facing south.

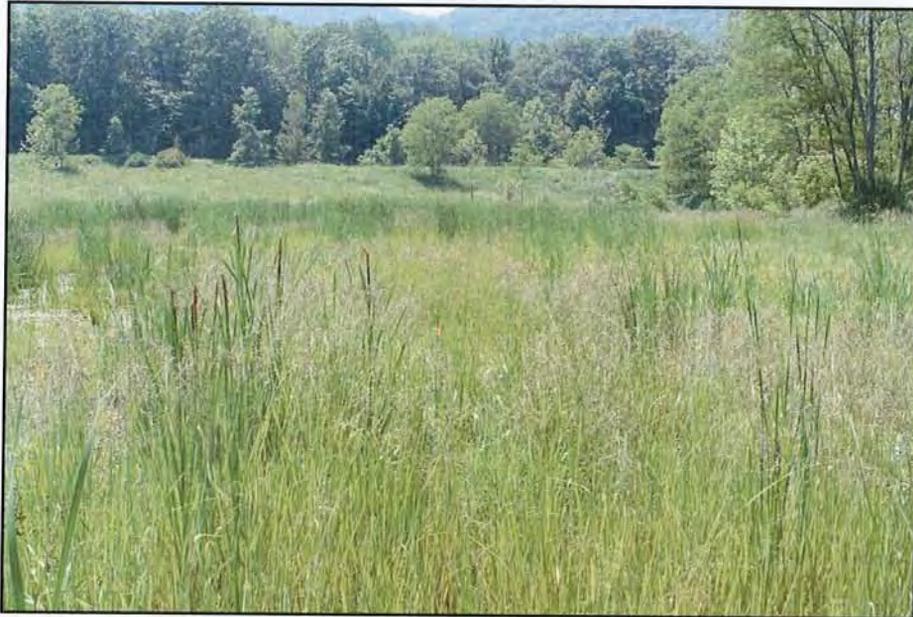
Photo 3. Mitigation Area D facing southeast from western boundary of wetland area.

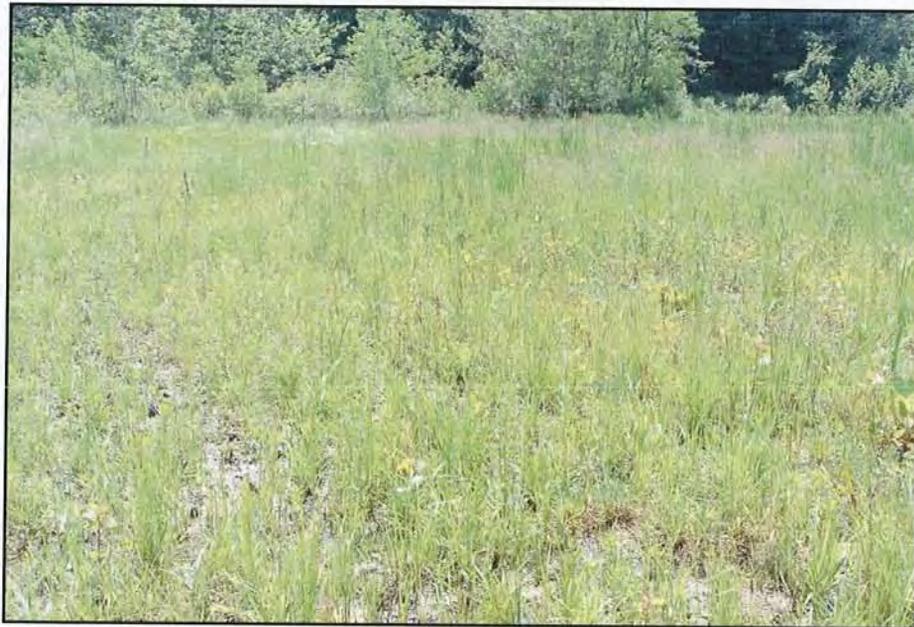
Photo 4. Southeast corner of Mitigation Area D facing south.

recommended to eradicate the existing population of common reed with chemical methods, as it is interspersed in a shrub community of willows. Invasion by common reed in Wetland D should be closely monitored.
