# **2011 SCHOHARIE CREEK BASIN FLOODING**

## **Site Reconnaissance and Flood Evaluation**

*Prepared for:*  
New York Power Authority

**May 2012**

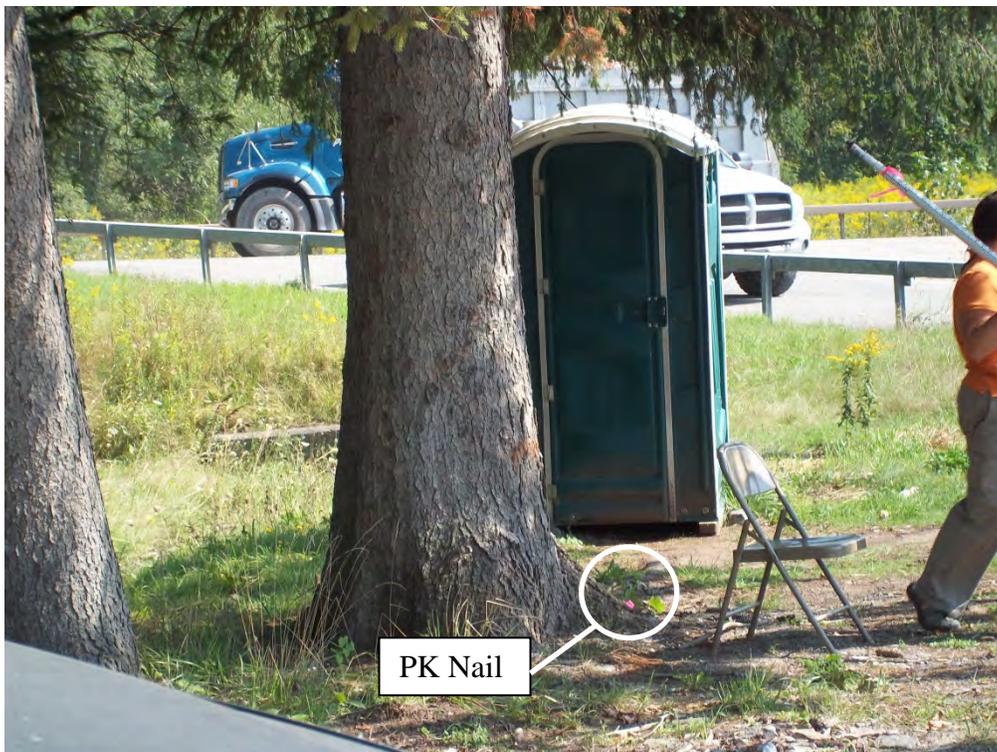
P02 (Survey Point 557) – PK nail driven into tree to locate high water mark (see photo above). NYS Route 990V in background (Photo taken 9/2/2011)

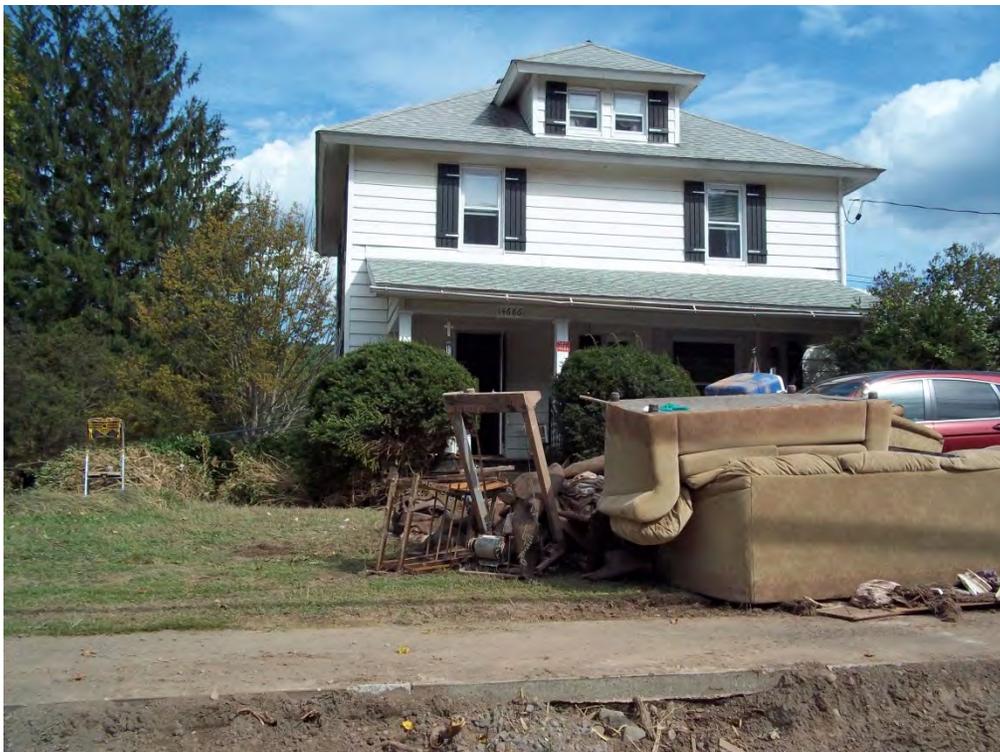
P06 (Survey Point 1010) – 14686 NYS Route 23 in Prattsville. Mud line on home approximately 9 inches above the first floor/porch elevation. (Photo taken 8/31/2011)

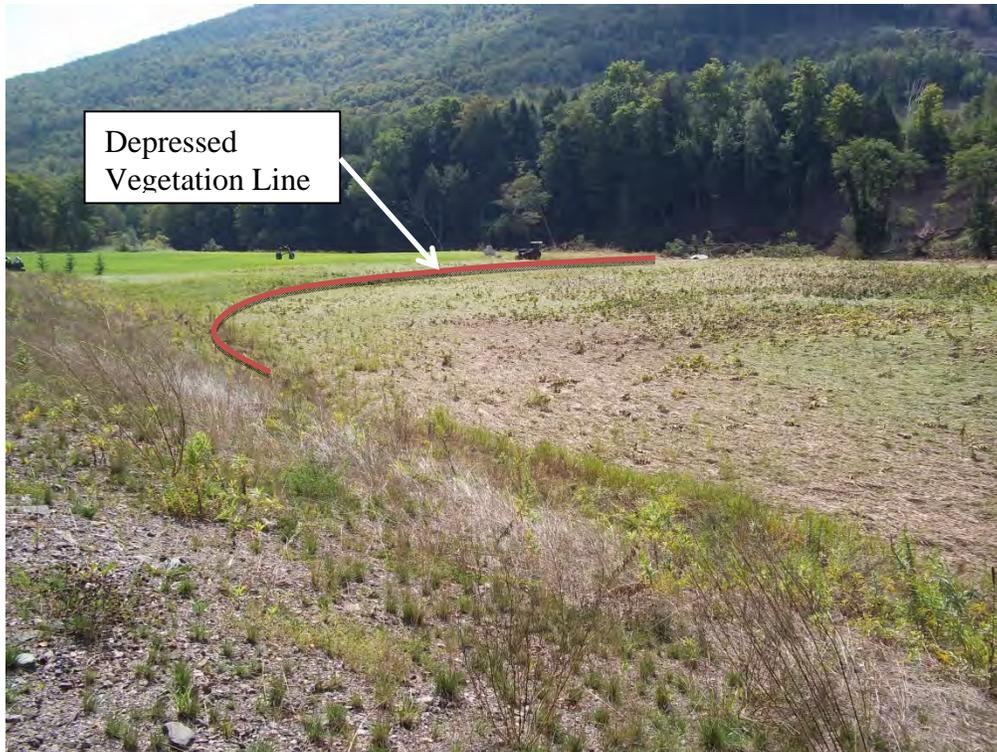
P16 (Survey Point 1044) – Field behind Diamond Landscaping Building. High water approximately by elevation of depressed vegetation (Photo taken 9/2/2011)

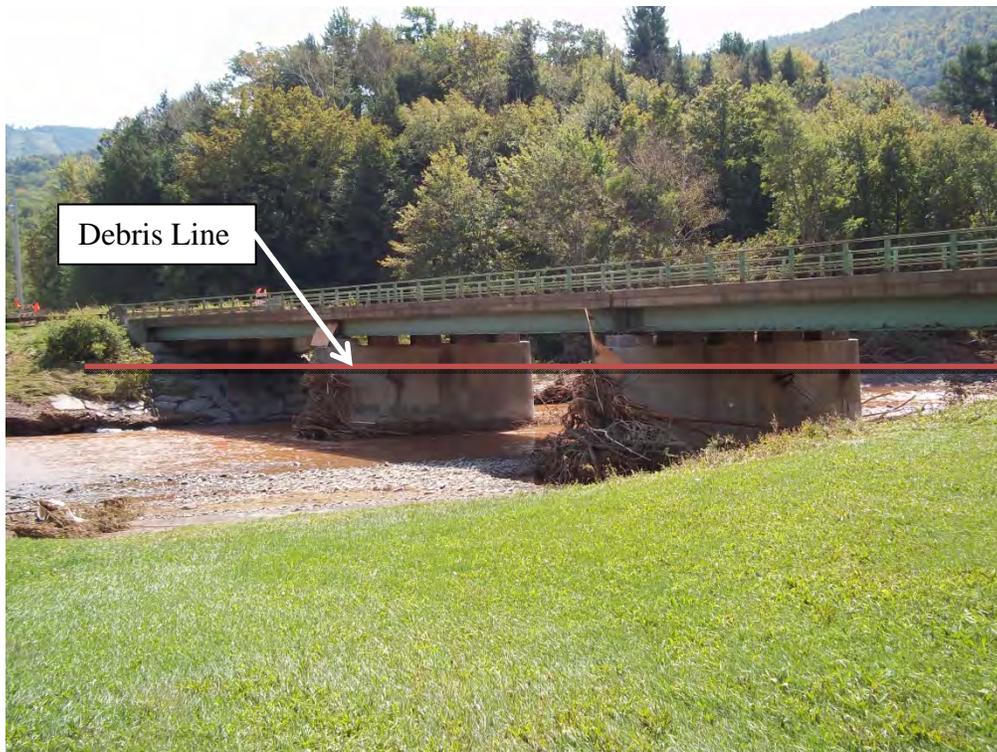
P17 (Survey Point 1043) – Upstream face of South Street bridge in Windham. High water elevation estimated based on elevation of debris on bridge pier and on banks. (Photo taken 9/2/2011)

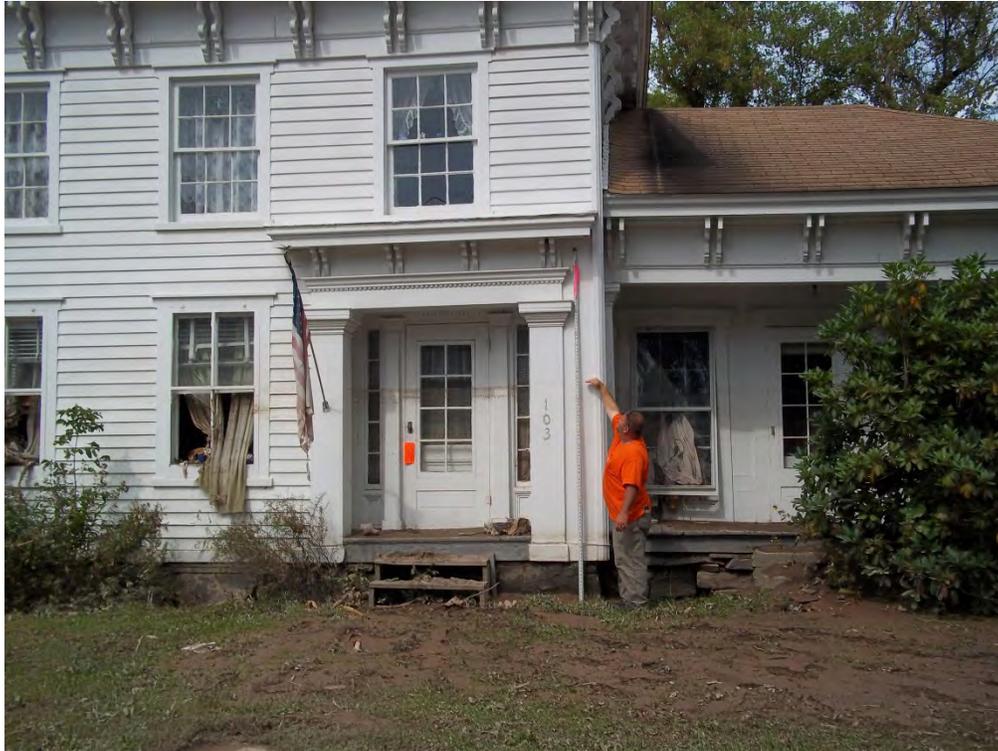
P31 (Survey Point 1029) – Mud line at 103 Bear Ladder Road, Blenheim. Surveyor is pointing to mud line with right hand. (Photo taken 9/1/2011)

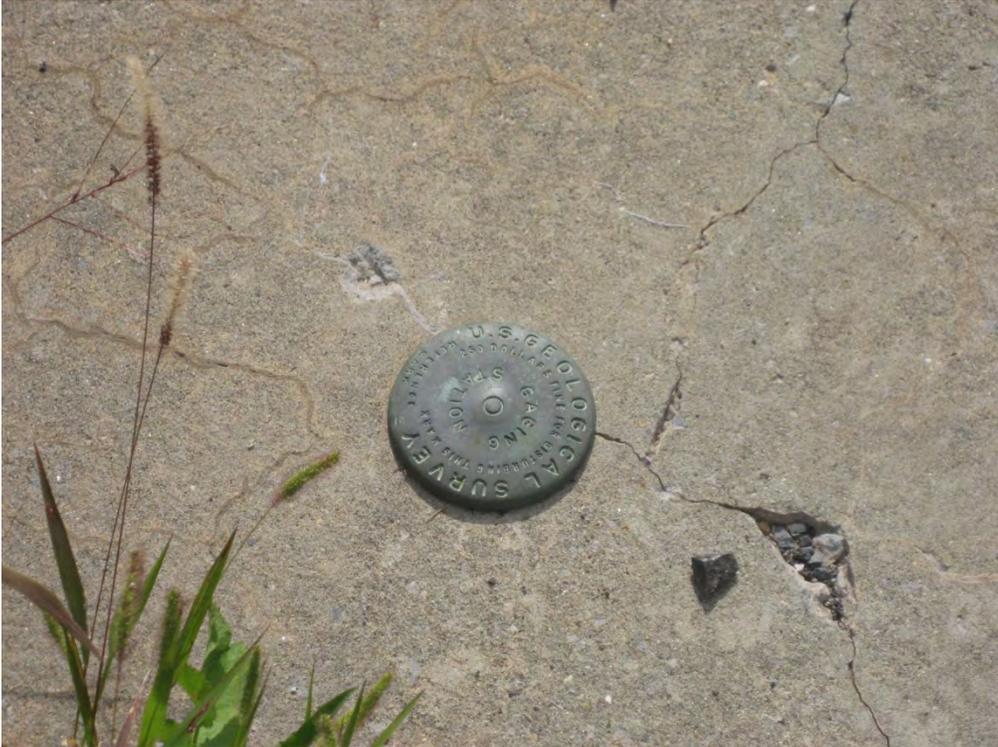
P36 (Survey Point 545) – USGS survey disc located on northeast abutment of NYS Route 30 bridge in Breakabeen (Photo taken 9/1/2011)

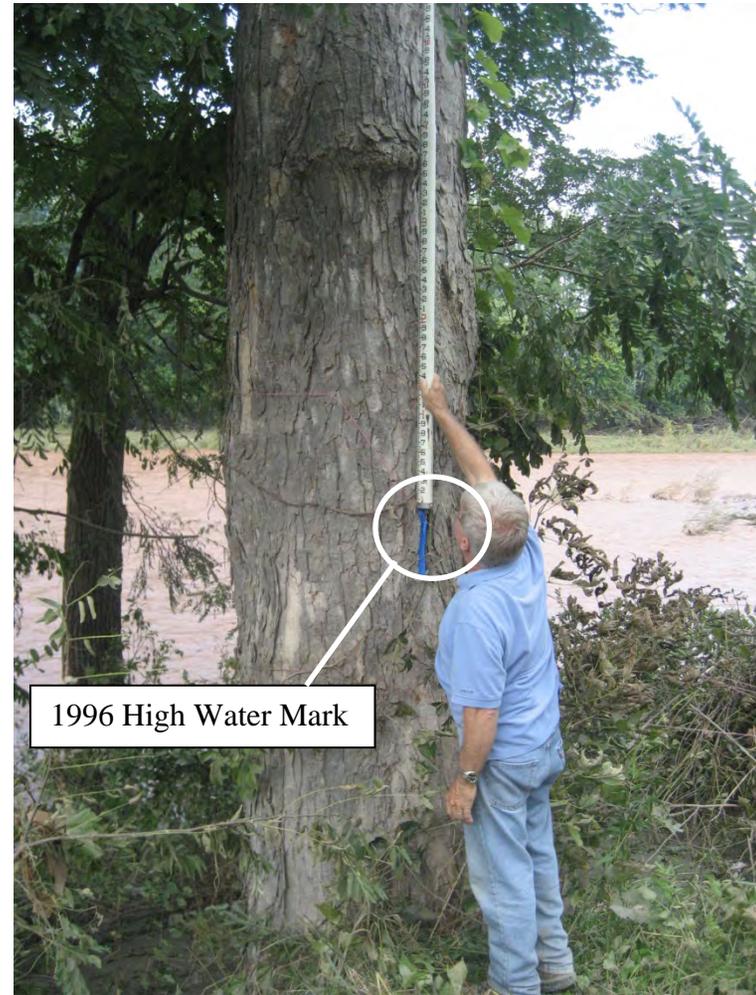
P41 (Survey Point 1022) – High water mark from 1996 flood (blue ribbon was added during 2011 survey). 2011 flood level approximately 3.8 feet above estimated 1996 high water level in area. (Photo taken 9/1/2011)

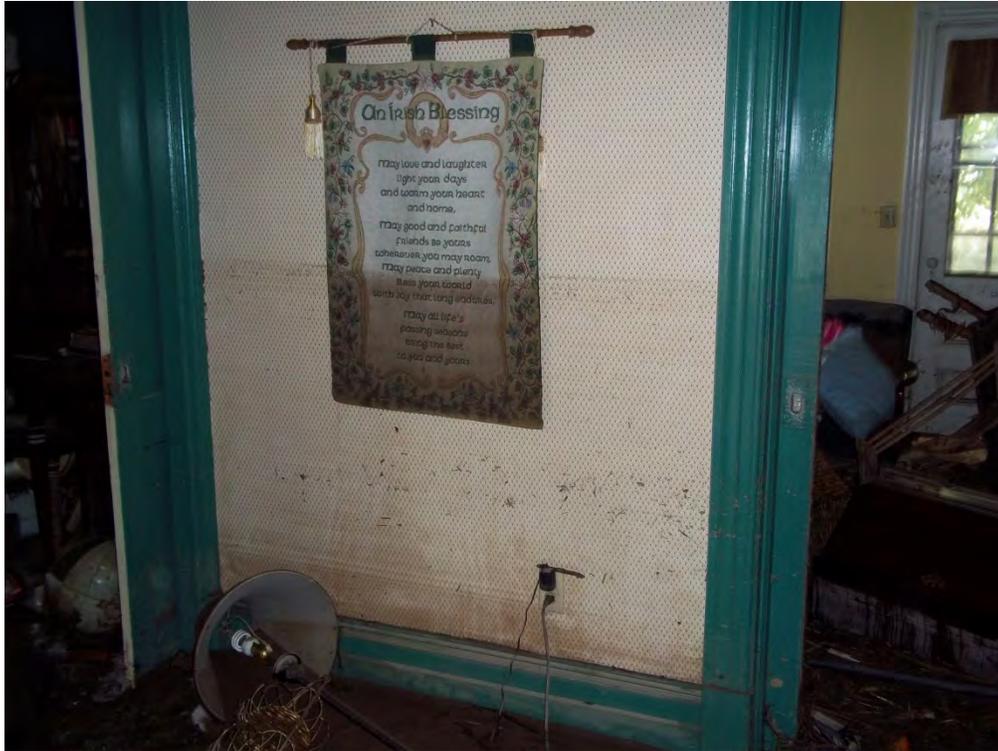
P42 (Survey Point 1023) – Mud line on interior of residence at 168 River Street in Middleburgh. Approximately 4.1 feet above the first floor elevation of home. (Photo taken 8/30/2011)

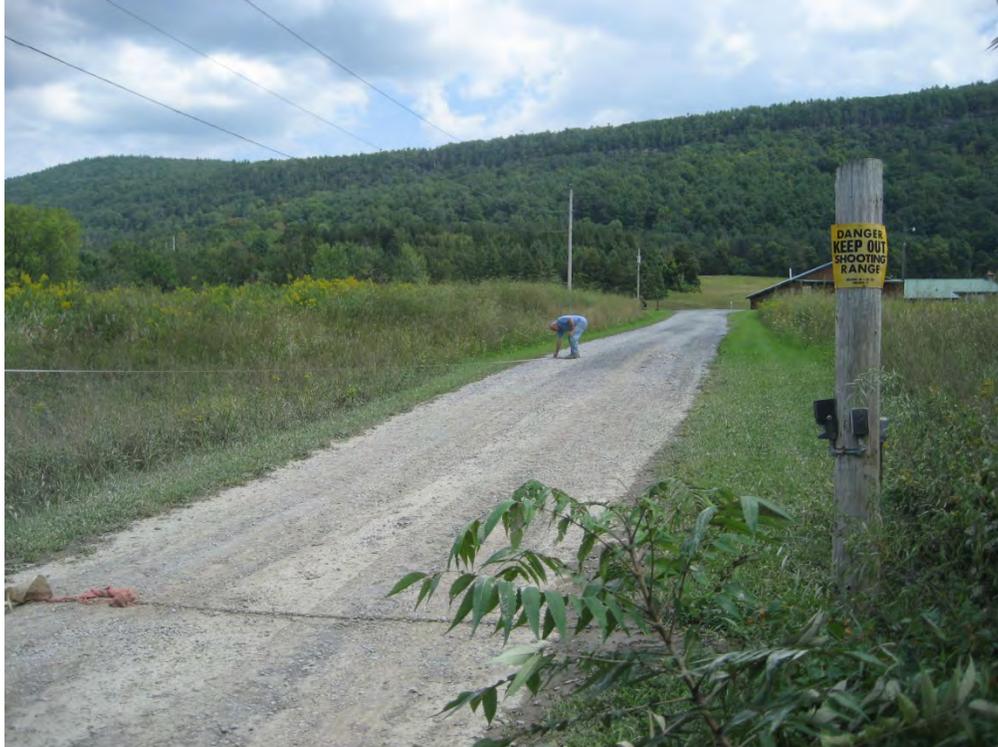
P43 (Survey Point 541) – Debris line located past entrance to Middleburgh Rod and Gun Club, near surveyor in photo. (Photo taken 9/1/2011)

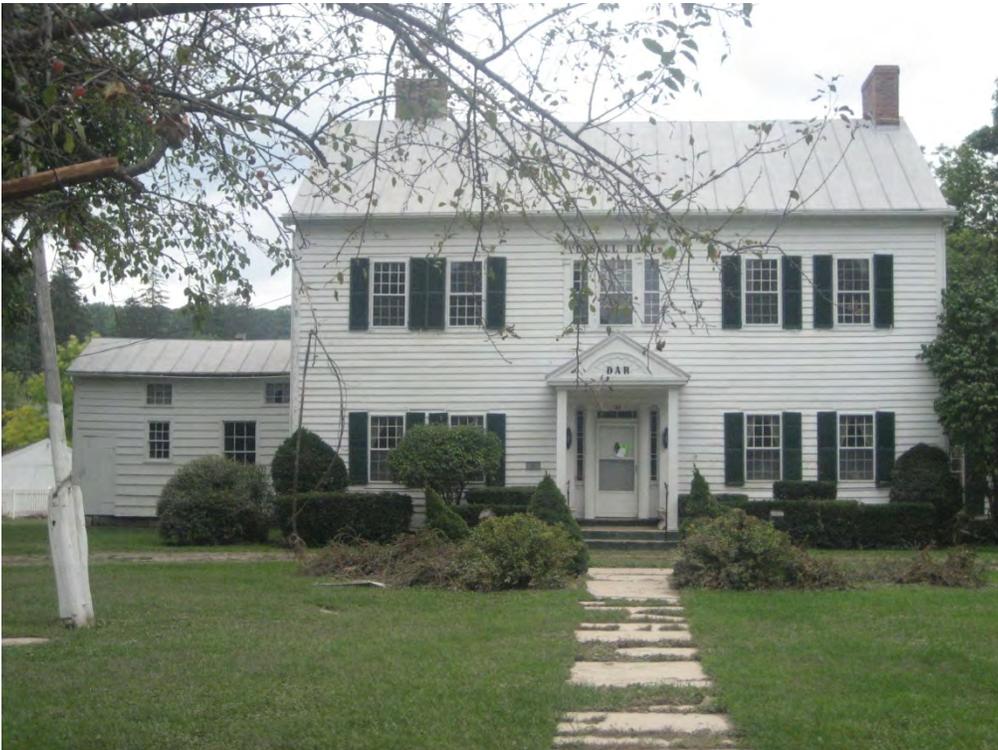
P45 (Survey Point 537) – Lassell Hall, Schoharie. Mud line approximately 4.9 feet above porch elevation. (Photo taken 9/1/2011)

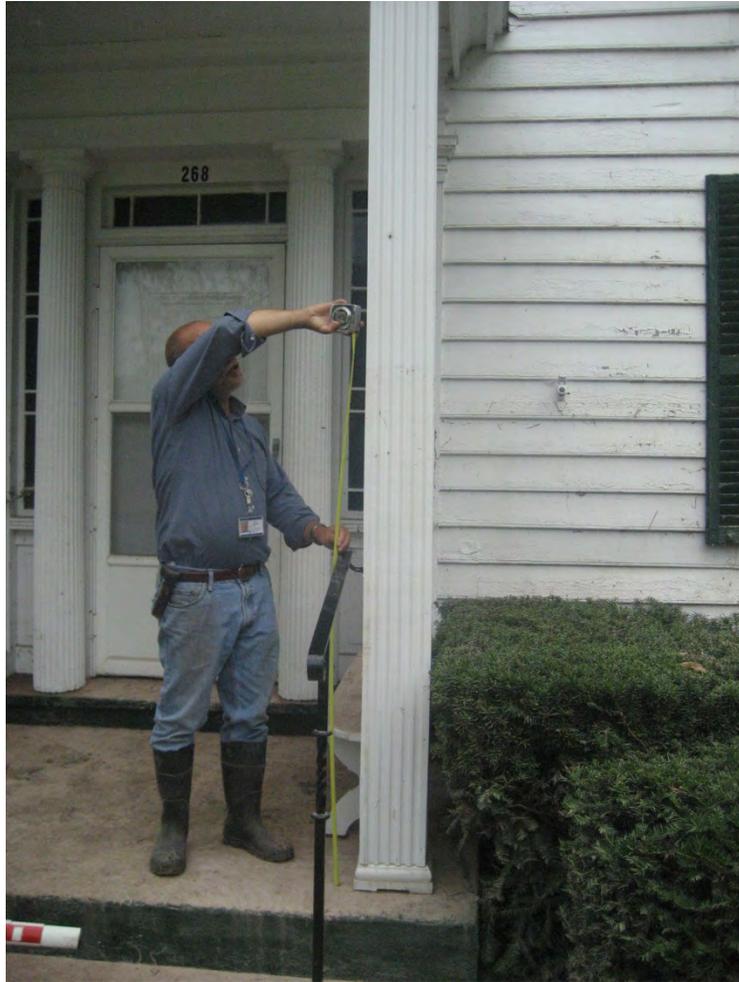
P46 (Survey Point 537) – Column in front of Lassell Hall, Schoharie. Mud line estimated approximately 4.9 feet above porch elevation. (Photo taken 9/1/2011).

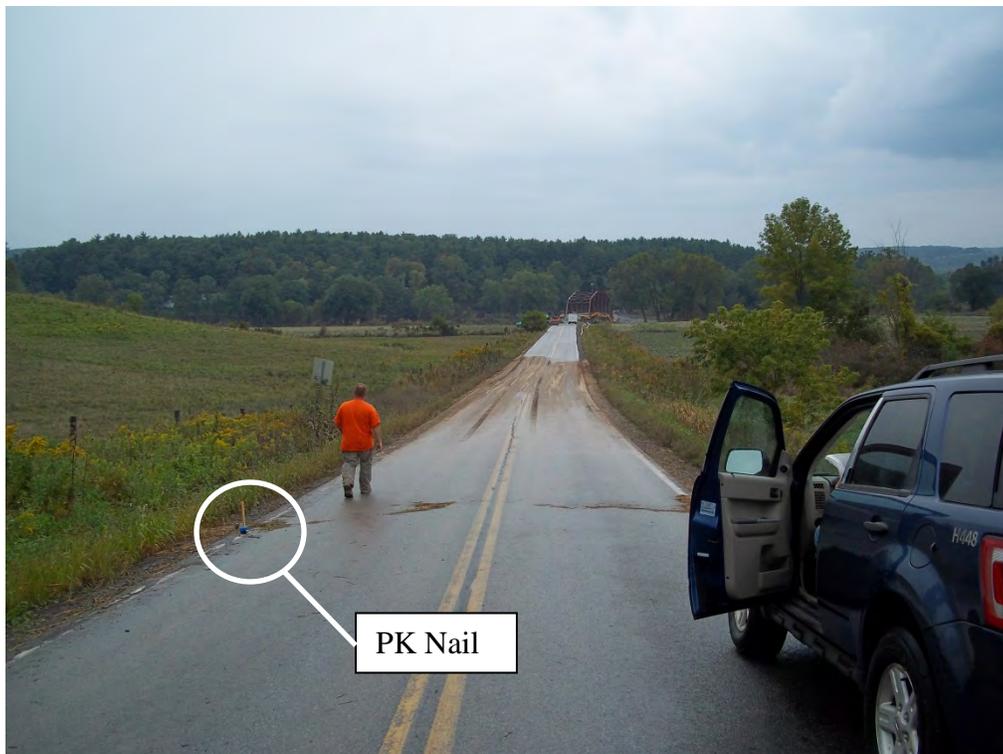
P49 (Survey Point 536) – Debris line on Junction Road south of bridge. PK nail driven into pavement at debris line, blue ribbon near stake on left side of photo. (Photo taken 9/1/2011)

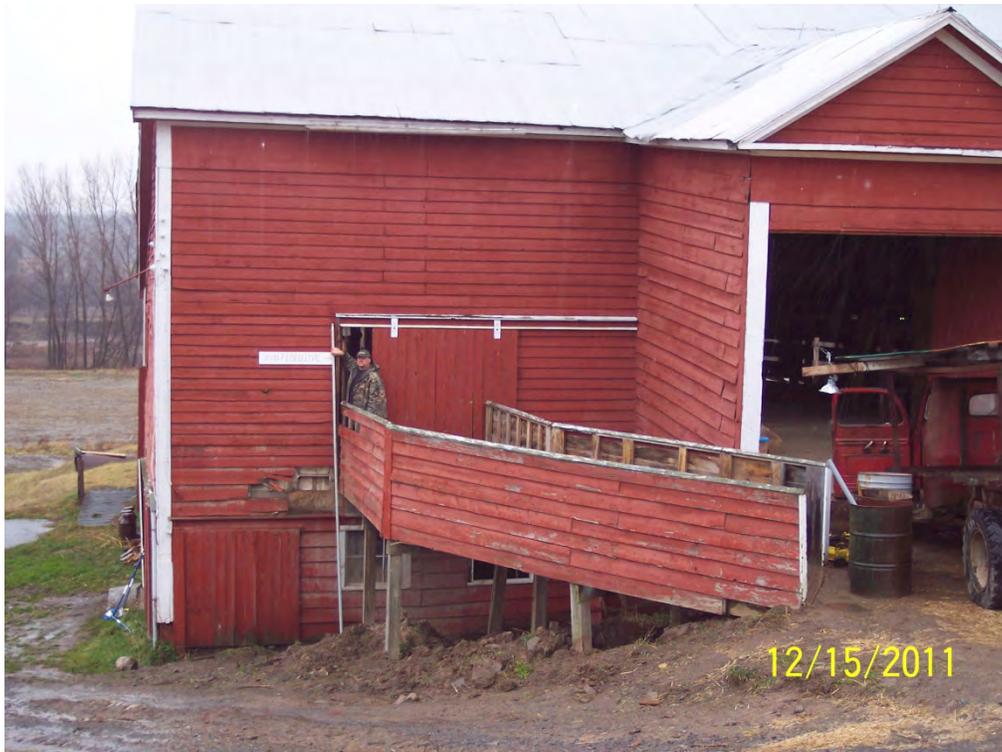
P50 (Survey Point 1020) – Red barn at the “Pumpkin Patch” near Central Bridge, NY. High water mark identified at white sign near surveyor’s hand (Photo taken 12/15/2011)

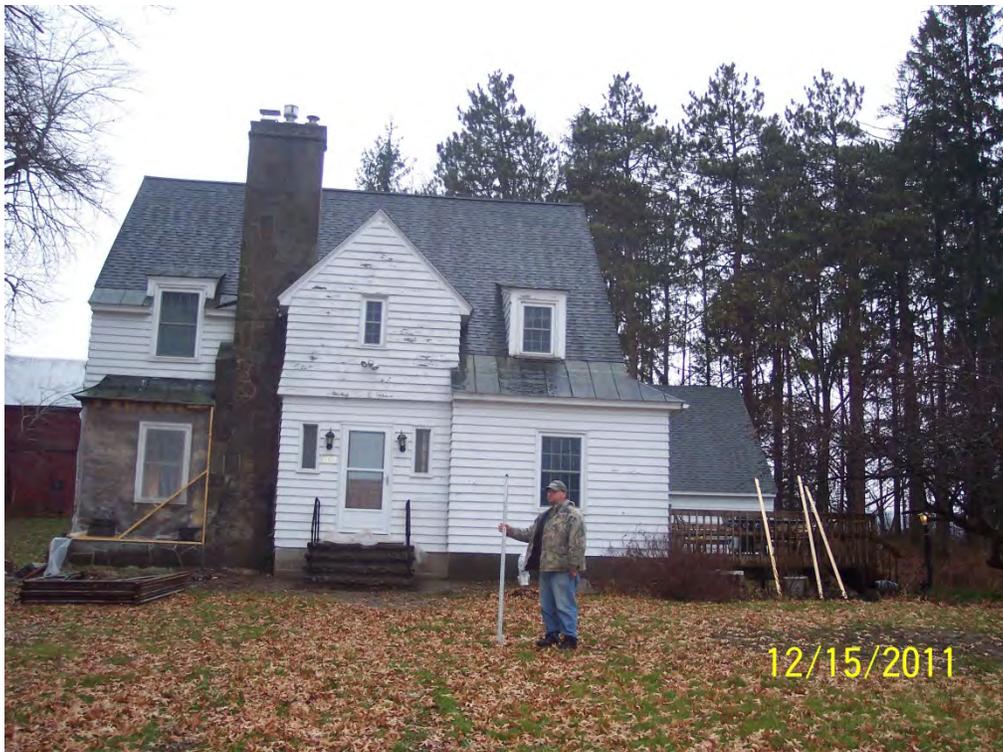
P52 (Survey Point 1019) – 102 Charleston Road, Esperance. Surveyor standing at approximate location of flooding during 1996 flood (as estimated by resident, Photo taken 12/15/2011).

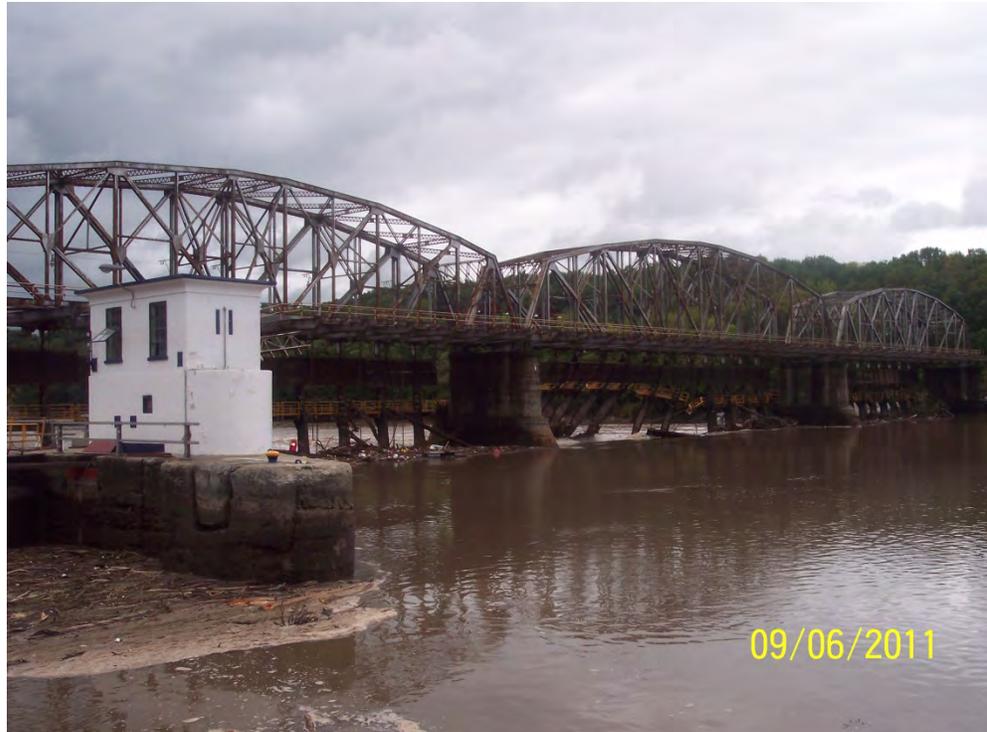
P58 (Survey Point 501), above – West (upstream) lock building at Lock 11. (Photo taken 9/6/2011)

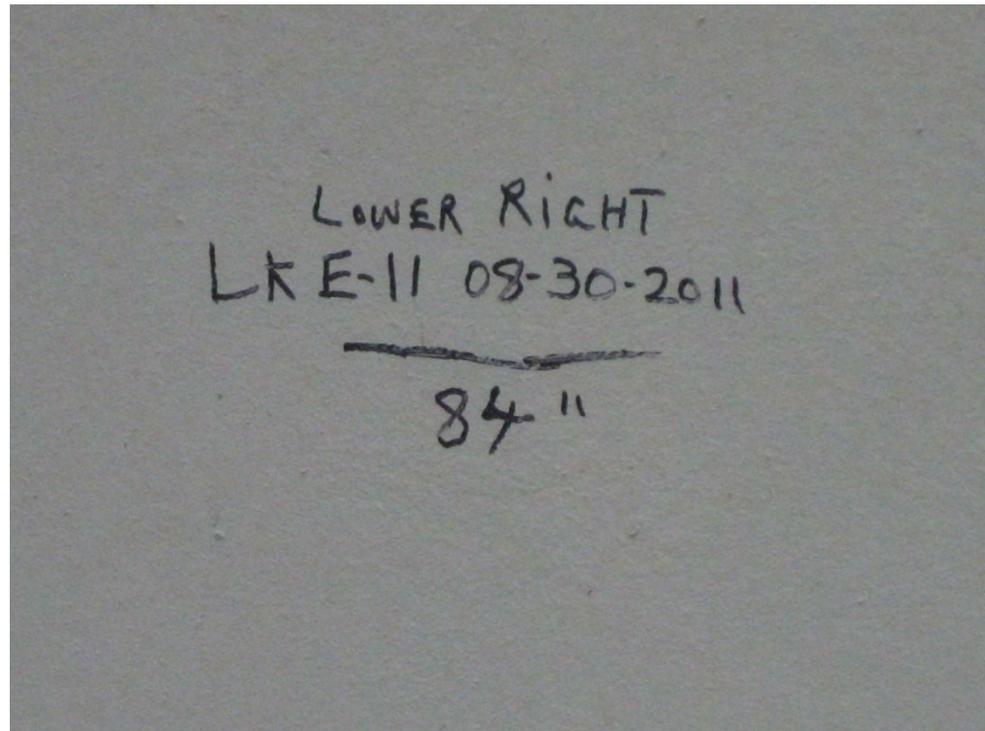
P61 (Survey Point 502), below – Close up of high water marker shown in above photo. (Photo taken 9/6/2011)

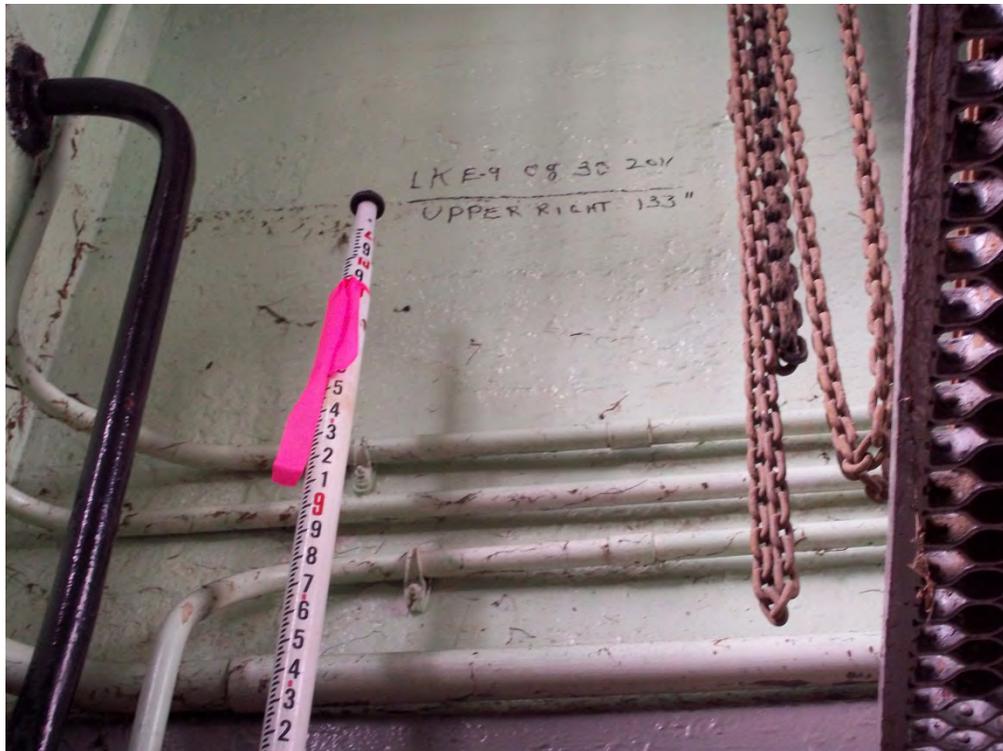
P65 (Survey Point 1009) – High water mark identified inside west (upstream) lock building, Lock 9. (Photo taken 9/6/2011)

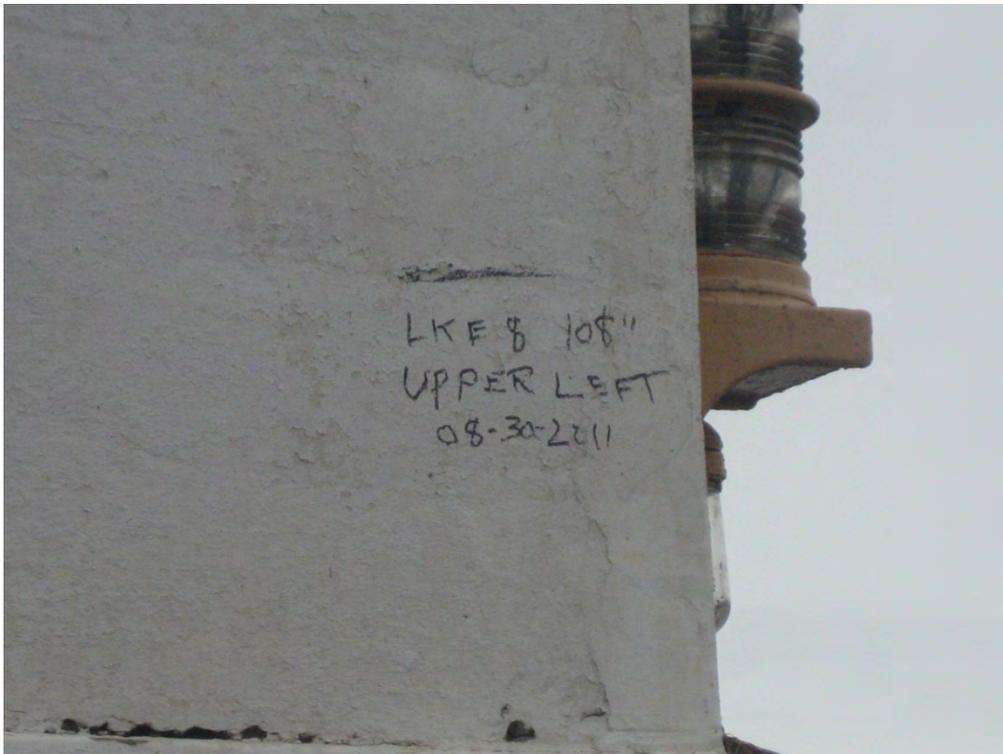
P67 (Survey Point 516) – High water mark identified outside west (upstream) lock building, Lock 8.  
(Photo taken 9/6/2011)

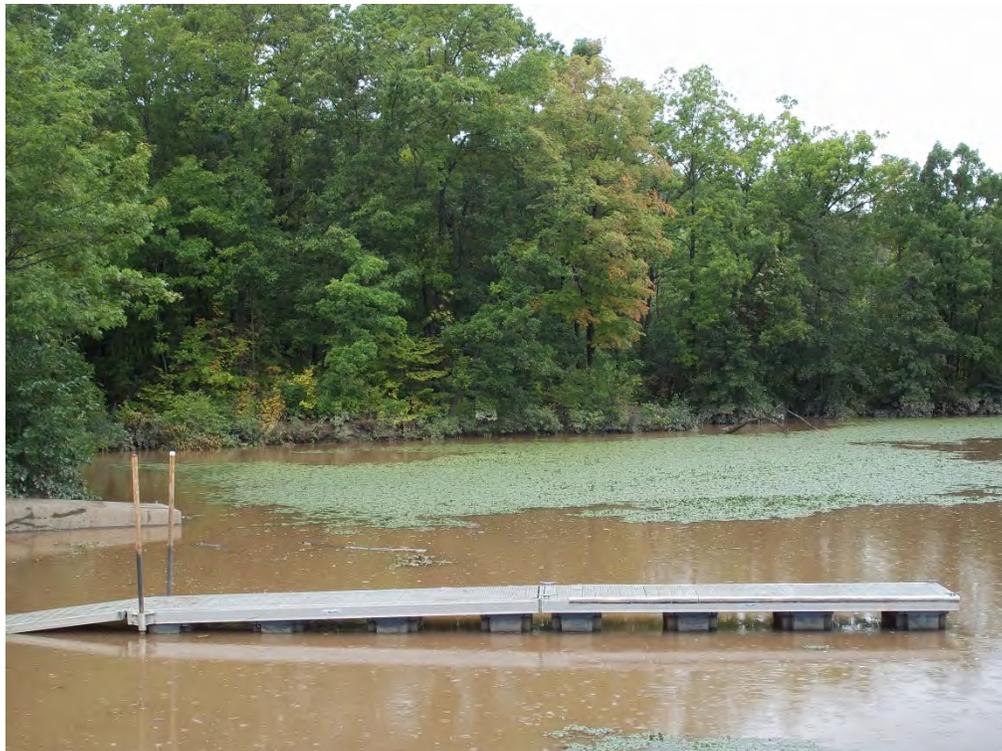
P69 (Survey Point 1017) – Right bank upstream of Lock 7 (Vischer Ferry Project). High water elevation surveyed based on mudline beyond. (Photo taken 9/6/2011)

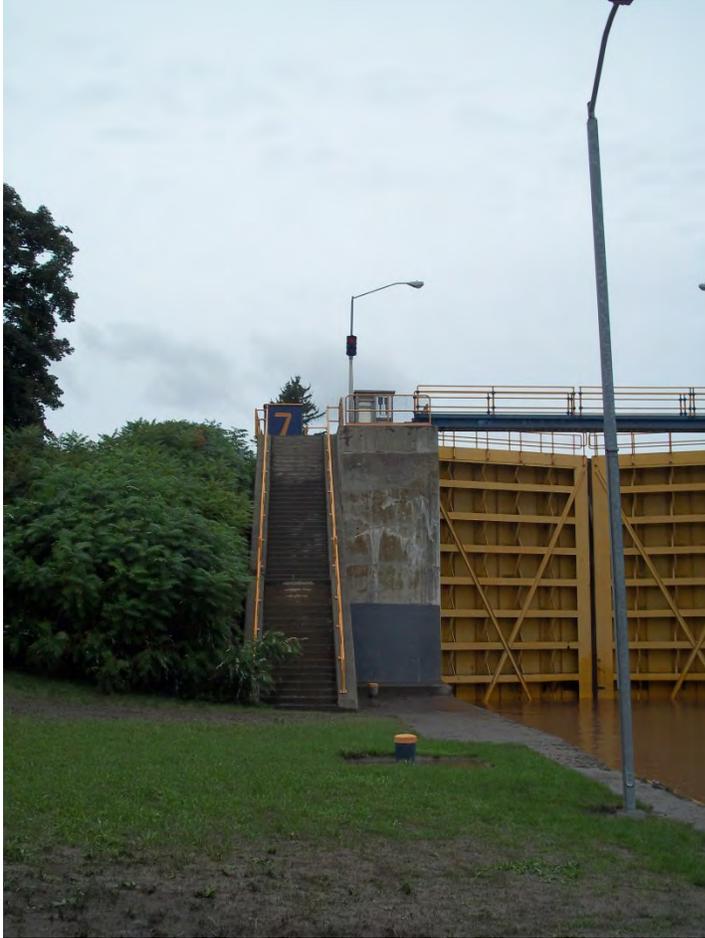
P70 (Survey Point 522), left – Downstream face of lower lock wall at Lock 7 – Vischer Ferry (Photo taken 9/6/2011)

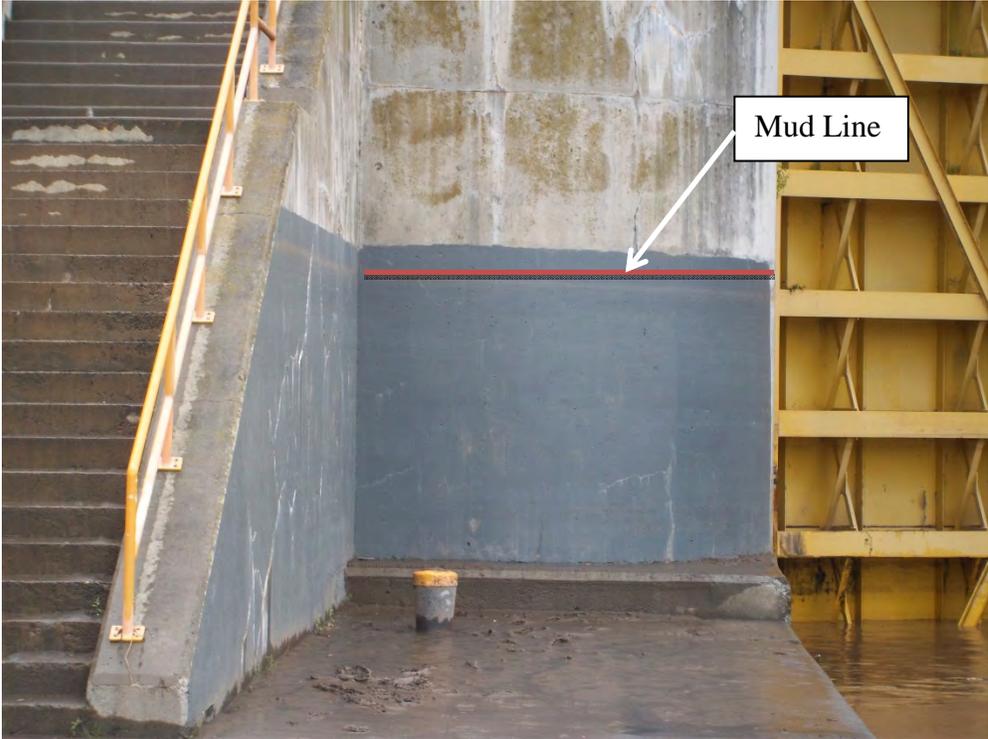
P71 (Survey Point 522), below – Close up lower lock wall from photo above. (Photo taken 9/6/2011)

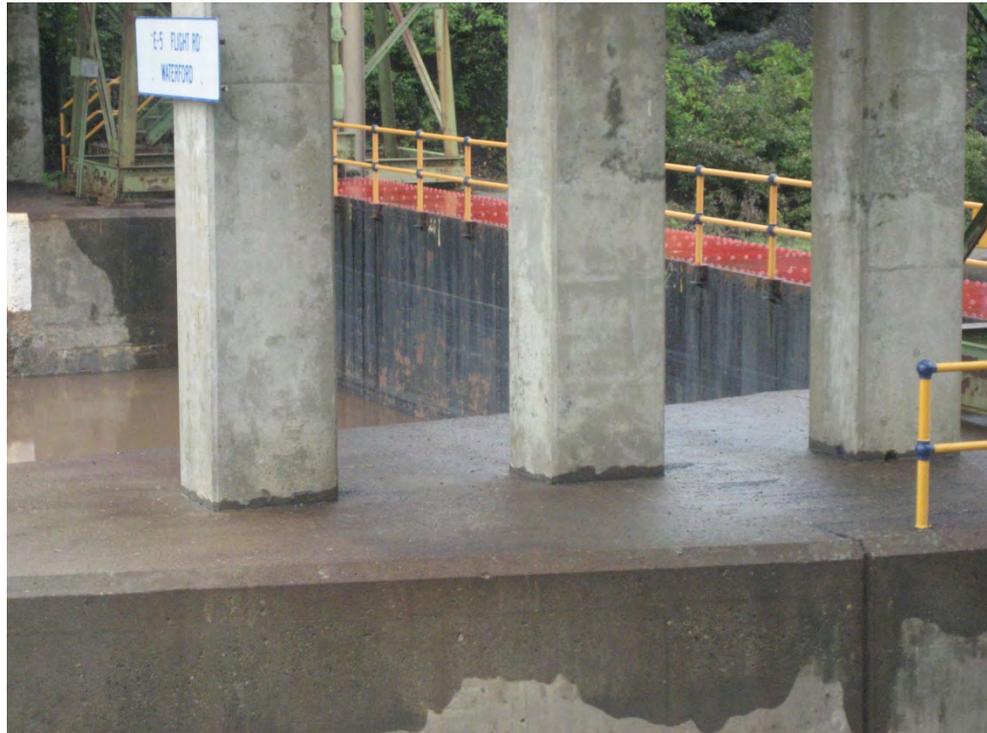
P73 (Survey Point 524), below – Gate (beyond concrete piers). Water line observed, approximately at El. 191.5 BCD (El. 189.77 NAVD) from staff gage in photo above. Staff gage located beyond left side of photo. (Photo taken 9/6/2011)

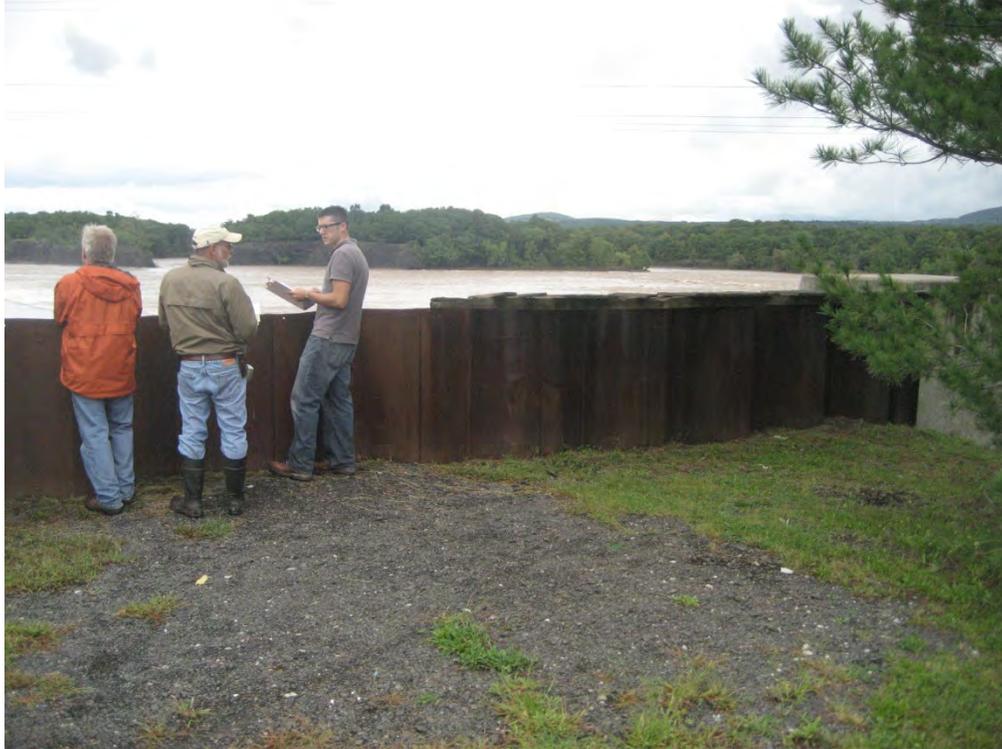
New York State Dam is located in Cohoes, NY, approximately 500 feet downstream of the Saratoga Street bridge over the Mohawk River. A high water mark (mud line) was observed on the steel sheet piling on the right (south) bank of the river, immediately upstream of the dam. The mud line was measured approximately 56 inches below the top of the sheet piling. The elevation of the mud line was surveyed at El. 60.0 (Survey Point 526).

P74 (Survey Point 526) – New York State Dam in Cohoes, NY. Sheet piling located immediately upstream of the dam, right bank. (Photo taken 9/6/2011)
