**TRANSMITTAL
REPORT
SOUTH ACCESS ROAD SLIDE AREA EVALUATION
BLenheim-GILBOA PUMPED STORAGE PROJECT
NEW YORK POWER AUTHORITY
FERC PROJECT NO. 2685-NY**

**SOUTH ACCESS ROAD SLIDE AREA EVALUATION
BLENHEIM-GILBOA PUMPED STORAGE POWER PROJECT
NEW YORK POWER AUTHORITY
FERC PROJECT NO. 2685-NY
JANUARY 5, 1998**

**PROJECT NO. 97-1734
JANUARY 5, 1998**

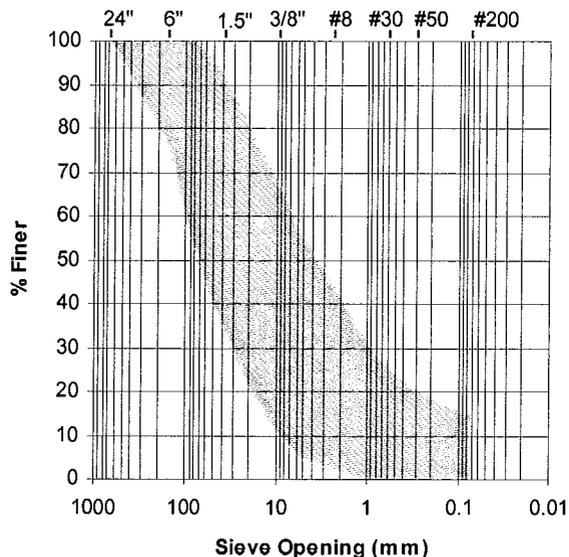
Figure 6-1 Grain size and grain size distribution

The material to be used for the berm should fall with the band of grain distribution curves shown on Figure 6-1.

A good gradation of the rock fill will allow reduction of voids and increase the weight and effectiveness of the berm.

be coordinated in detail with the operation of the Lower Reservoir. For example, the lower most portion of the berm should be started at the end of filling the Upper Reservoir, say on Sunday night or early Monday morning. We recommend that the material be free draining with grain size characteristics as shown above on Figure 6-1, with the coarser material being placed initially on the existing foundation material.

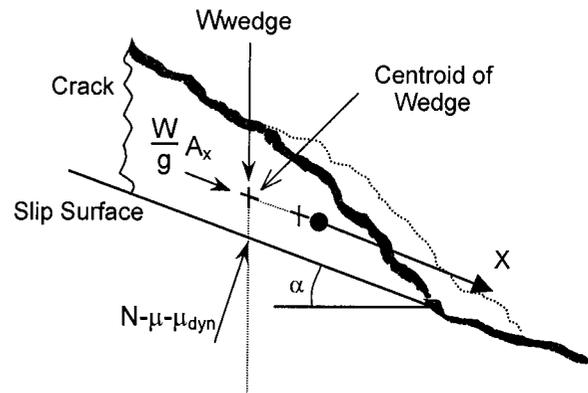
Figure 7-1 Free Body Diagram of Sliding Mass

As stated above, the travel angle calculated for the South Access Road Slide is approximately 11.6 degrees. The basic components of the dynamic model are highlighted in Figure 6-1.

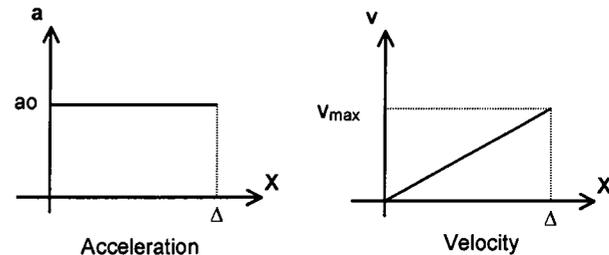
Figure 7-2 Constant acceleration distribution

The most conservative acceleration versus time distribution would involve constant acceleration versus time with a linearly increasing velocity distribution over the entire distance of movement. The block would continuously accelerate and come to an abrupt halt at the end of the movement, usually in contact with a body of water or an impeding slope such as the opposite wall of a valley. The acceleration and velocity distribution will have the shape shown in Figure 7-2.

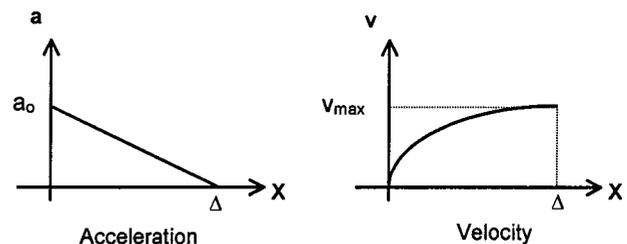
Figure 7-3 Linear acceleration distribution

A slightly less conservative and more realistic acceleration distribution was selected for our dynamic model. The acceleration is postulated to begin at a maximum and decrease linearly to zero at the maximum distance of movement. We believe

this distribution is closer to reality from the perspective that a moving mass tends toward a more stable position as it moves, thus decelerating (Figure 7-3).

This also results in a block with increasing velocity and coming to an abrupt halt at the end of movement. The velocity distribution is parabolic shaped with a sharp drop at the end of movement. Eliminating the earthquake component of the acceleration function, and estimating μ to be a fraction of W , say $F W$, the maximum velocity as a function of distance is calculated from the function given below:

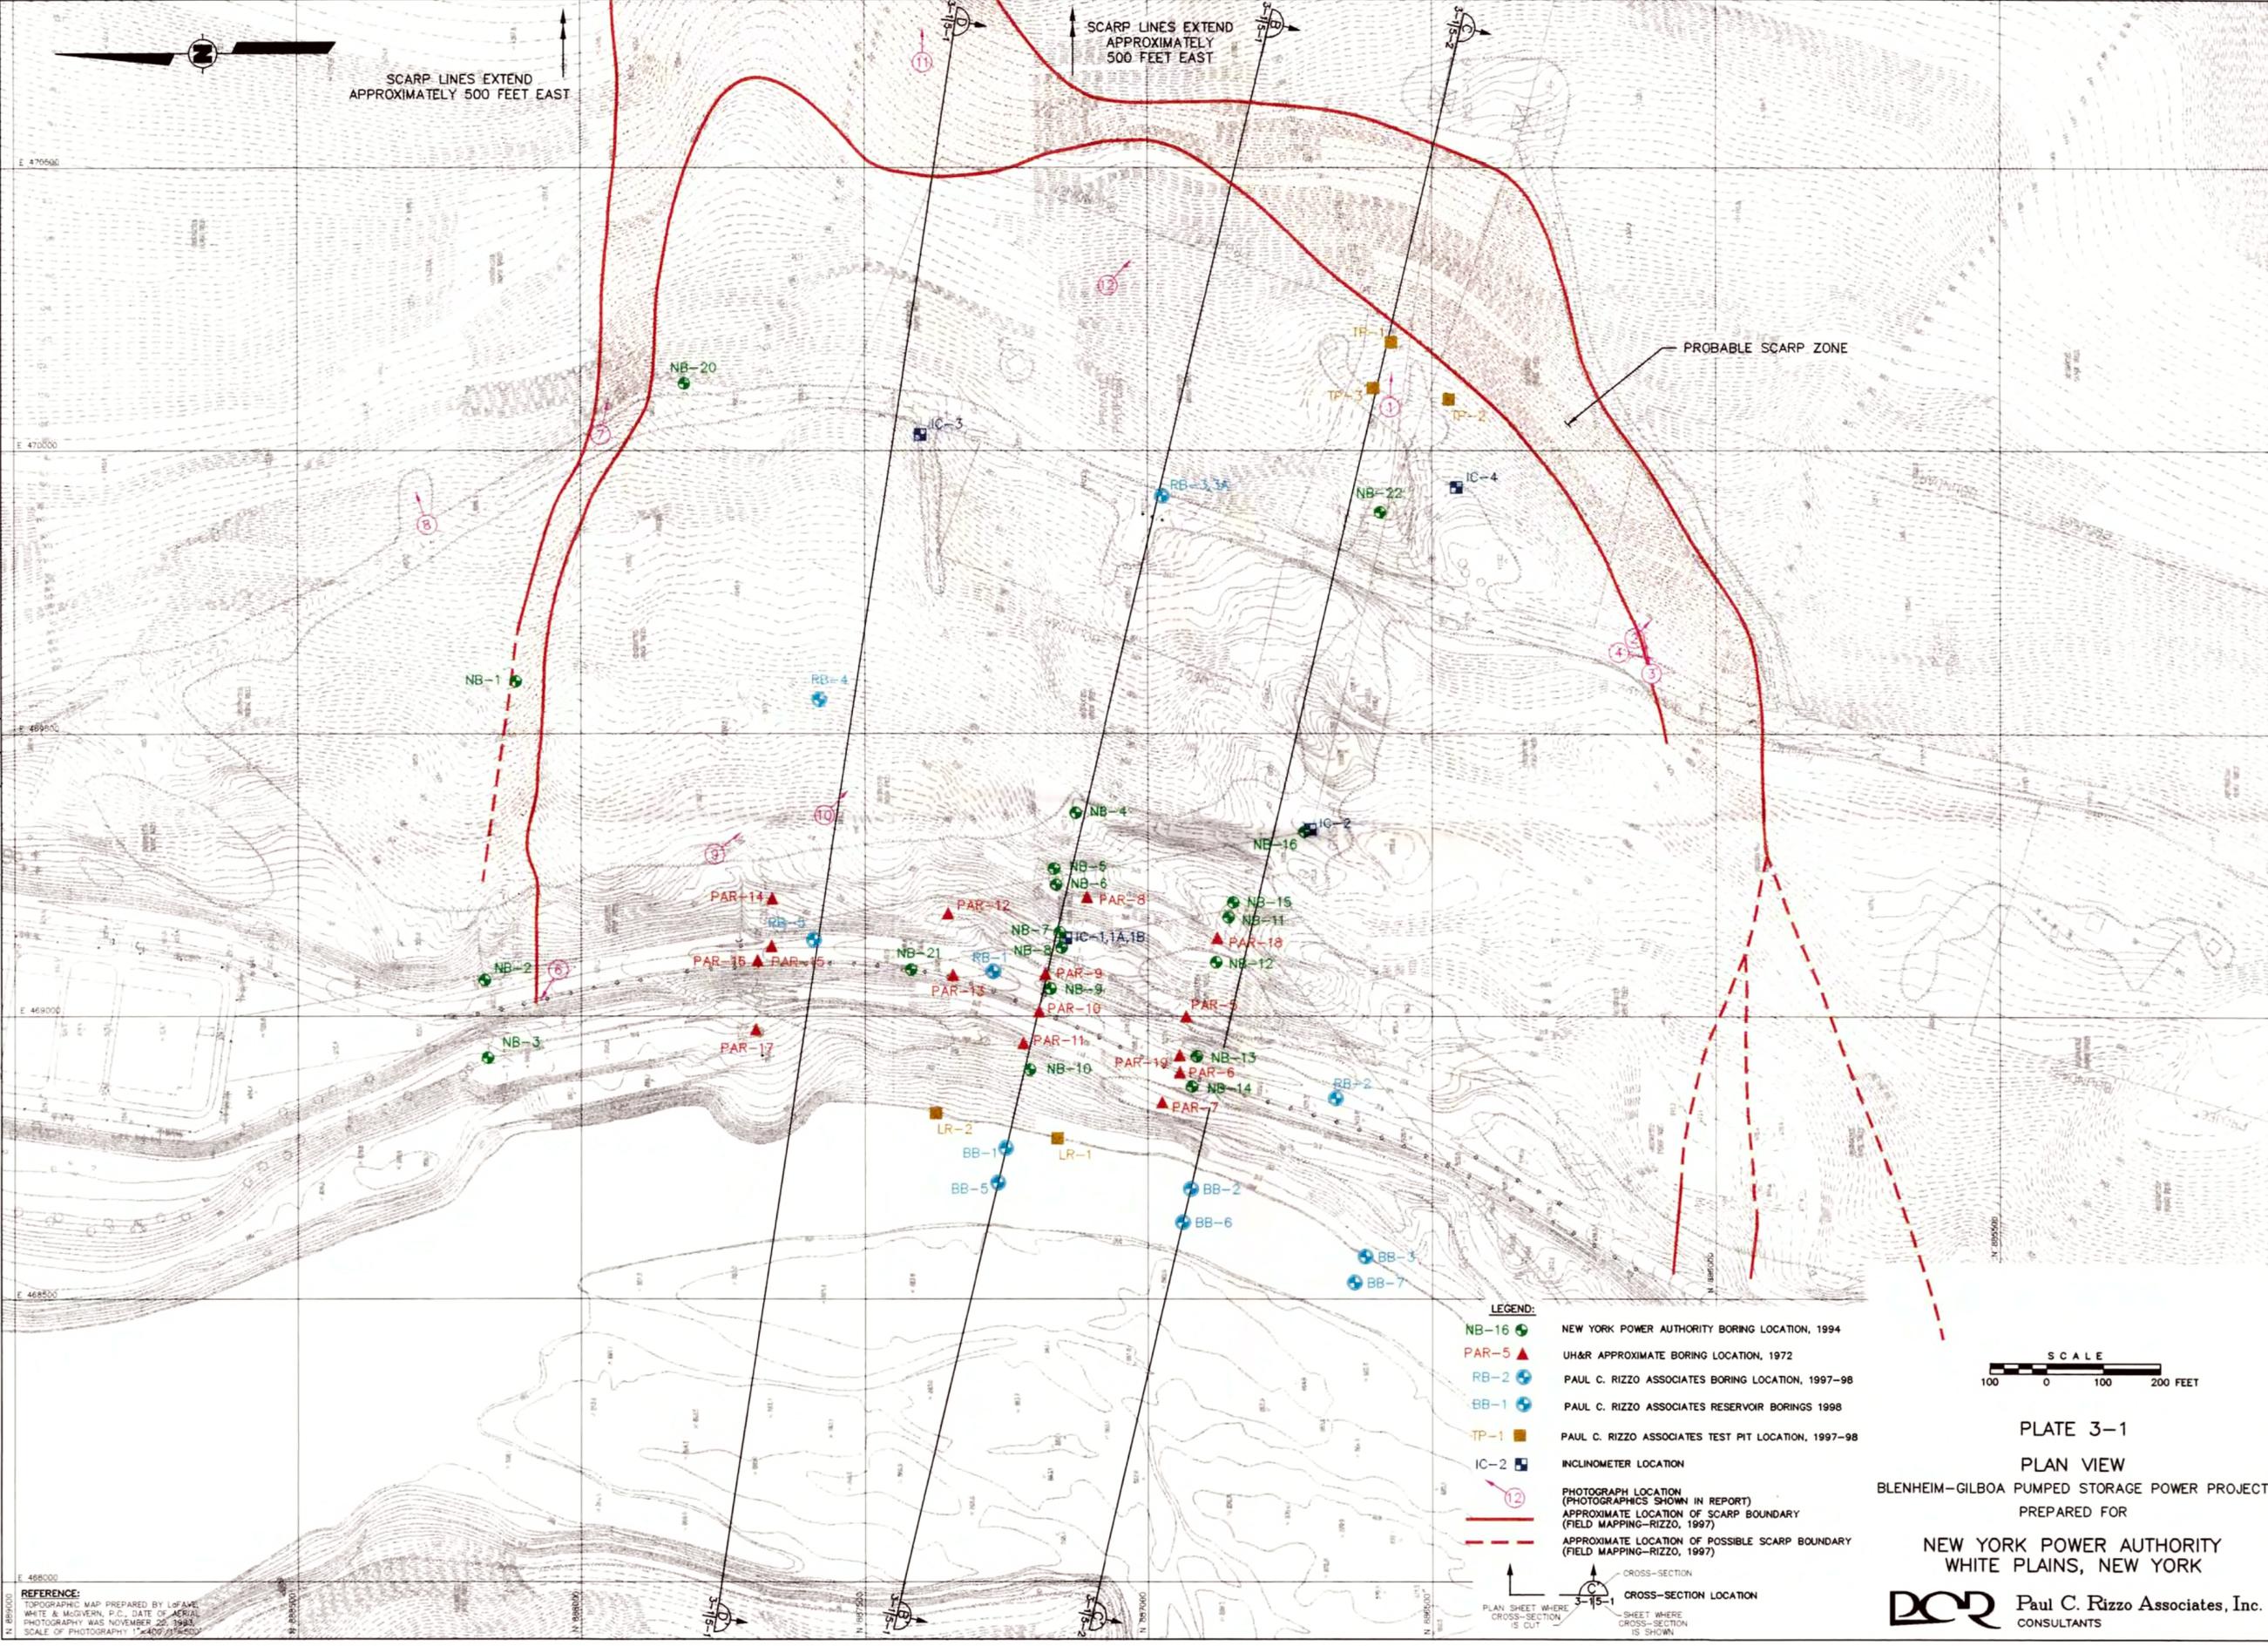
PLATE 3-1
 PLAN VIEW
 BLENHEIM-GILBOA PUMPED STORAGE POWER PROJECT
 PREPARED FOR
 NEW YORK POWER AUTHORITY
 WHITE PLAINS, NEW YORK
 Paul C. Rizzo Associates, Inc.
 CONSULTANTS

During Phase III, surface water mapping within the slide zone began at the north end of Valenti Road Extension (in the area of Photograph No. 8 as shown on Plate 3-1) and proceeded south. The observed surface water features were mapped by walking their entire length both above (to their headwaters) and below the road (often the entire distance to the Lower Reservoir). Areas of standing water or poor drainage were marked with colored flagging for future surveying (if required). Base maps were developed showing the approximate location and extent of the surface water features.

The stability of the slope adjacent to the South Access Road was analyzed at three critical cross sections as shown in plan on Plate 3-1. A rapid drawdown case was considered, whereby the water level in the Lower Reservoir was dropped 40 feet over a 2-day period. Stabilization analysis was performed for berm placement at the toe of the slide. This remediation alternative presents a cost-effective method of stopping or reducing the movement of the potential toe slides in slope beneath the Transmission Lines.

- The estimated maximum velocity of the slide as discussed in the preceding section.
- The cross-sectional area of the sliding mass as estimated from the scarp lines shown on Plate 3-1 and the infrared image presented as Plate 1-1. We believe the slide area is approximately 2,000 feet wide.
- The volume of the portion of the slide that actually displaces water.
